UNITED STATES AIR FORCE
AIRCRAFT ACCIDENT INVESTIGATION
BOARD REPORT

E-4B, T/N 73-1676

55th WING
OFFUTT AIR FORCE BASE, NEBRASKA

DATE OF ACCIDENT: 12 MAY 2010

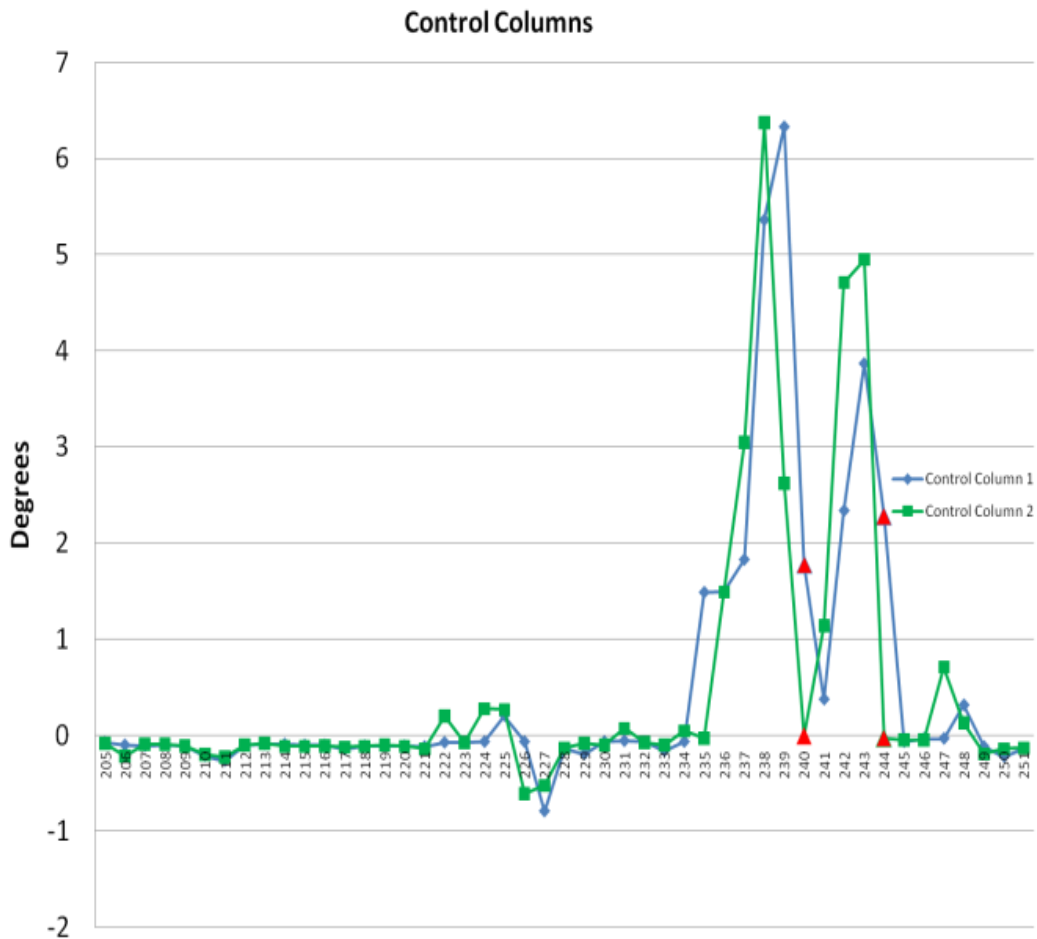
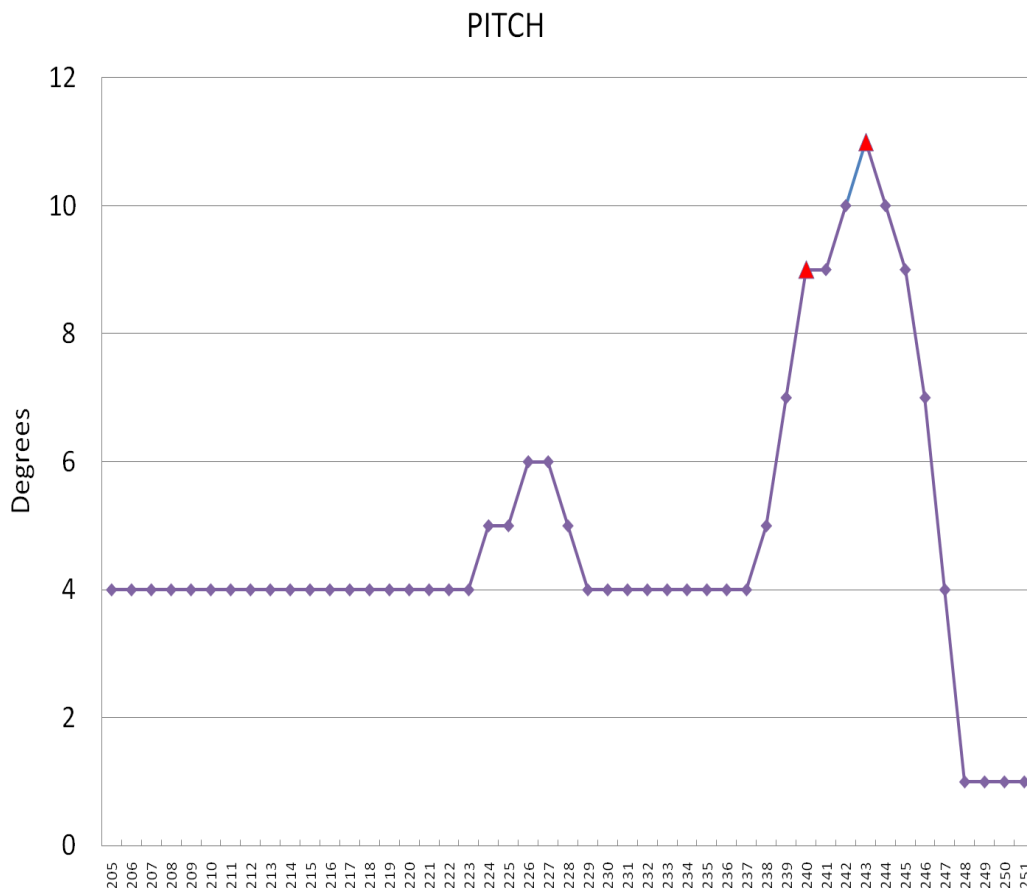
Immediately after the initial touchdown, the MA became airborne again, with no members of the MC immediately aware they were airborne (Tab V-6.18). Upon the first touchdown, MP1 had initially relaxed aft control column pressure (released backpressure on the yoke) (Tab DD-3). However, when he realized the MA was again airborne, MP1 pulled back on the yoke again in an attempt to smooth the subsequent landing (Tabs DD-3 and V-4.13). While airborne from the bounce, pitch on the MA came up to approximately 11 degrees, due in part to MP1’s aft control column input (Tabs DD-3 and DD-6). As the MA then settled back towards the runway, portions of the lower aft fuselage made contact with the runway surface, causing a “tail strike” (Tab V-4.14).

At approximately 2310 local time, at approximately 1,300 feet past the approach end threshold of RW 30, the tail section of the MA struck the ground approximately 2-3 feet to the right of the centerline nearly simultaneously to the landing gear touching down (Tab II-6). The MA sustained damage under the fuselage tail area that contacted the runway, as described in section 6 below.

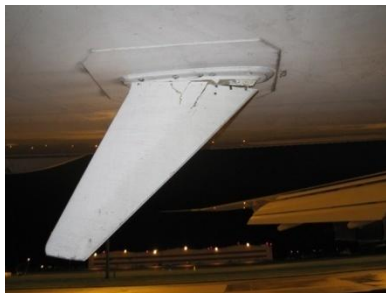
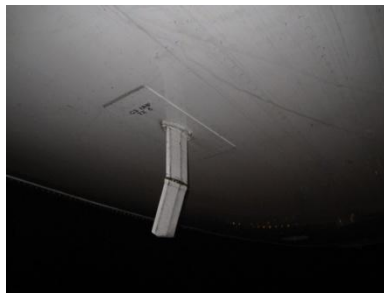
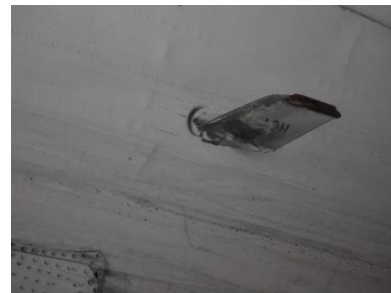
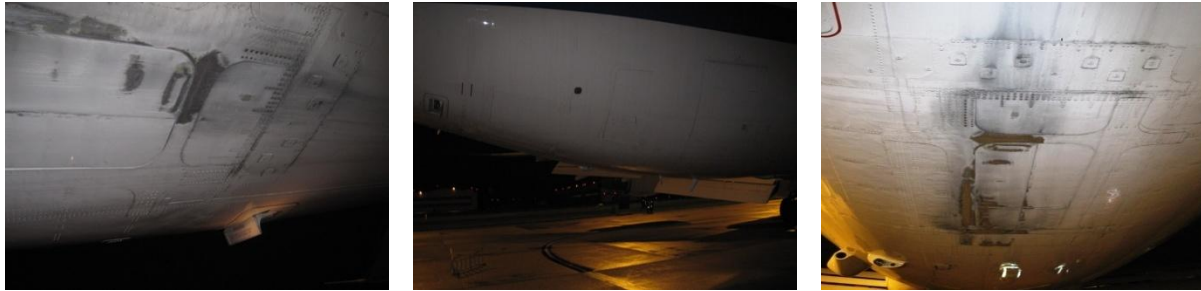
After landing, the MA taxied under its own power after the mishap and was inspected by Quality Assurance and 55 WG Safety personnel. Damage to the aircraft was photographed immediately following the mishap after the aircraft taxied to parking. (Tabs S-7 through S-14). The aircraft sustained substantial damage from Body Station (BS) 1800 to BS 2320 on the belly of the aircraft. External damage to the very high frequency data link antenna, a command, control, and communications (C3) “receive” antenna, drain mast next to the long trailing wire antenna doors, aircraft left outflow valve, and the drain mast for the aft lavatories was visible upon landing, along with scrapes along the skin (Tab P-3). No relevant pre-existing defects were noted.
