**UNITED STATES AIR FORCE**  
**AIRCRAFT ACCIDENT INVESTIGATION**  
**BOARD REPORT**

**F-15E STRIKE EAGLE, T/N 91-000304**

**492D FIGHTER SQUADRON  
48TH FIGHTER WING  
ROYAL AIR FORCE LAKENHEATH, UNITED KINGDOM**

**DATE OF ACCIDENT: 21 MARCH 2011**

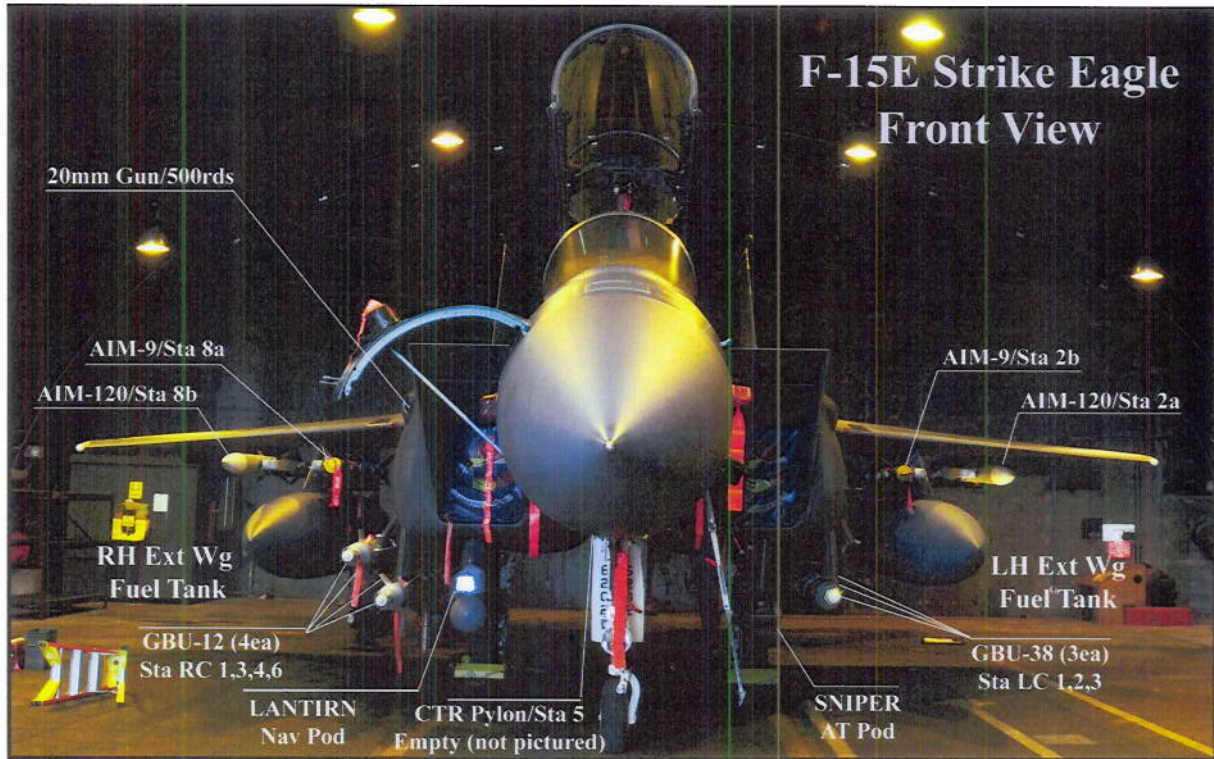
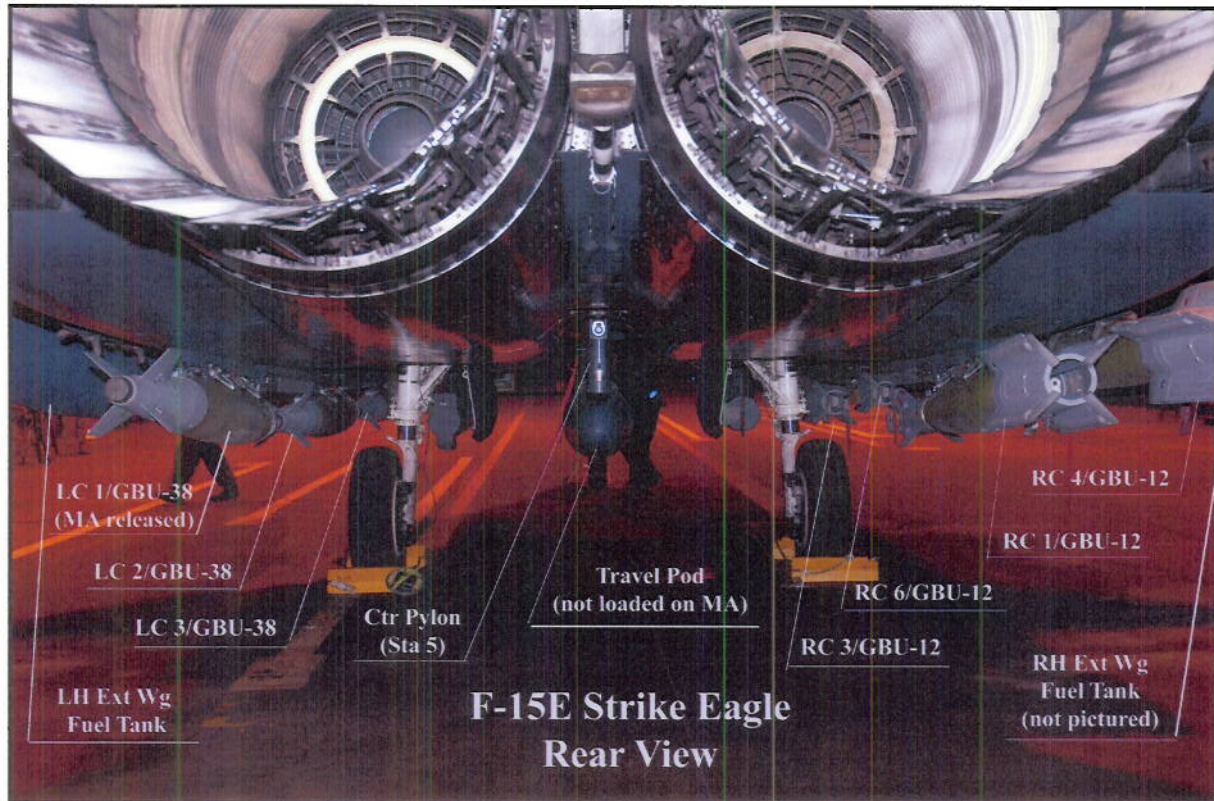
In order to execute mission objectives, the MF was configured with two AIM-120s (outboard wing stations 2a, 8b), two AIM-9s (inboard wing stations 2b, 8a), two 610 gallon external fuel tanks (wing stations 2, 8), two 750 gallon Conformal Fuel Tanks (CFTs), Sniper Advanced Targeting Pod, LANTIRN Navigation Pod, three GBU-38s (Left Conformal stations 1/2/3), four GBU-12s (Right Conformal stations 1/3/4/6), 500 20mm rounds of ammunition, and centerline pylon not loaded with stores. The aircraft is inherently right wing heavy by 1,850 foot pounds (ft-lbs) due to the gun and its support equipment; with the added stores, the MA had a take-off lateral imbalance of 8,168 ft-lbs (Tabs V-1.7, V-1.14, V-2.6, V-4.6, AA-13 to AA-16).

*The photographs below depict a front and back view of the F-15E's munitions configuration. Photographs were provided by the Air Force Public Affairs Office at RAF Lakenheath, UK. Labels and descriptions were added by the AIB based on witness and documentary evidence.*

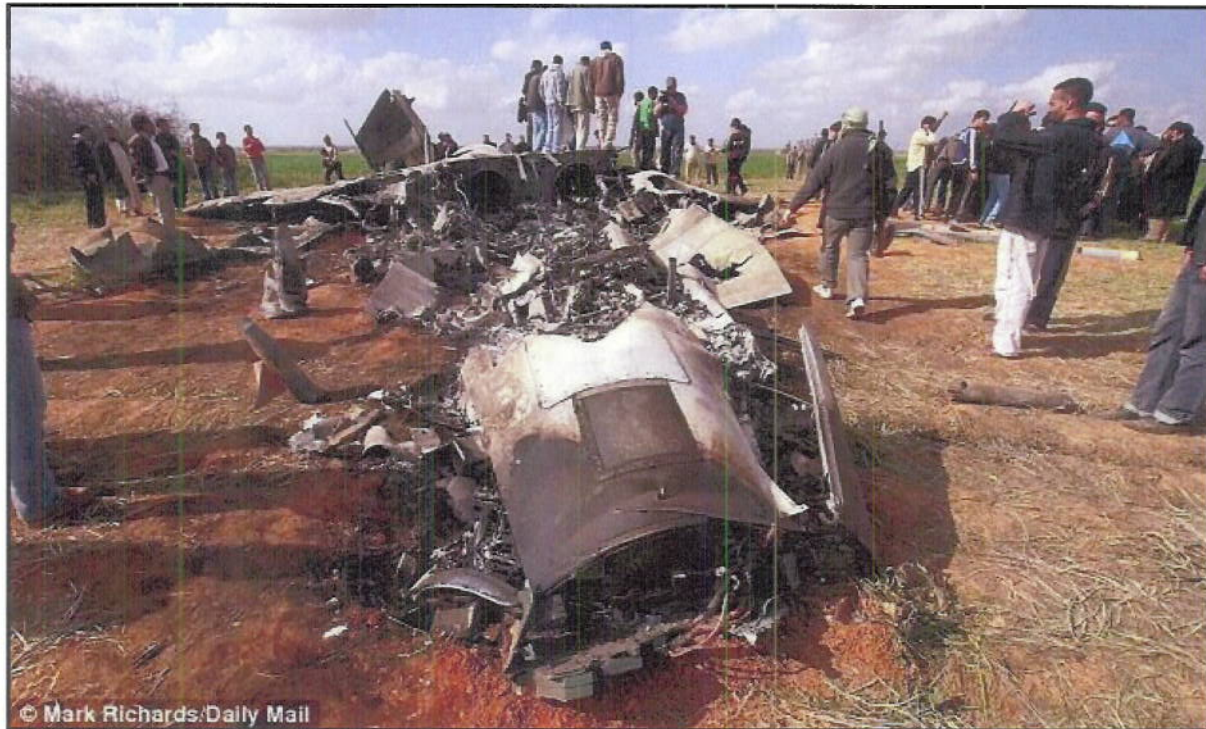
### Front View of Mishap Aircraft's Nose Section

The MA impacted the ground at approximately 2129Z in an unpopulated area near Benghazi, Libya and was destroyed. Photographs from the impact site indicate the MA struck the ground flat with near zero forward velocity and significant left rotation. This damage to the MA is consistent with a left flat spin. There were no known civilian casualties or additional damage at impact (Tabs M-3, M-4, N-4, P-5, and S-4 to S-18).

*The photograph shows the MA impacted the ground in a spin. This is apparent from the fact that the length of the MA is not significantly compressed, the aircraft nose is compressed flat on the ground, and the ground around the nose section is not cratered or significantly scarred.*

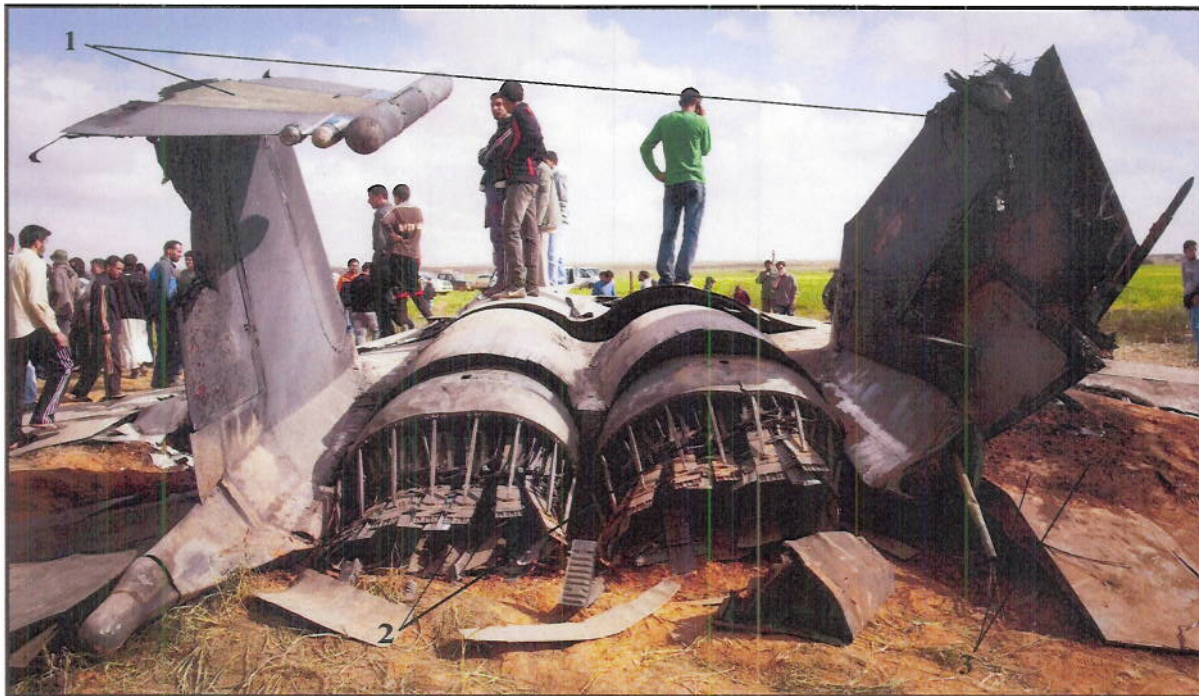
## Back View of Mishap Aircraft on Impact

*The photograph shows the MA was rotating left upon impact. The flat left spin rotation is evident from (1) the tops of the vertical tails which are mainly intact; (2) the compressed engine nozzles; and (3) the soil covering the right horizontal stab.*

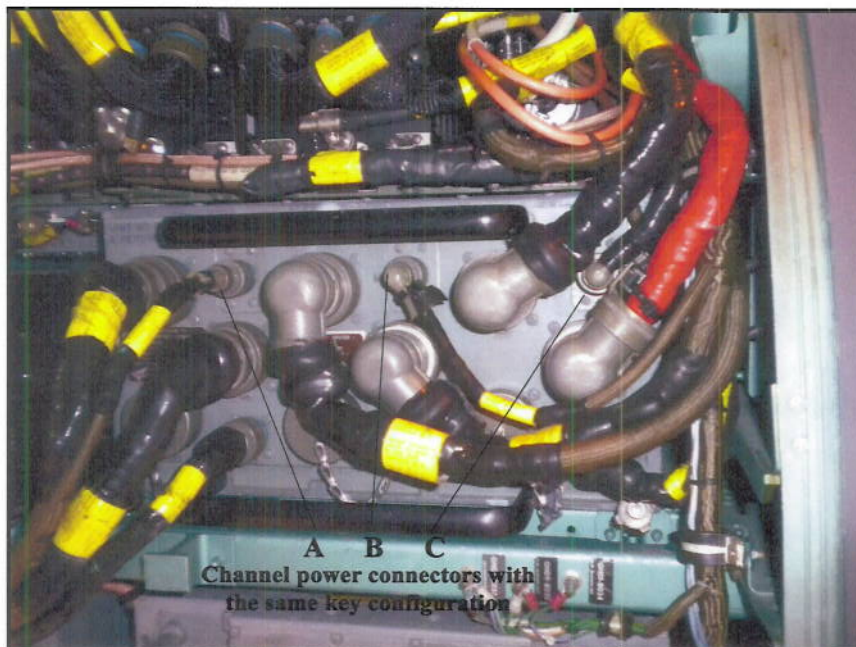
### FCC Channel Power Connectors

Evidence indicates that the maintenance member performing the FCC installation was not qualified to perform the task. The member was in training at the time of the incident but had no start date in his training record. Further, the Avionics Expeditor, who inspected the FCC installation, signed off the red X entry as complete without identifying that two power connectors were reversed. A red X entry indicates an unsafe or unserviceable condition in which the aircraft may not be flown until the condition is corrected (Tabs V-3.3, V-5.6, V-11.3, and V-15.9). This discrepancy, however, was corrected by the day-shift FCC operational check-out conducted on the MA prior to the mishap sortie taking off. And finally, another minor procedural discrepancy involved failure to document FCC removal from cannibalized aircraft. The FCC is a serial number controlled LRU, which requires entry into IMDS. However, no such

*The photo above shows properly configured FCC connections. Of note, the A, B, and C channel power connectors all have the same connector/receptacle key configuration. The B and C connectors are often mistakenly reversed during installation due to the matching connector/receptacle key configuration and the close proximity to each other.*
