UNITED STATES AIR FORCE
AIRCRAFT ACCIDENT INVESTIGATION
BOARD REPORT

F-16C, T/N 88-0433

**421st FIGHTER SQUADRON
388th FIGHTER WING
HILL AIR FORCE BASE, UTAH**

DATE OF ACCIDENT: 4 MAY 2012

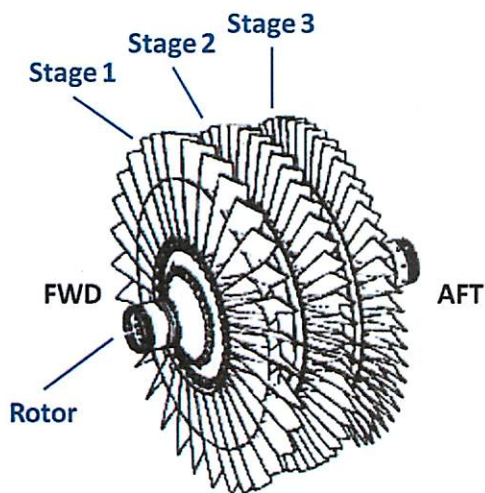
Figure 6. Fan Stages 1, 2, and 3 (Tab V-2.39)

The fan assembly exhibited extensive damage due to impact and ingested blade parts. On the first stage fan, blade 17's dovetail was still attached to the rotor, but the airfoil was broken off. A remnant of 17's airfoil was found inside the fan section and exhibited severe mechanical damage. Six inches of blade 17 was never recovered. (Tab J-21) Figure 6 shows the three fan stages with rotors and blades. Figure 7 depicts the first stage rotor and a single blade.

The stage 2 and 3 blades all exhibited mechanical damage in the form of missing material, nicks and dents. Five consecutive stage 2 blades were missing approximately 1 inch of the blade tip. These blades were located in line with stage 1 blade number 17 and in the direction of rotation. (Tabs J-21 through J-23)

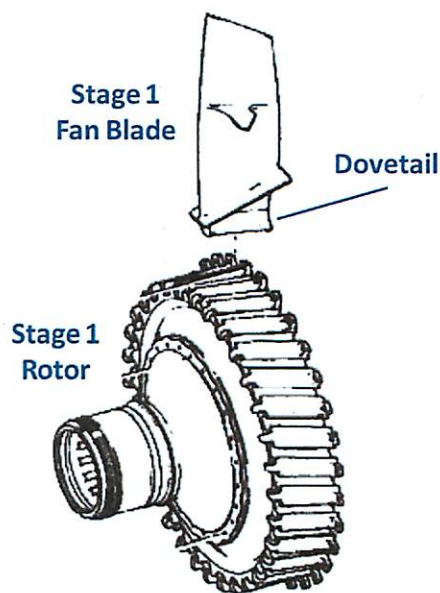
Figure 7. Stage 1 Fan Blade and Rotor (Tab V-2.34)

Blade 16, the next blade in the direction of fan rotation to blade 17, had damage to the center of the platform edge adjacent to blade 17. Blade 15 had liberated approximately 2 inches from the tip. (Tab J-21)

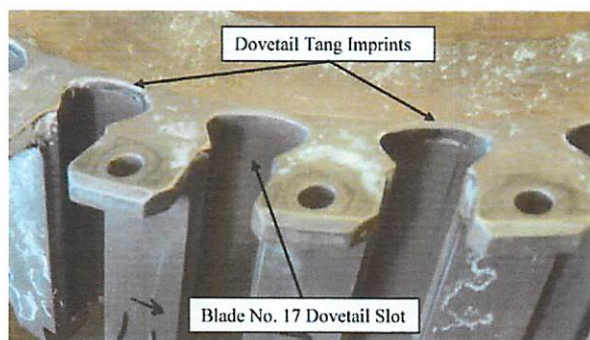
Figure 8. Fan Blade Rotor Dovetail Slots (Tab J-22)

Evaluation of the dovetail slots on the first stage fan rotor showed imprints at every location except blade 17. (Figure 8) This indicates that the first stage fan blades and dovetails experienced imbalance and improper stress, except blade 17. This further shows that blade 17 was not in place at the time of imbalance. (Tabs J-21 through J-22)

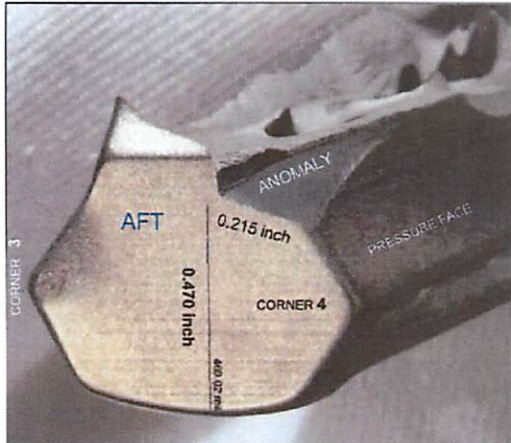
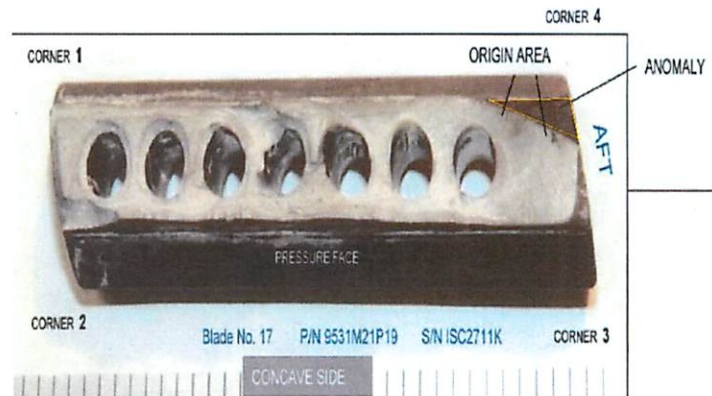
Figure 9. Dovetail View w/ Anomaly (Tab J-41) Figure 10. Dovetail View from Broken Blade Side (Tab J-36)

Analysis of physical evidence indicates blade 17 in the first stage fan assembly separated from its base during flight. (Figures 9 and 10) The separation was due to fatigue cracking that propagated from the edge of an anomaly until final tensile overload occurred. (Tab J-34)

Metallographic evaluation revealed that the surface anomaly was formed during the manufacturing process at temperatures only encountered at forging, and not during normal engine operation. Fan blade 17 separated about 0.5 inches from the blade root. The crack causing blade separation originated at corner 4 (aft end on the convex side), along the edge of the surface anomaly. The fracture surface was consistent with crack initiation and propagation by high alternating stress and low cycle fatigue from normal engine operation. Regular engine use caused cracking to form at the edge of the anomaly, eventually resulting in blade separation. (Tabs J-34 through J-36)

Based on the blade inspection checklist in Figure 9, the anomaly falls within parameters mandating replacement, specifically under section 8(c). The inspector could have noticed the anomaly based on its size and location, as it was significantly larger than a nick or dent. The blade was not replaced during the visual inspection at Tinker AFB during fan assembly buildup. (Tabs U-19 through U-20 and V-9.11 through V-9.12) After the initial blade installation at the 4K TAC in April 2004, no scheduled inspection or maintenance would have permitted discovery of the anomaly. (Tabs V-2.25 through V-2.27)

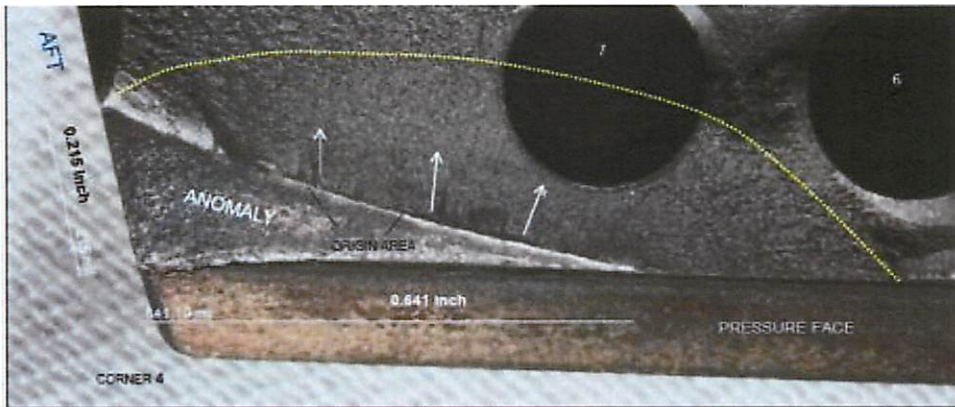
Figure 11. Magnified View of the Anomaly (Tab J-39)

Figure 11 depicts a close up of the triangular surface anomaly at corner 4 on the pressure face. The anomaly measured 0.215 inches along the aft face, 0.641 inches along the shank surface, and 0.739 inches along the fatigue origin area. The white arrows indicate the fatigue cracks emanating from the anomaly edge. The dotted yellow line depicts the boundary of the fatigue

Fan blade 17 separated due to an anomaly at the base of the blade. Metallurgical analysis indicates the anomaly was created during a manufacturing process. Normal engine operation or maintenance actions could not cause the anomaly. Eight years of operating fatigue caused cracking that propagated from the edge of the anomaly until final tensile overload occurred.

The surface anomaly on blade 17 was caused during the manufacturing process, as only forging temperatures could cause the discrepancy. Since the anomaly was caused during manufacturing, it would have been present during the installation inspection. Photos of the blade clearly show the anomaly on the surface of the dovetail. Prior to installation, blade 17 underwent a visual inspection of the dovetail surfaces and corners. The inspection process required a visual examination looking for nicks, dents, scratches and/or wear on the blade base. The visual inspection checklist mandates discarding blades with such an anomaly based on its size and location. The anomaly fell within category 8(c) on the inspection checklist, as it was at a very minimum a dent or nick on the surface of the dovetail. The blade was nevertheless installed on the fan rotor after inspection. The blade was never removed after 2004 and no post-installation maintenance procedure performed would have revealed blade 17's anomaly.
