UNITED STATES AIR FORCE
AIRCRAFT ACCIDENT INVESTIGATION
BOARD REPORT

F-15E STRIKE EAGLE, T/N 90-0254
391st FIGHTER SQUADRON
366th FIGHTER WING
MOUNTAIN HOME AIR FORCE BASE, IDAHO

LOCATION: SOUTHWEST ASIA
DATE OF ACCIDENT: 3 MAY 2012
BOARD PRESIDENT: COLONEL HENRY L. CYR
CONDUCTED IAW AIR FORCE INSTRUCTION 51-503

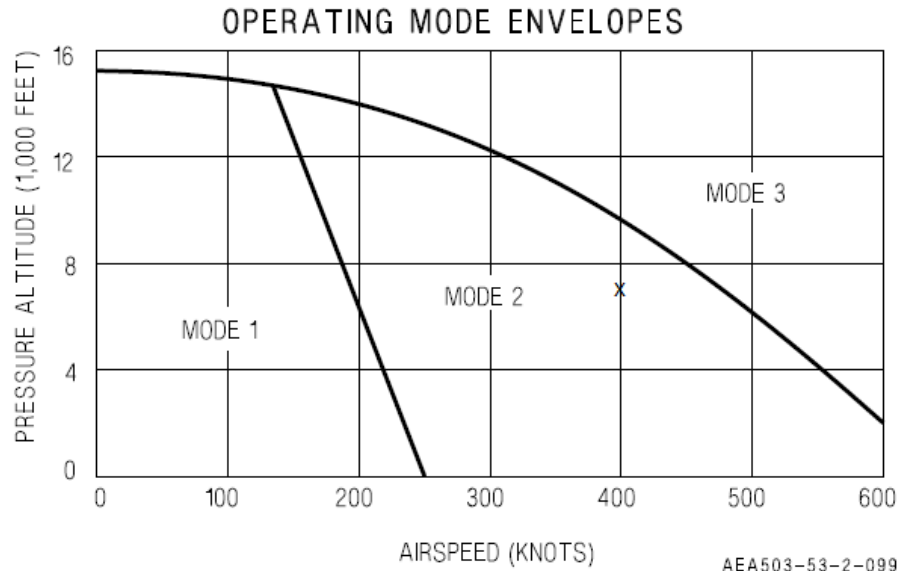
The MP initiated successful ejection within the performance envelope of the Advanced Concept Ejection Seat II (ACES II) ejection system. The MP experienced a Mode 2 ejection, while the MW experienced a Mode 1 ejection, despite the MA being well within the altitude and airspeed parameters for a Mode 2 ejection (see fig. 1). (Tab H1.1)

Fig. 1. Digital Recovery Sequencer Mode Selection Criteria
(MC's ejection parameters highlighted with an "X") (Tab H1.1)

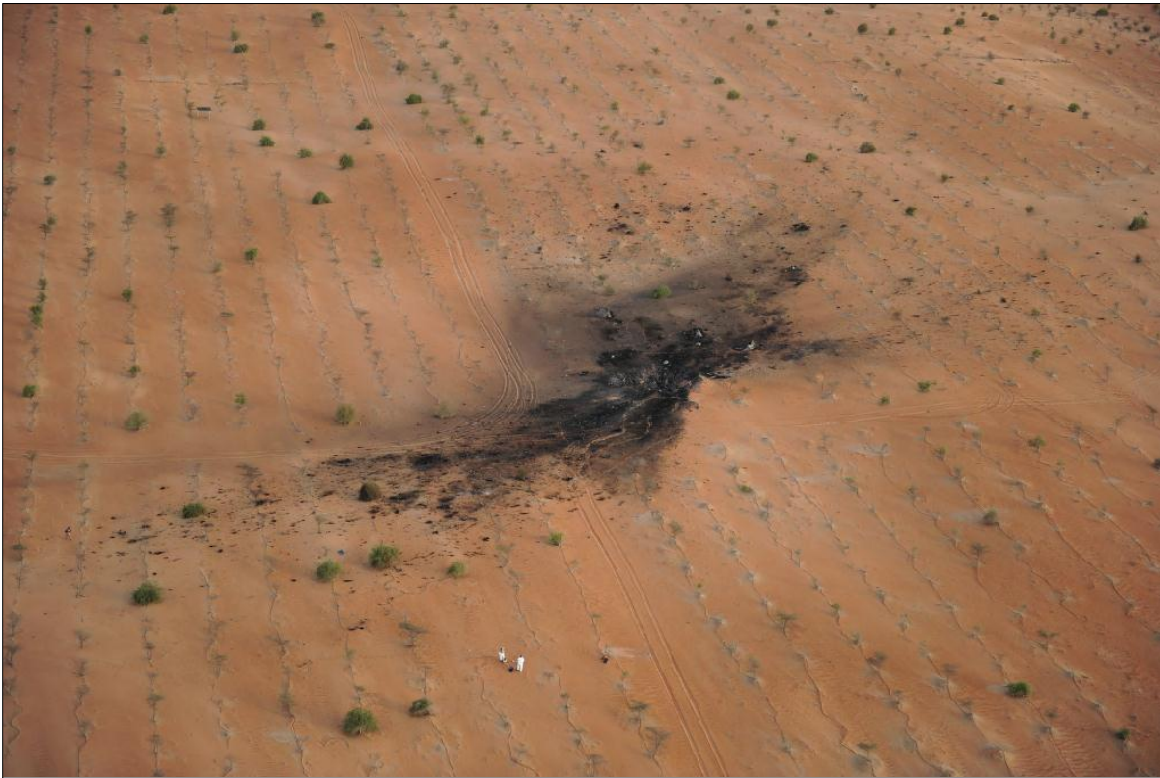
Upon impact, the aircraft created a scatter field measuring approximately 800 ft. by 1200 ft. (see fig. 3). The main wreckage consisted of a large crater with both engines still attached to the aircraft structure forward of the crater with both wings and left and right empennage sections nearby (see fig. 4). The forward and center fuselage sections were not identifiable at the wreckage site. The majority of the debris field was forward of the crater with small pieces of the wreckage surrounding the area in a radial pattern. Evidence of all flight control surfaces remained either installed or nearby to their respective airframe locations. (Tab J4, H2, J7, J14)

Fig. 3. Overview of Mishap Site

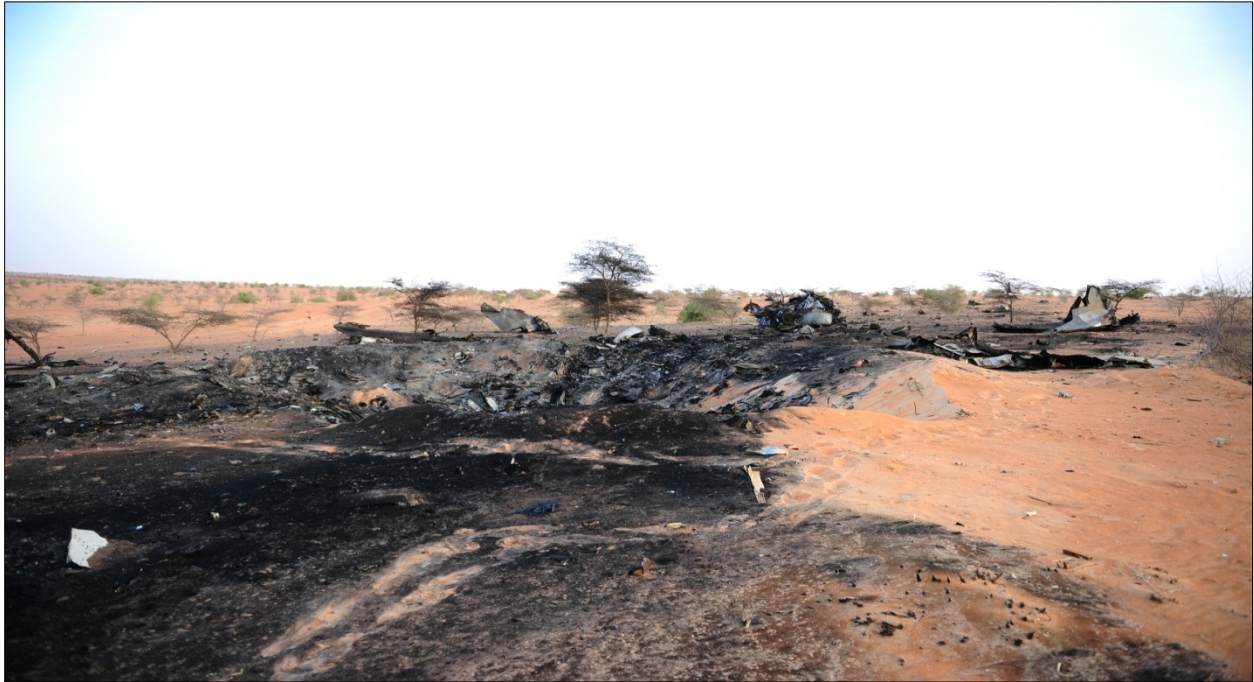
Fig. 4. Mishap Site Crater

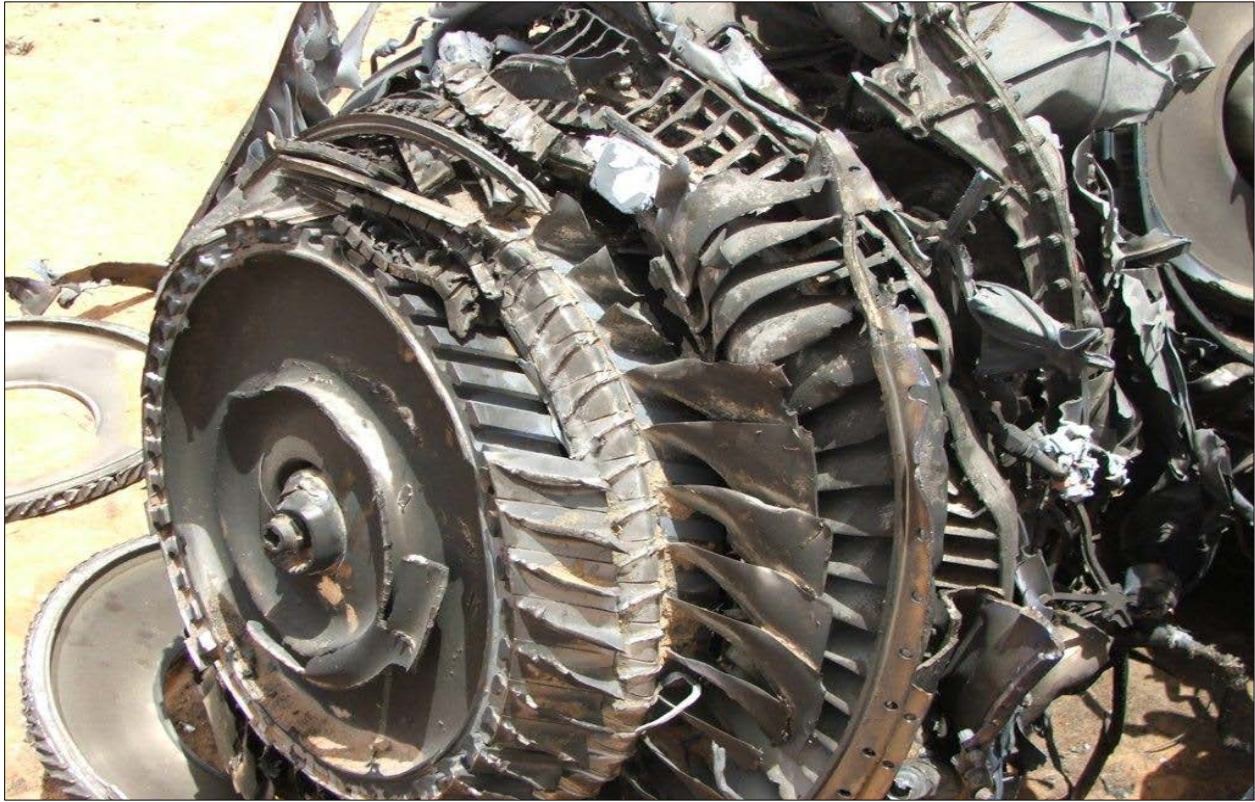
The number 2 engine (PW0E720172) showed evidence of a titanium fire in the compressor section. The engine was severed aft of the compressor split case, and evidence of the titanium fire was visible in the rear compressor section when reviewed at the mishap site. The engine was recovered and investigation focused on the Core Module and compressor section, and the hardware condition upstream of the compressor. (Tab J7) The HPT and FDT were inspected internally using an Olympus iPlex borescope to establish the condition of these components. The IFM 2nd and 3rd stage blade disks remained with the rest of the engine (see fig. 5). There were numerous fan blades remaining in their respective positions in the 2nd and 3rd stage blade disks. (Tab J7) Evidence from the IFM, HPT and FDT was used to determine the engine was wind milling at the time of impact. (Tab J7)

Fig. 5. PW0E720172 Inlet Fan Module

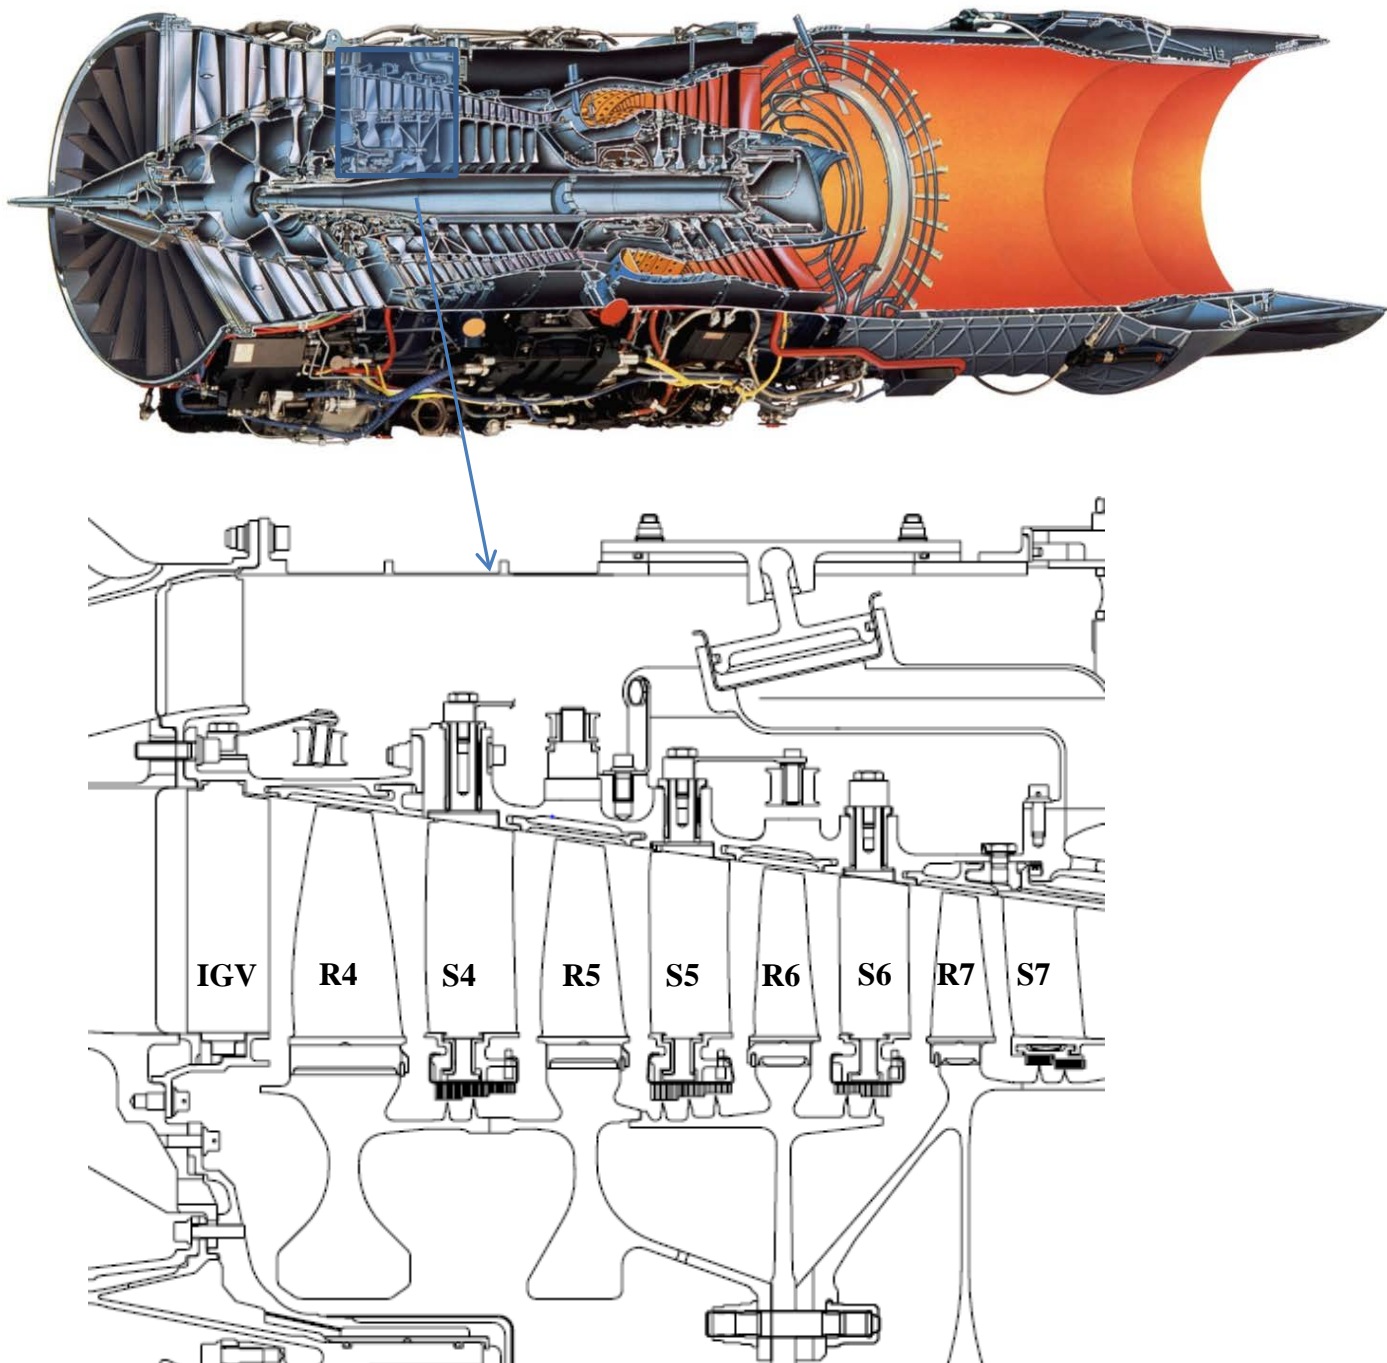
Post-mishap analysis localized the start of the titanium component fire to the 5th and 6th stages of the engine. Analysis was also able to determine the core of the mishap engine did not shift forward or rearward, eliminating one potential cause of the fire. The compressor case was removed for investigation. The 4th through 9th case was damaged by fire and impact. The case was severed by a titanium fire at both the 5th and 6th stage area, creating three separate pieces of the case. The 5th and 6th stage blade area was completely burned through for the entire circumference of the case, with the greatest damage at the 4 to 5 o'clock position, viewed aft looking forward. (Tab J7) The 7th stage area was burned, but not through the case. The 8th through 13th stage area was not burned through, but had melted material covering the blade air seal abradable material. The abradable material in those locations did not display any blade tip rubbing other than what is normally seen in the compressor. When the radial location of the compressor is not maintained correctly during engine operation, (rotor/blade shift/imbalance or case displacement) the blades will contact the abradable material and create deep rubs; this was not evident in the mishap engine. (Tab J7)

Fig. 6. Cross Section of the forward Portion of the High Pressure Compressor

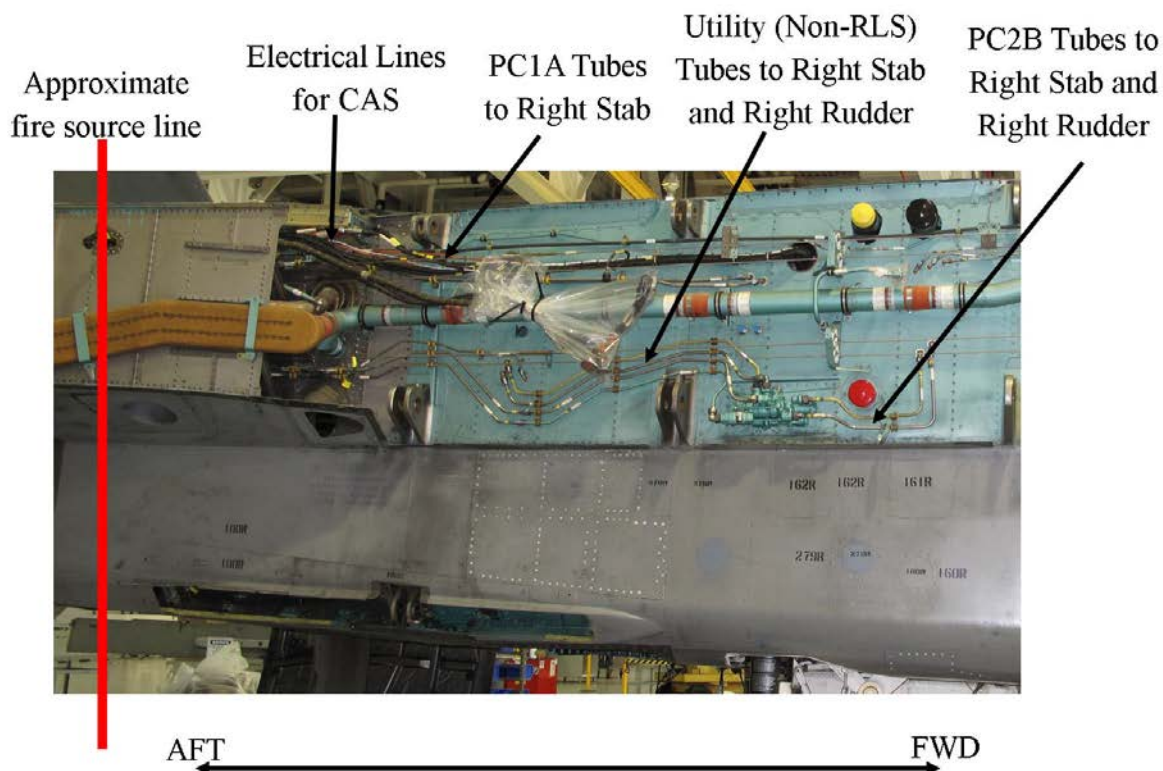
The evaluation of the right engine (PW0E710172) indicated an unidentified component failed for an unknown reason during normal engine operation. A titanium fire was initiated in the inner diameter of the compressor case in the 5th, 6th and 7th areas. Compressor material liberated and mechanically damaged all of the compressor blades aft of the 5th stage. The titanium fire at the 5th and 6th stage area in the split case burned through the compressor case for nearly the entire 360 degree circumference of the case. The titanium fire subsequently burned through the Front Fan Duct in numerous areas and into the aircraft engine bay. (Tab J7)

Fig. 7. Red line depicts likely burn-through location of titanium fire from engine bay in close proximity to PC1, PC2, and Utility hydraulic lines.
