Assessment of the USAF Aircraft Accident
Investigation Board (AIB) Report on the F-22A Mishap
of November 16, 2010

SUBJECT: Assessment of the USAF Aircraft Accident Investigation Board (AIB) Report on the F-22A Mishap of November 16, 2010 (Report No. DODIG-2013-041)

F-22A, T/N 06-4125

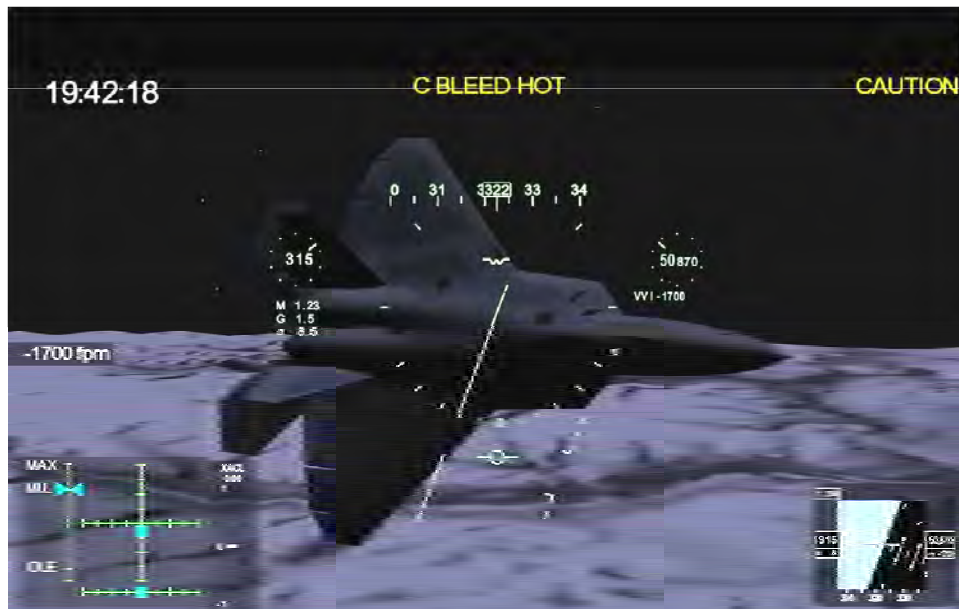
The MA was at 50,870 ft MSL, 315 knots calibrated airspeed (KCAS), 1.23 M, with an attitude of 1 degree nose up, 69 degrees right wing down (RWD), heading 323 degrees, 1.5 g, and with a vertical velocity indication (VVI) of -1,700 ft per minute (fpm). (Tab EE)

Figure 2 19:42:18 -- MA parameters at assertion of C BLEED HOT caution ICAW. (Tab EE) See Tab Z-10 for a diagram explaining the symbology in the Figures.

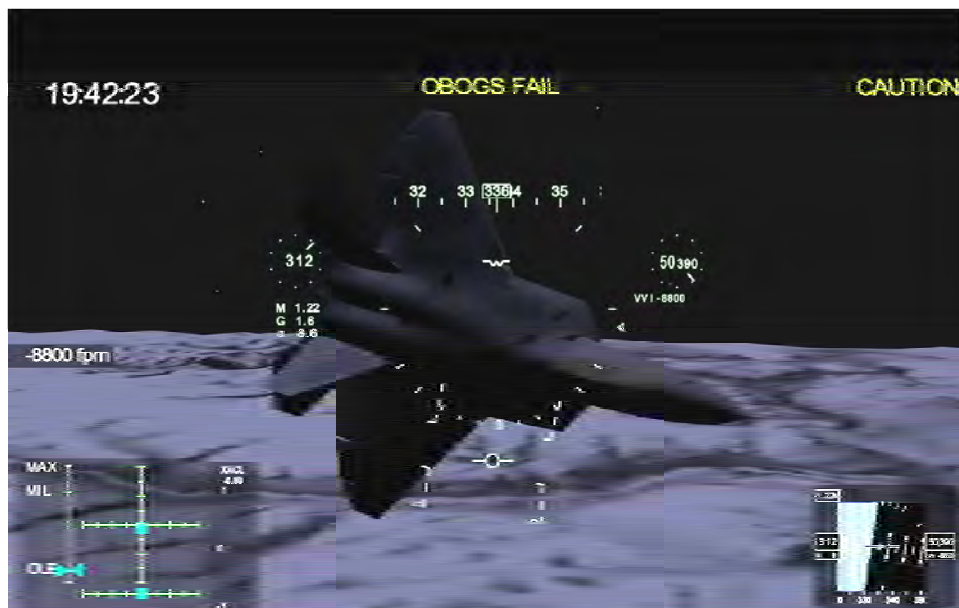
The C BLEED HOT caution ICAW cleared at 19:42:21L indicating the overtemperature condition no longer existed after the IVSC commanded the bleed air ducts to the closed position and stopped the flow of bleed air to the ECS. Due to the ECS no longer supplying pressure to OBOGS, the pressure dropped below the 10 pounds per square inch (psi) minimum threshold and displayed an OBOGS FAIL caution ICAW at 19:42:23L. (Tab J-12 and J-23)

Figure 3 19:42:23 – MA parameters at assertion of OBOGS FAIL caution ICAW. (Tab EE)

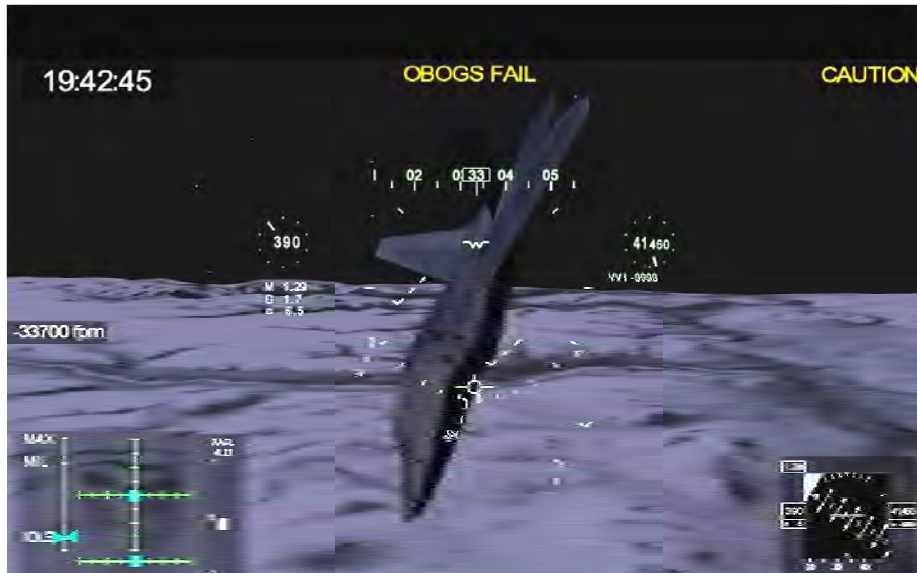
At the assertion of this ICAW until 19:42:45L, the MP retarded the throttles to IDLE power and deliberately continued a controlled, descending right hand turn to descend to a lower altitude IAW the checklist. (Tab BB-29) At this time the MA was at 41,460 ft MSL, 390 KCAS, 1.29M, 30 degrees ND, 44 degrees RWD, 1.7 g, and with a VVI of -33,700 fpm. (Tab EE)

Figure 4 19:42:45 – MP deliberately flew to a controlled attitude of 30 degrees ND and 44 degrees RWD in order to descend to a lower altitude IAW the checklist. (Tab EE)

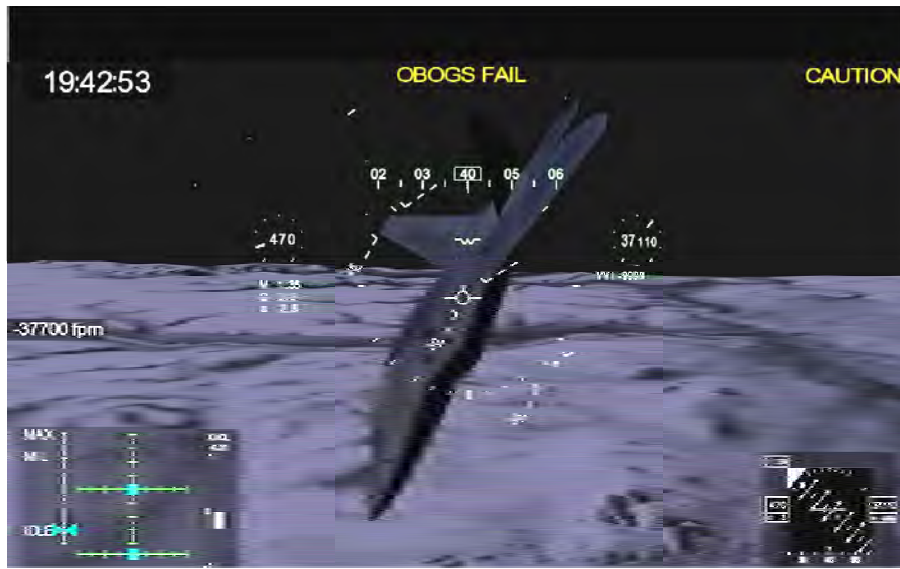
The CSMU mishap data discrete signal showed partial pressure to the MP's oxygen mask stopped shortly after 19:42:37L, which would lead to severely restricted breathing. (Tab J-43) From 19:42:45L until 19:42:53L, the MP made no inputs to the stick, pedals, or throttles, and the MA maintained a relatively stable bank angle and attitude. The MA was at 37,110 ft MSL, 470 KCAS, 1.35M, 30 degrees ND, 46 degrees RWD, 0.8 g, with a VVI of -37,700 fpm. (Tab EE)

Figure 5 19:42:53 – MA parameters after 8 seconds of zero MP inputs to stick, pedals, or throttles. (Tab EE)

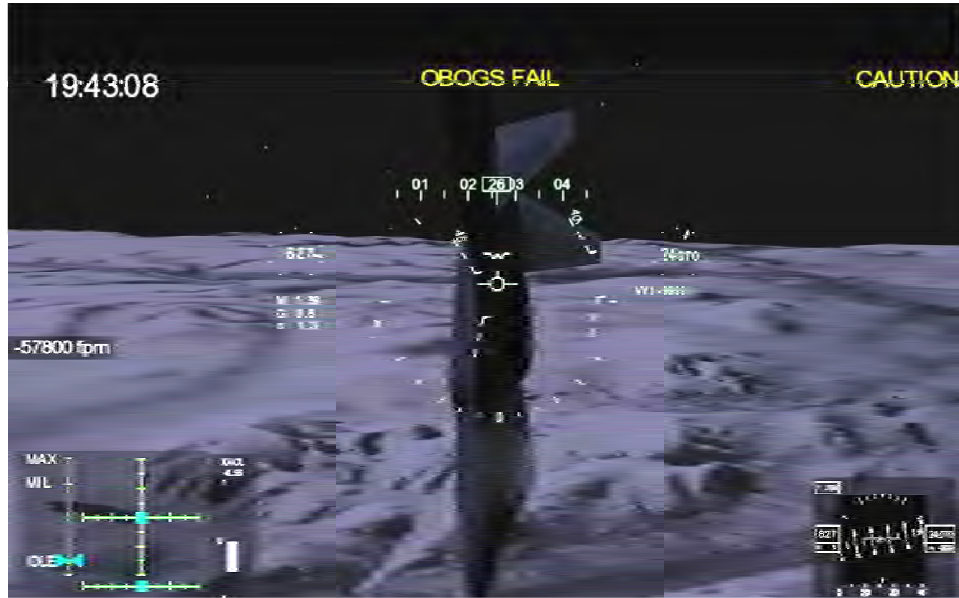
At the completion of these stick and pedal inputs at 19:43:08L, the MA had rolled through inverted, experienced less than 1 g of gravitational force, and went from a RWD to Left Wing Down (LWD) attitude, and the descent rate of the aircraft significantly increased. The parameters at this time were 24,070 ft MSL, 627 KCAS, 1.39M, 44 degrees ND, 81 degrees LWD, 0.8 g, with a VVI of -57,800 fpm. (Tab EE)

Figure 7 19:43:08 – MA parameters when stick and pedal inputs cease after the 240 degree roll. (Tab EE)

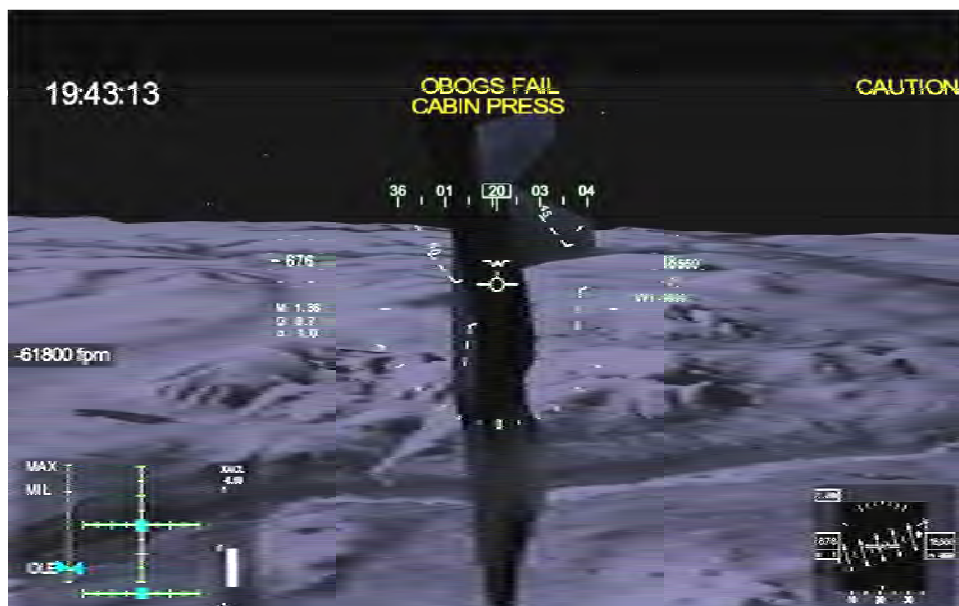
After 19:43:08L, there were no stick inputs and only very minor pedal inputs for the next 15 seconds. At 19:43:13L, passing approximately 19,000 ft MSL, a CABIN PRESSURE caution ICAW asserted based on cockpit pressurization exceeding its normal schedule. (Tab J-13)

Figure 8 19:43:13 – MA parameters at assertion of CABIN PRESS caution ICAW. No stick or pedal inputs. (Tab EE)

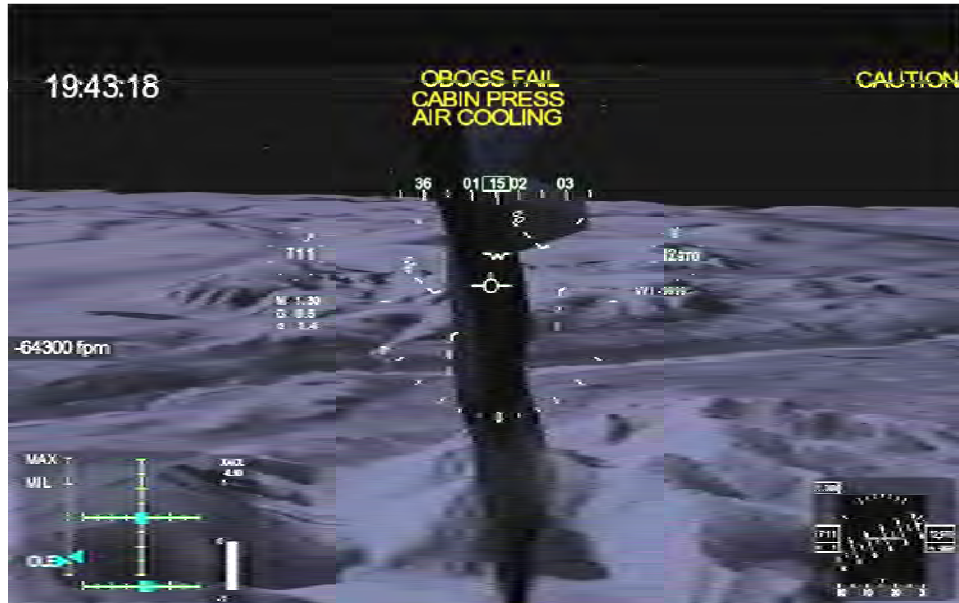
At 19:43:18L, passing 12,400 ft MSL, an AIR COOLING caution ICAW asserted. This ICAW would assert 60 seconds after a C BLEED HOT caution ICAW if the aircraft were not receiving an adequate cooling air source to its avionics. (Tab J-13)

Figure 9 19:42:18 – MA parameters at assertion of AIR COOLING caution ICAW. No stick or pedal inputs. (Tab EE)

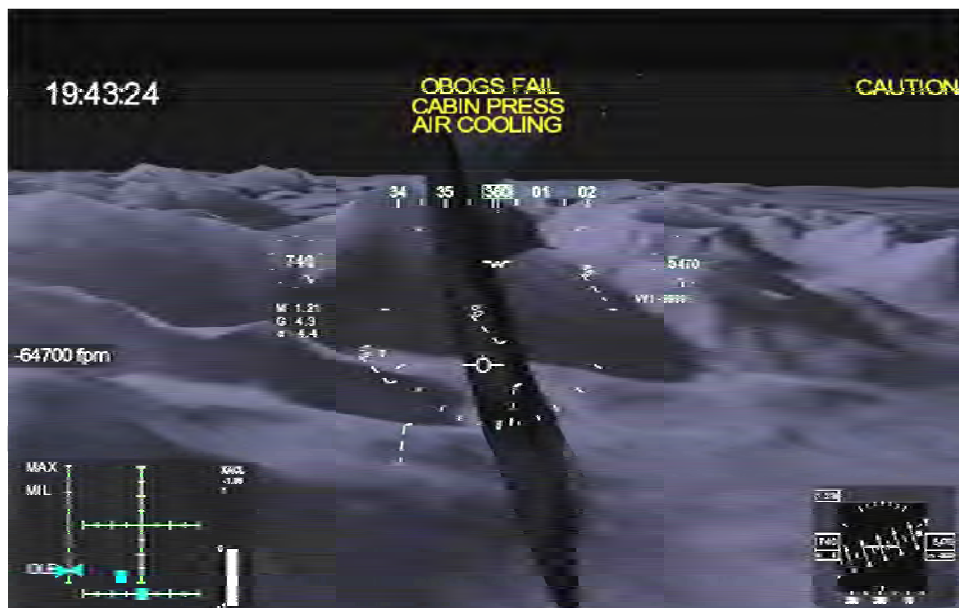
At 19:43:24L the MP performed a dive recovery at 5,470 ft MSL by pulling aft on the stick, producing a 7.4 g pull up maneuver. The MA impacted the ground 3 seconds later, inflicting fatal injuries to the MP and destroying the MA. (Tab EE)

Figure 10 19:43:24 – MP initiates full aft stick pull to start dive recovery at 5,470 ft MSL. (Tab EE)

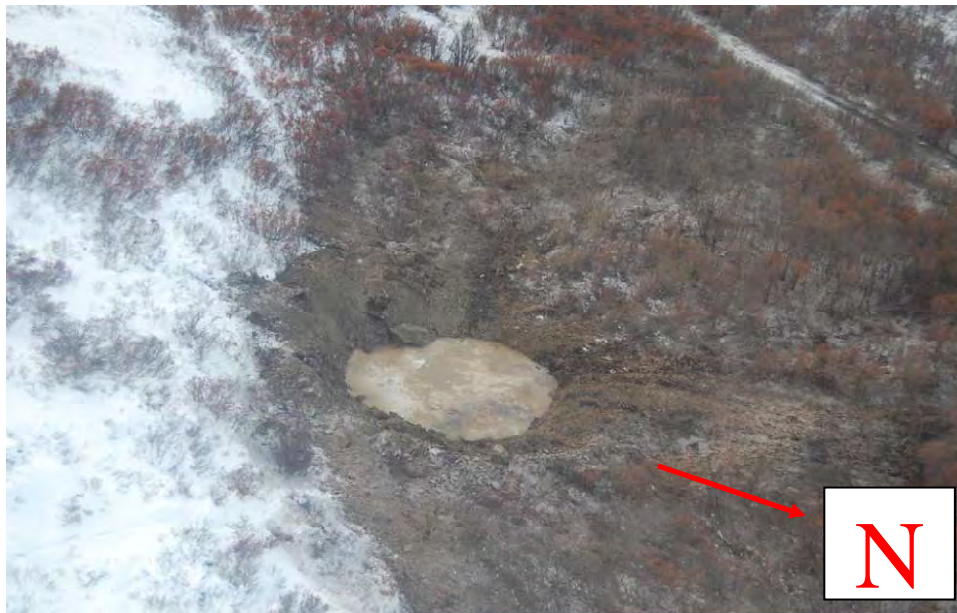
At 19:43:27L, the MA impacted the ground at 735 KCAS, 1.17M, 48 degrees ND, 47 degrees LWD, 7.4 g, with a VVI of -57,900 fpm. The impact site is approximately 120 NM north of JBER, AK, in the Talkeetna Mountain range. The site is approximately 3,100 ft MSL near the edge of a south-west to north-east running valley. The impact crater is located at the valley floor where it begins to slope upwards towards the southeast. The valley floor is approximately one-half mile wide at this point and has a stream running through it approximately 60 yards west of the impact point. (Tabs J-4 through J-6)

The debris field consisted of small aircraft and engine pieces extending approximately one-quarter mile from the crater. The upslope wall of the crater and aircraft impact angle appear to have focused the debris pattern in a 60 – 80 degree wide arc from west to north. (Tabs J-4 through J-6)

Figure 11 Impact Crater 17 Nov 2010 (Tab S-7)

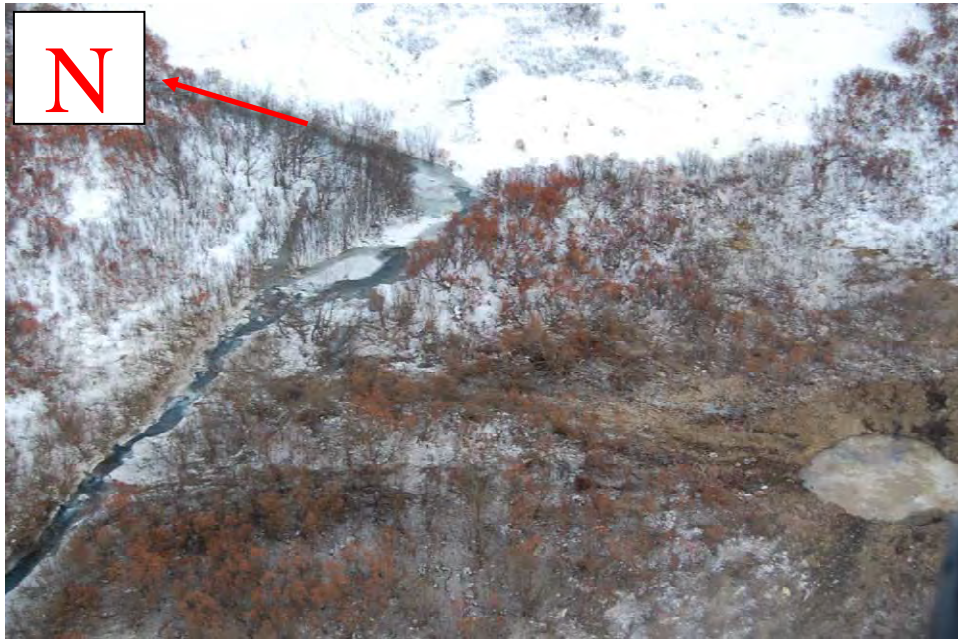
Figure 12 Impact Site. 17 Nov 2010 (Tab S-7)

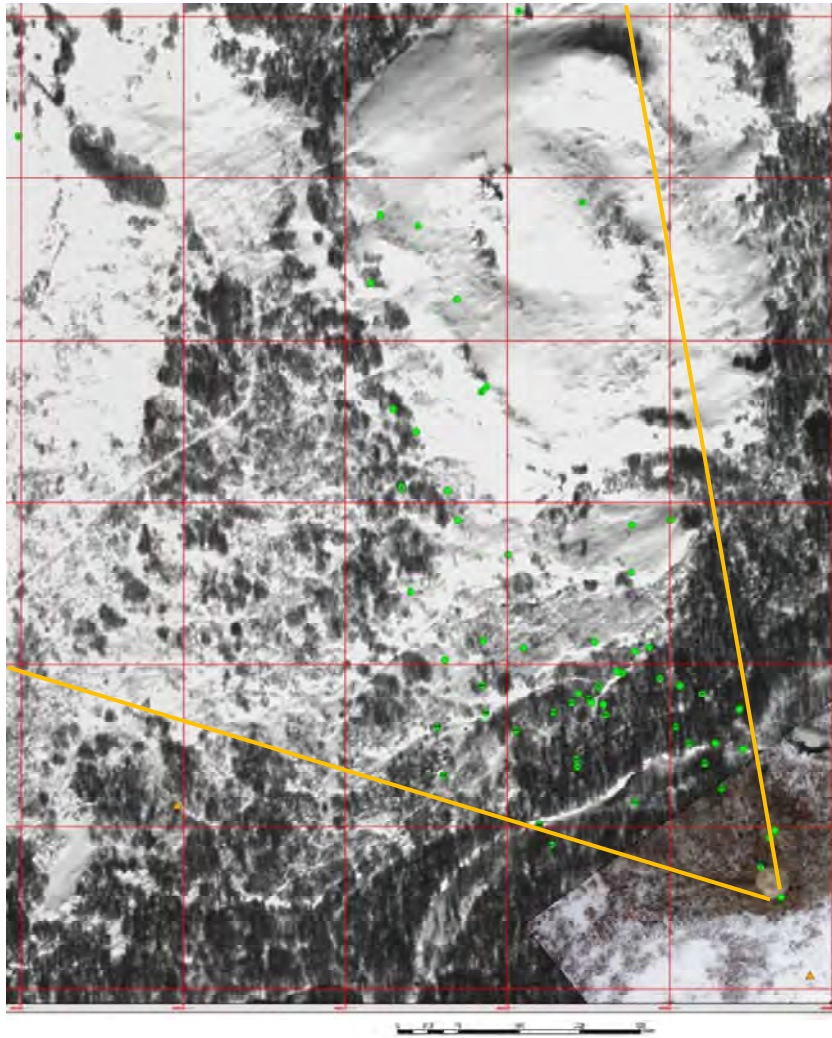
Figure 13 Aircraft Parts Scatter Diagram. Parts represented by green dots. (Tab S-4)

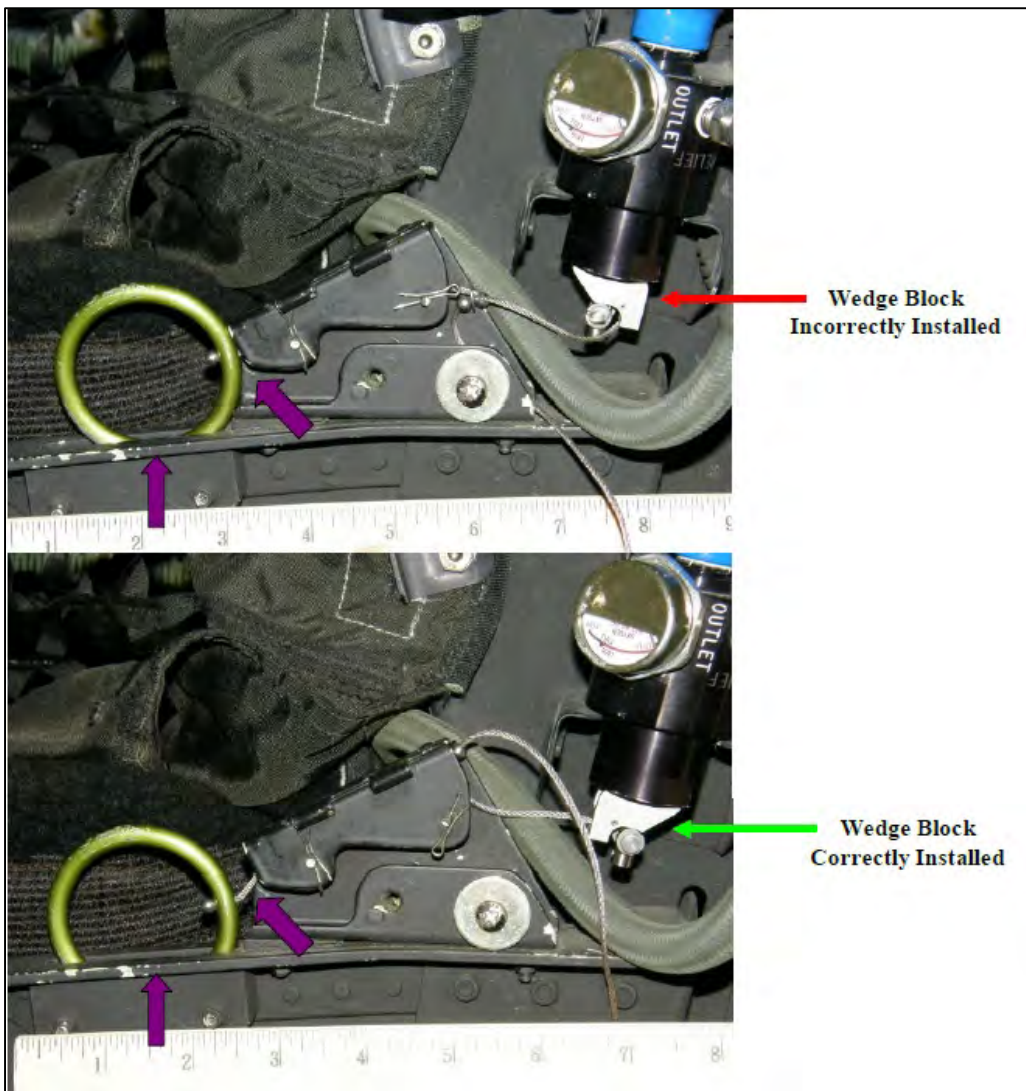
The AFRL report identified that if the EOS wedge block had been incorrectly installed, the wedge block would be unable to move or rotate during manual EOS ring activation. However, during ground simulation the board members were able to initiate the EOS in the incorrectly installed position. (Tab U-4)

Figure 14- The wedge block installed incorrectly (red arrow) and correctly (green arrow). Notice the position of the ring within the seat (purple arrows) based on wedge block position. (Tab Z-6)

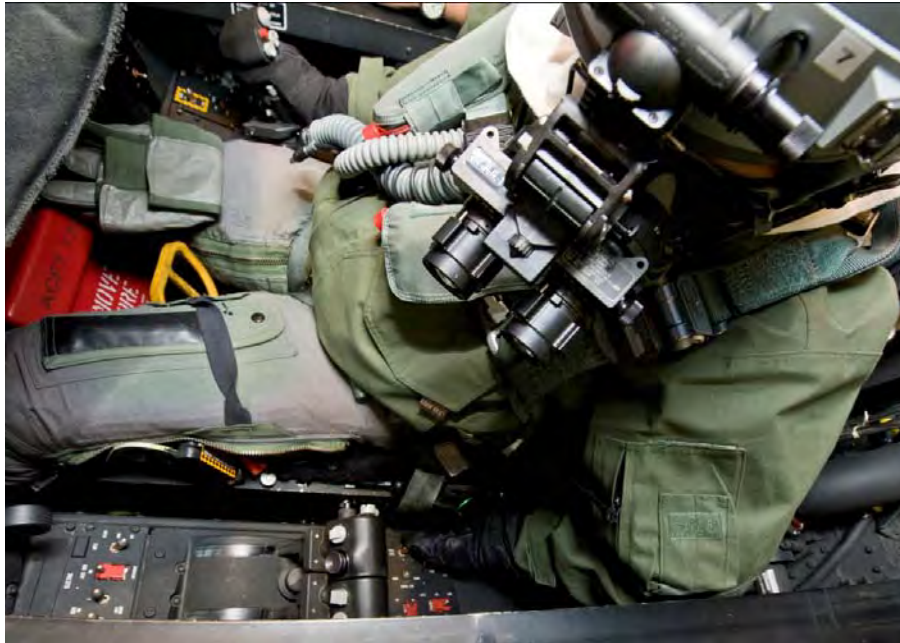
Figure 15 - Pilot pulling EOS activation ring. NVG interfering with EOS ring visualization. (Tab CC-5 and Tab Z-7)

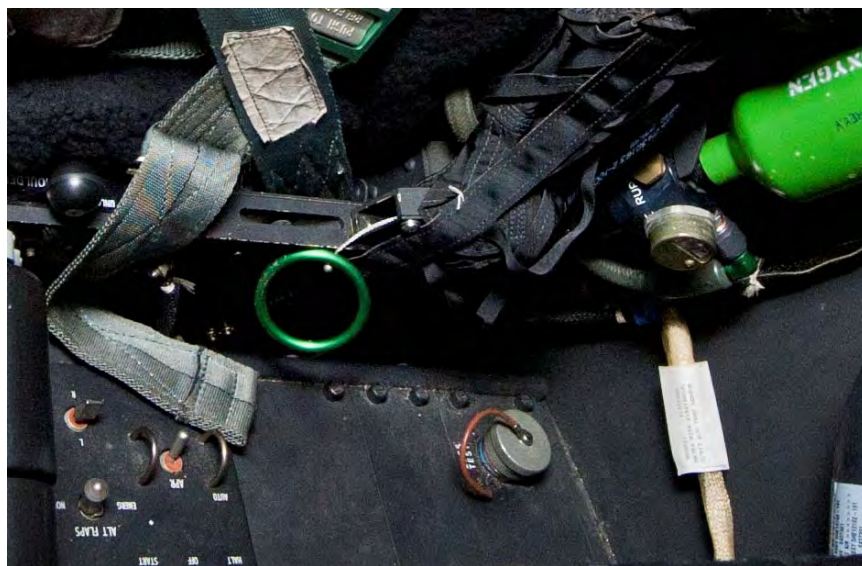
During ground simulation, the manual EOS activation ring was unseated and dropped between the seat and console prior to EOS activation. This was done to simulate a failed initial pull,

which may have occurred for various reasons, including: the EOS activation ring was dropped or the EOS cable jammed during an attempted manual activation. Retrieval of the ring from between the seat and console would be difficult based on the seat position, night environment, and with personal equipment interference (as discussed in the next section). (Tab CC-5)

Figure 16- Manual EOS activation ring fallen below lip of seat. (Tab CC-5 and Tab Z-8)

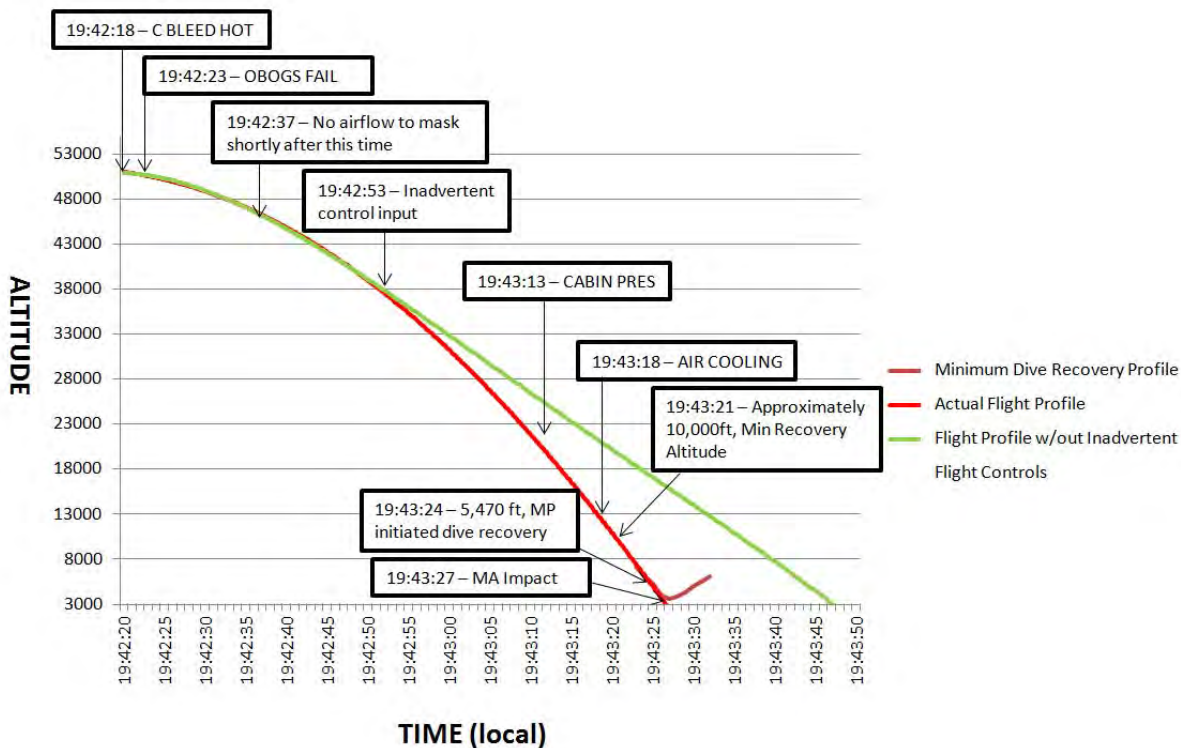
Fifth, the MP was late to recognize the necessity for a dive recovery. At 19:43:27L, the MP impacted the ground because his channelized attention and breakdown in visual scan resulted in unrecognized spatial disorientation. When the MP recognized the MA attitude and altitude, he was below minimum recovery altitude. Figure 17 shows the actual initiation of the attempted dive recovery altitude along with the 1F-22A-1 minimum recovery altitude.

Figure 17 Flight profiles for MS. Actual flight profile (red), flight profile without inadvertent flight control inputs (green), and minimum altitude dive recovery profile (maroon) shown.
