UNITED STATES AIR FORCE
AIRCRAFT ACCIDENT INVESTIGATION
BOARD REPORT

T-6A, T/N 07-3890

89TH FLYING TRAINING SQUADRON
80TH FLYING TRAINING WING
SHEPPARD AIR FORCE BASE (AFB), TEXAS

DATE OF ACCIDENT: 1 MAY 2019

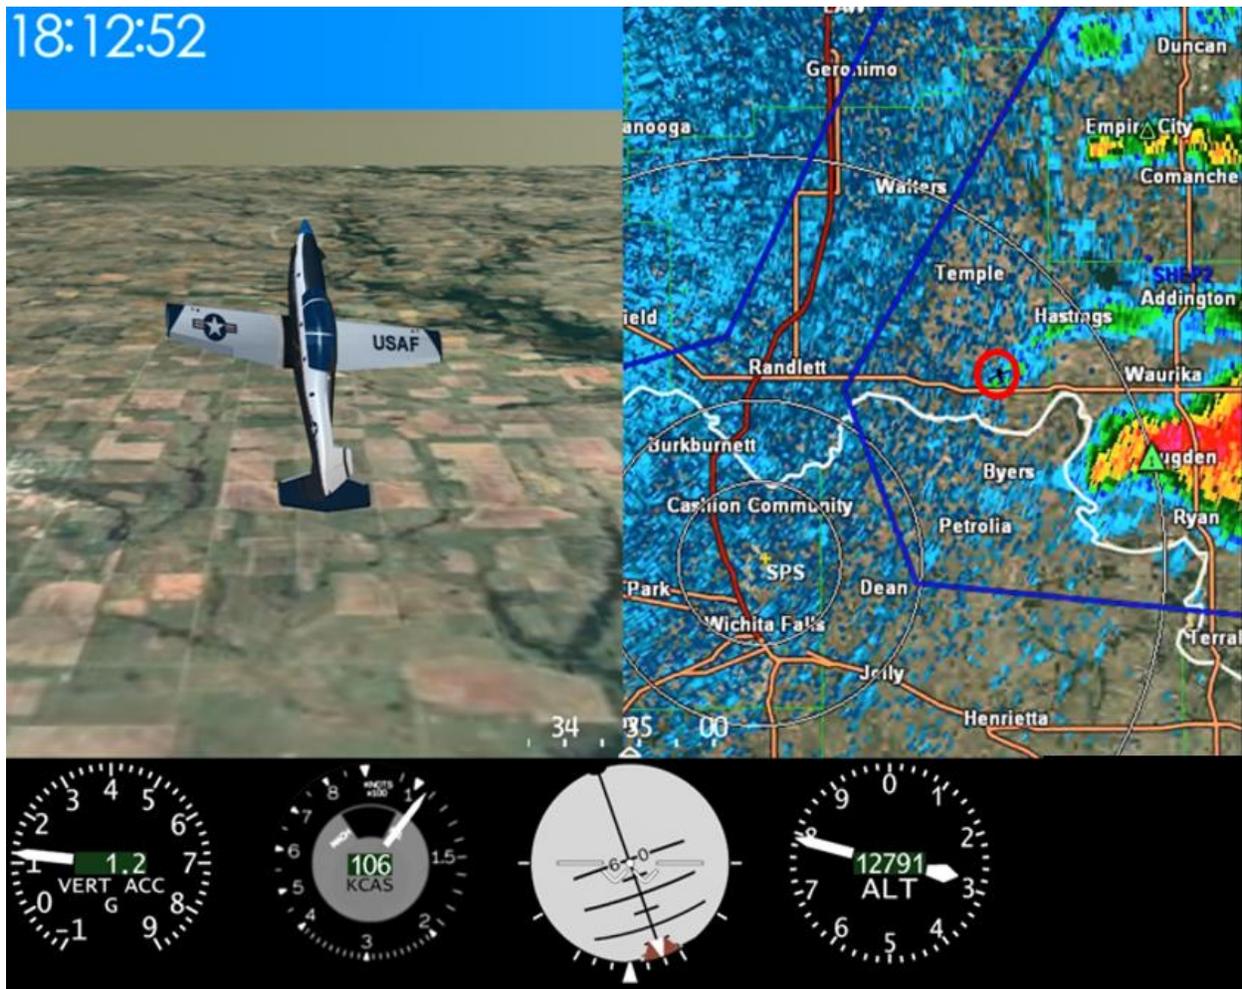
Figure 1: On the left, the MA maneuvering before loss of control effectiveness. On the right, the red circle represents the approximate aircraft location. Time is represented as Greenwich Mean Time (Tab NN-2).

Around 13:12:52L the MP recognized the extreme nose-high condition and alerted the MIP they were approaching the MOA ceiling with critically low airspeed (Tabs MM-4 to MM-10 and V-2.10). The MIP attempted to recover by letting the nose fall to gain airspeed (Tabs V-1.9 and V-1.21). During this maneuver, the MA entered a cloud and the MC lost all outside visual references (Tabs MM-14 and NN-2). At maximum-power and 30° nose-high, the MIP attempted to roll wings-level (Tabs JJ-8, MM-14, and NN-2).

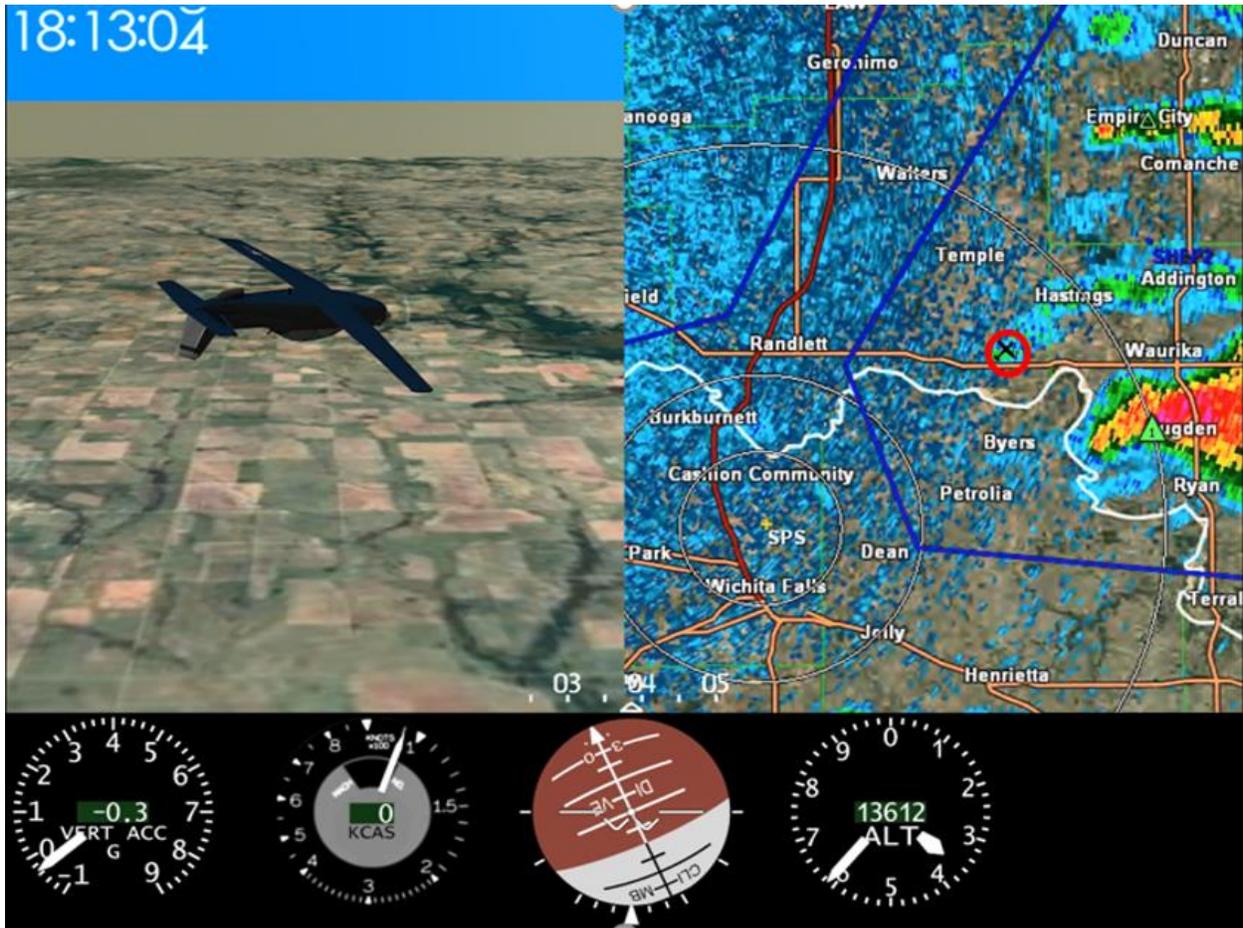
Upon initiating a left roll, the MA departed controlled flight due to the combination of insufficient airspeed, a high angle of attack, and high power setting (Tab NN-2). This resulted in a left torque-roll, placing the MA into a power-on, inverted spin while still in Instrument Meteorological Conditions (IMC) (Tabs BB-135 to BB-136, JJ-8 and NN-2). A left torque-roll occurs when aerodynamic forces are insufficient to overcome the rolling motion induced by the propeller (Tabs BB-135 to BB-136).

Figure 2: The left depicts the MA departing controlled flight. On the right, the red circle represents the approximate aircraft location (Tab NN-2).

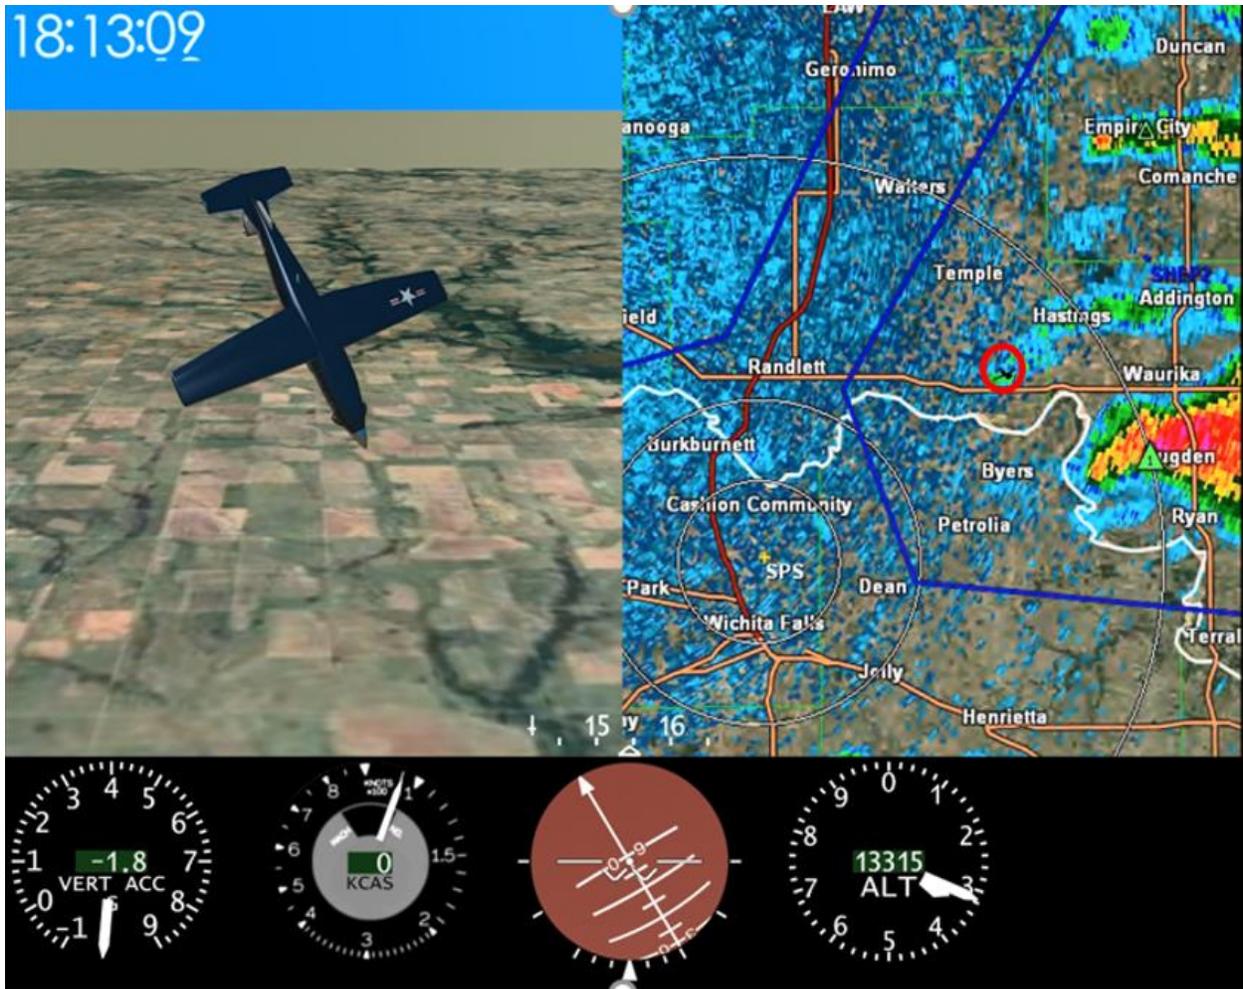
Figure 3: The left depicts the MA established in spin. The red circle on the right represents the approximate aircraft location. (Tab NN-2)

After failing to regain control, the MIP announced the intention to eject (Tab MM-15). The MP recommended delaying the ejection, believing the trajectory could be rectified (Tabs V-1.11 and V-2.11 to V-2.12). Recognizing the MP's T-6 proficiency, the MIP assumed the MP had better situational awareness and transferred aircraft control (Tabs V-1.11, V-2.11 to V-2.12, MM-6, and MM-15).

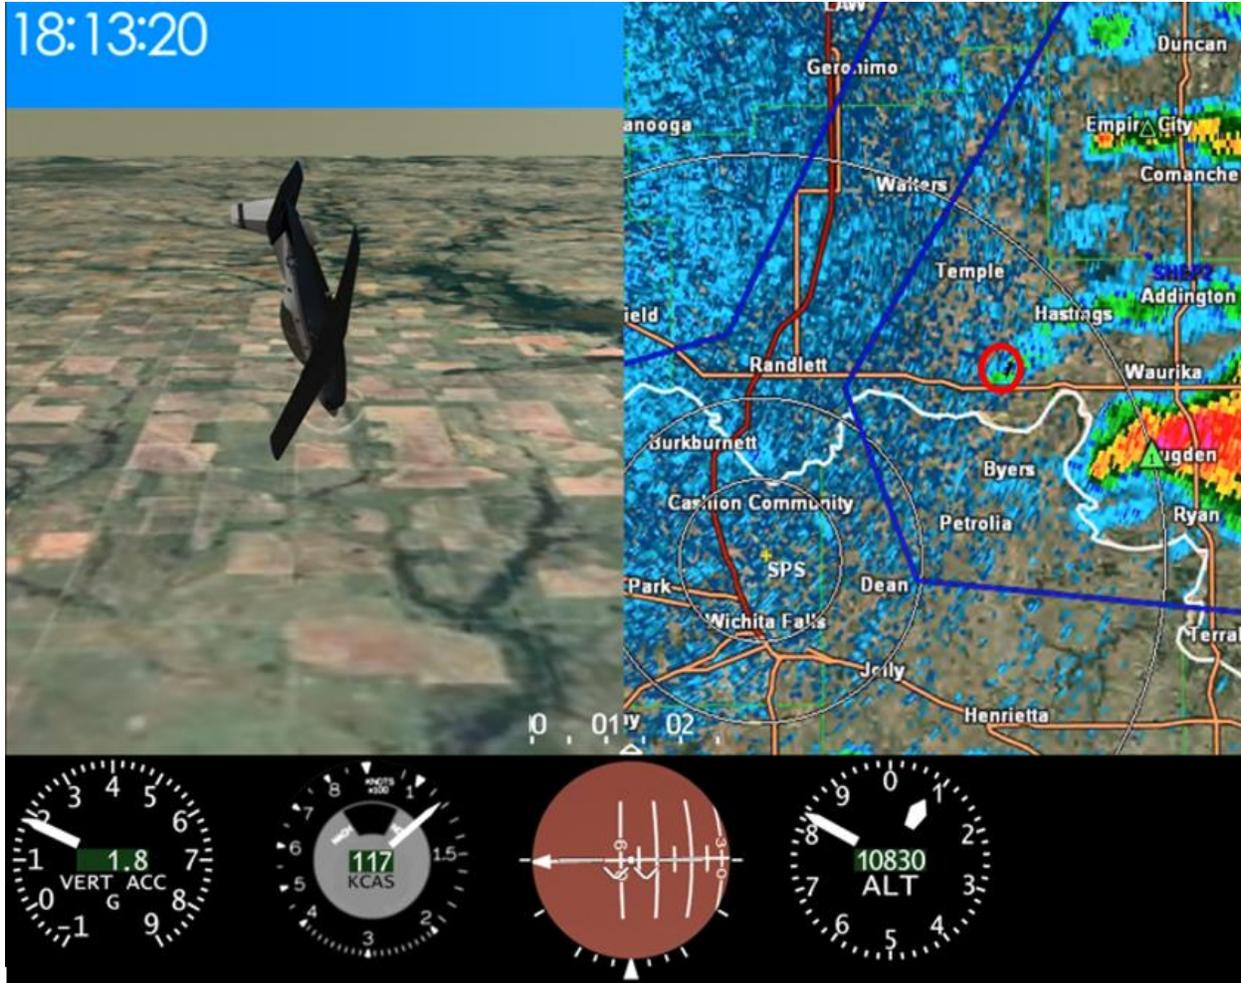
seats at approximately 13:13:20L (Tabs JJ-8, MM-6, and MM-15). The MC ejected at 10,830 feet MSL as the MA continued to spin 60° nose-low with inconsistent airspeed indications (Tabs JJ-8 and NN-2).

Figure 4: The left shows the MA condition at time of ejection. The red circle represents the approximate aircraft location. (Tab NN-2)

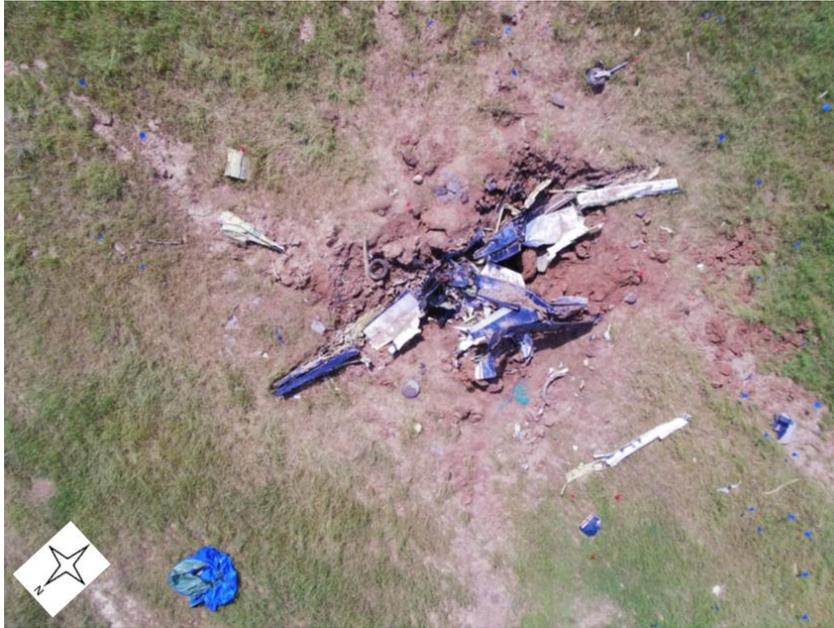
Figure 5: View of the crash site (Tab S-2)
