UNITED STATES AIR FORCE
AIRCRAFT ACCIDENT INVESTIGATION
BOARD REPORT

F-16CJ, T/N 91-0340

480TH FIGHTER SQUADRON
52D FIGHTER WING
SPANGDAHLEM AIR BASE, GERMANY

DATE OF ACCIDENT: 8 OCTOBER 2019

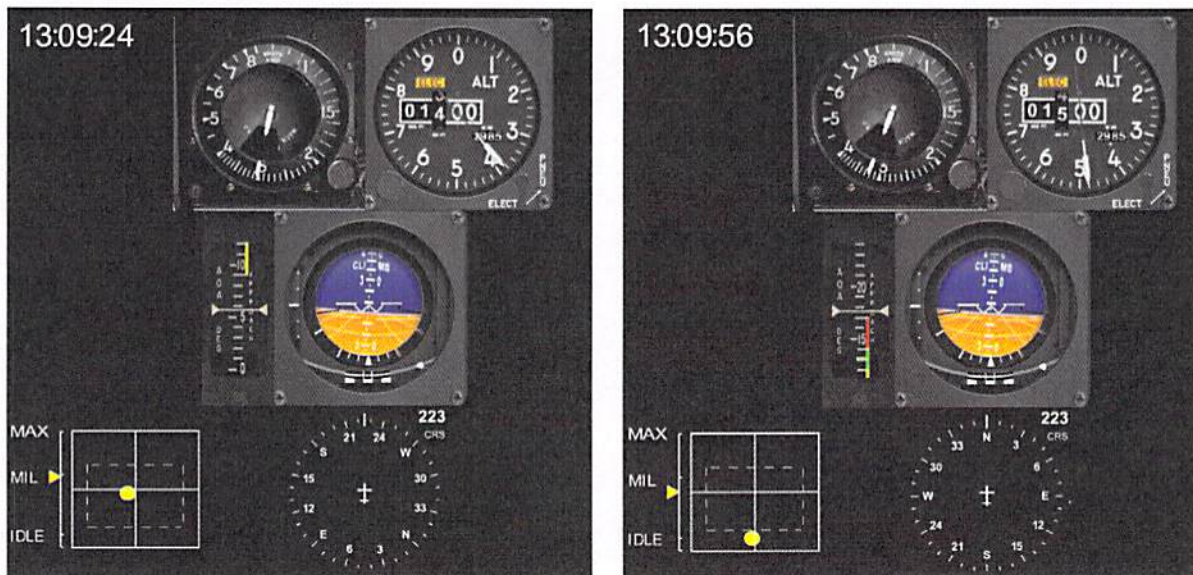
Figure 1: Parameters at Power Loss (Tab L-15) Figure 2: First Minimum Altitude (Tab L-15)

At this point, the MP realized his primary ADI was malfunctioning and not matching what he saw on the ground outside, so he began a more aggressive cross-check with his other flight instruments (Tab V-11.9 to V-11.11). Upon doing so, the MP noted his SAI showed a 60 degree right bank and slightly nose-high (Tab V-11.10). This reading did not seem to match his ADI or his perception of where he was compared to the ground (Tab V-11.11). At some point during his cross-check, the MP observed his EHSI powered back up, but was frozen and incorrectly indicating a heading of North as depicted in Figures 2 to 4 (Tab V-11.10). Additionally, his primary ADI, SAI, and EHSI were not responding as expected when he made flight control inputs (Tab R-23). While there is no information regarding the EHSI failing to north in Technical Order (TO) 1F-16CM-1, the ADI failure is consistent with warnings found the TO (Tab BB-14).

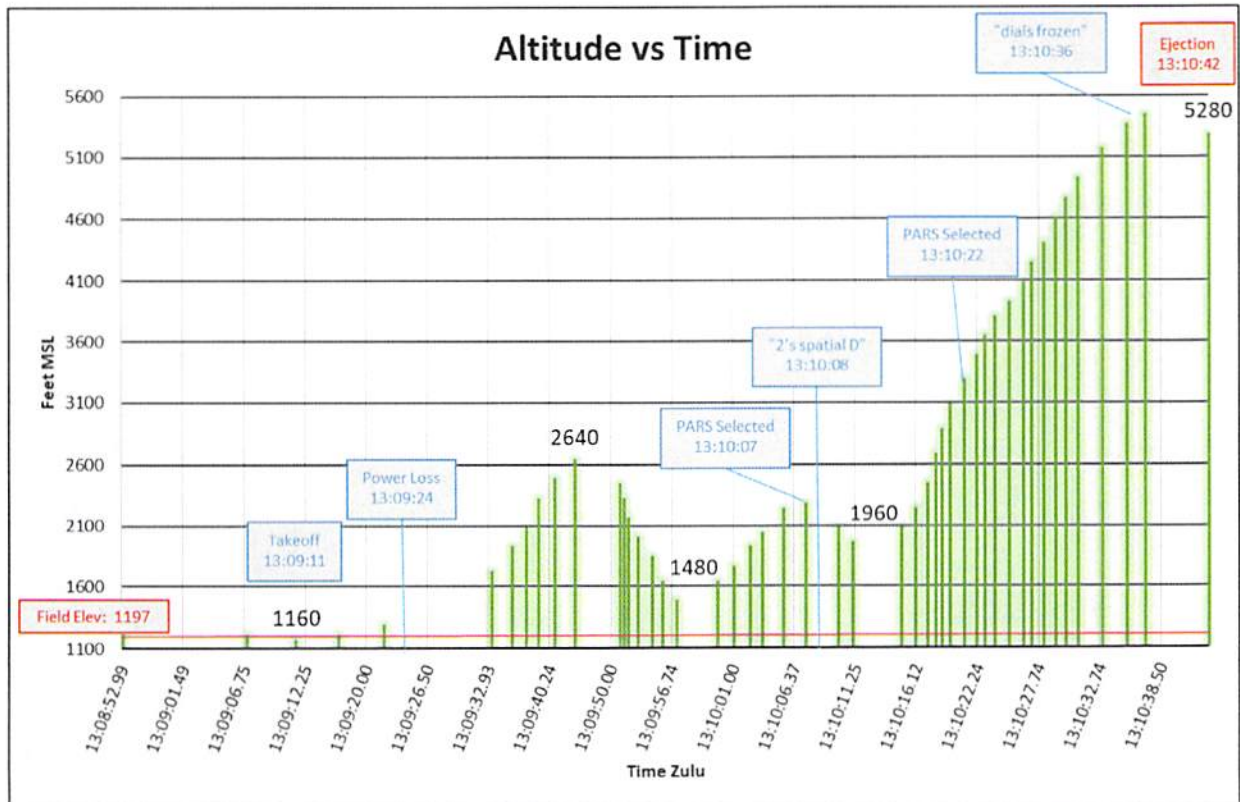
Figure 5: MA Altitude vs Time (Tabs L-16 and Z-5)

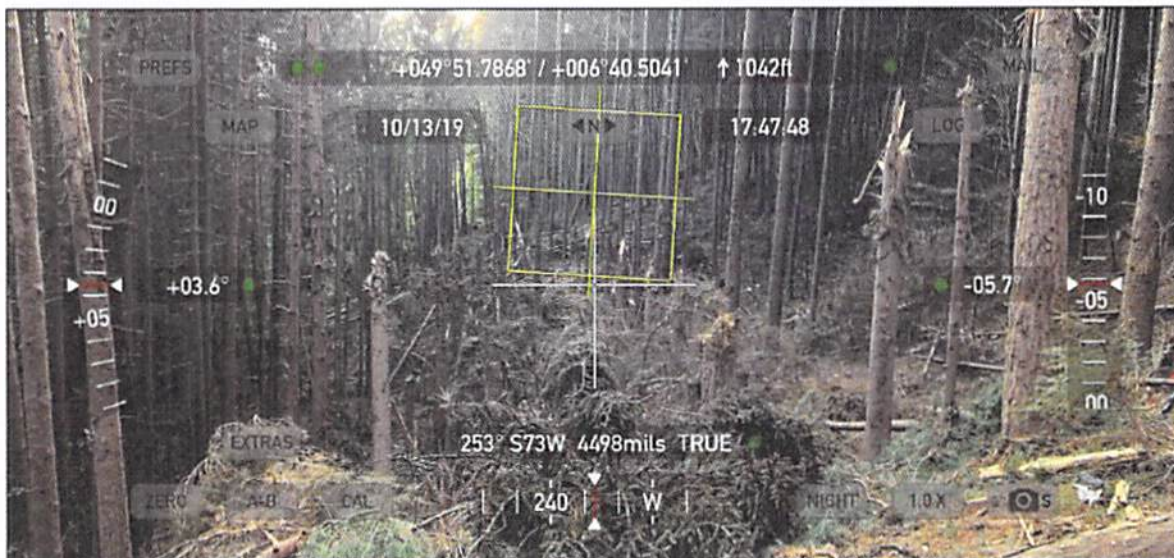
The MA continued to fly for another 42 seconds, after the MP ejected, and made initial contact with the tree tops at 15:11:24.87L, 8 nautical miles south (184 degrees true) of Spangdahlem AB (Tab J-27). The MA's parameters at the time of impact were: approximately 20-25 degrees of bank, 17 degrees nose low, 550 KCAS, and heading 248 degrees true (Tab J-30). Additionally, the MA had zero control inputs and an operable engine set at MIL power (Tab J-30). Upon contact with the trees, the MA was completely destroyed and shredded into mostly small pieces leaving a debris field approximately 1,000 feet long by 300 feet wide (Tab J-27). The terrain at the crash site is dense forest with steep, rapidly rising terrain and 100 foot tall trees as depicted in *Figure 6* (Tab J-27). There was no evidence of a post-impact fire at the site (Tab J-27). The impact resulted in zero casualties or fatalities (Tab O-3).

Figure 6: MA Impact Site (Tab J-27)

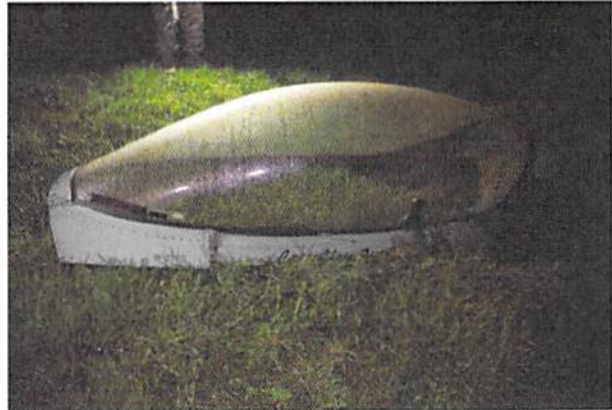
Figure 8: Canopy (Tab S-5)

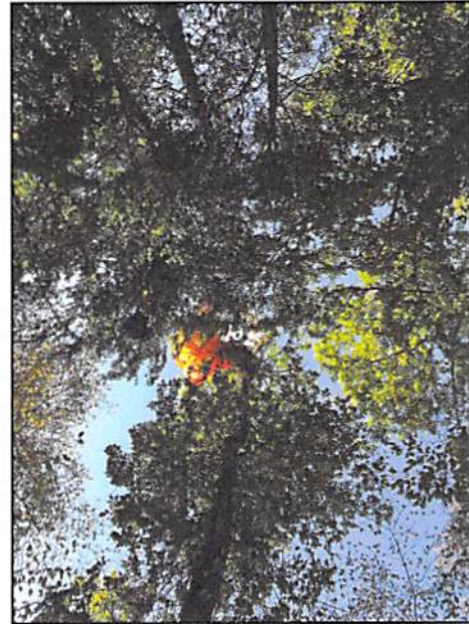
Figure 10: Parachute (Tab S-29)

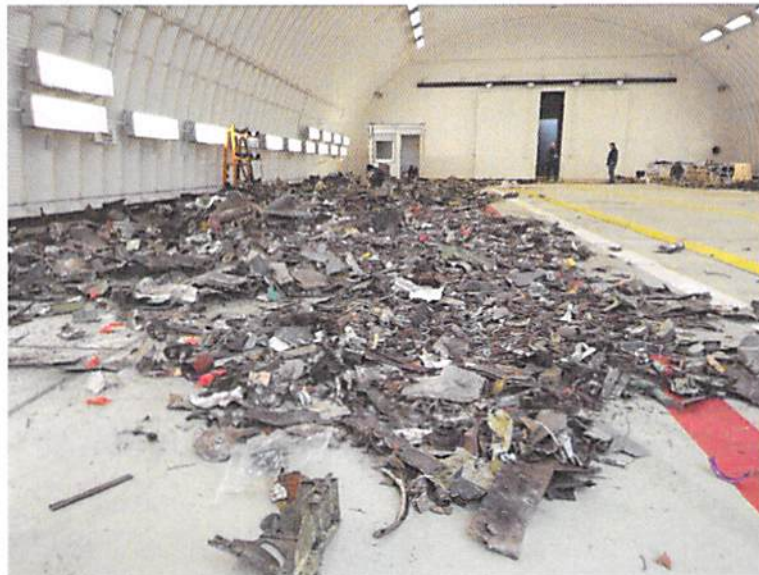
The MA impacted the trees 17 degrees nose low, 20-25 degrees right bank, and traveling approximately 550 knots (Tab J-30). The MA travelled approximately 1,000 feet through the forest and was completely destroyed during impact (Tab J-27). The majority of the MA was broken into pieces ranging in size from a few inches to a few feet (Tab J-27). Evidence of this is depicted in *Figure 11*. The largest debris recovered was 3 to 5 feet long (Tab J-27). The debris field was oblong in shape approximately 1,000 feet long and 300 feet wide at its widest point (Tab J-27).

Figure 11: MA Wreckage Recovered in PAS (Tab S-9)
