UNITED STATES AIR FORCE
AIRCRAFT ACCIDENT INVESTIGATION
BOARD REPORT

F-16CM, T/N 90-0714
80TH FIGHTER SQUADRON
8TH FIGHTER WING
KUNSAN AIR BASE, SOUTH KOREA

LOCATION: KUNSAN AIR BASE, SOUTH KOREA
DATE OF ACCIDENT: 2 DECEMBER 2019
BOARD PRESIDENT: COLONEL JARED J. HUTCHINSON
Conducted IAW Air Force Instruction 51-307

**SUMMARY OF FACTS AND STATEMENT OF OPINION
F-16CM, T/N 90-0714
2 DECEMBER 2019**

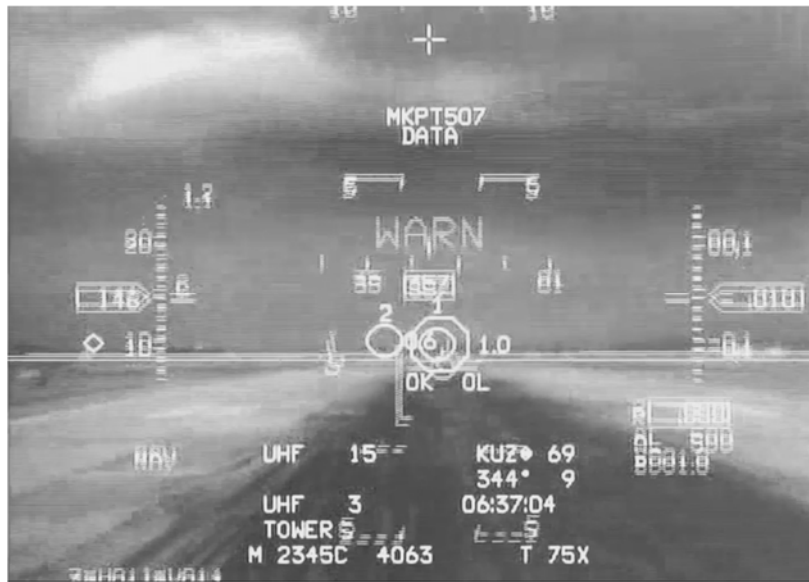
At 15:37:04.43L initial touchdown on the runway occurred (Image 4) (Tab L-2). The MA touched down at approximately 146 KCAS, approximately 130 feet before the approach end arrestment cable (Tabs J-23, L-2). After the MA initially touched down on the runway, the RMLG collapsed causing the MA to display WARN in the HUD and produce the landing gear warning horn (Image 4) (Tab L-2). The WARN displayed in the HUD and the landing gear warning horn cycled intermittently for the next 6 seconds, from initial touchdown to ejection (Tab L-2). The landing gear warning horn is an intermittent fixed volume signal which sounds in the headset when the nose landing gear (NLG) or main landing gear (MLG) is not down and locked and the aircraft is preparing to land (Tab BB -54). This will also cause WARN to display in the HUD (Tab BB -54). After initial touchdown, the MA bounced slightly and became airborne again (Tabs J-21, L-2).

Image 4. MA's Initial Touchdown (Tabs L-2, Z-3)

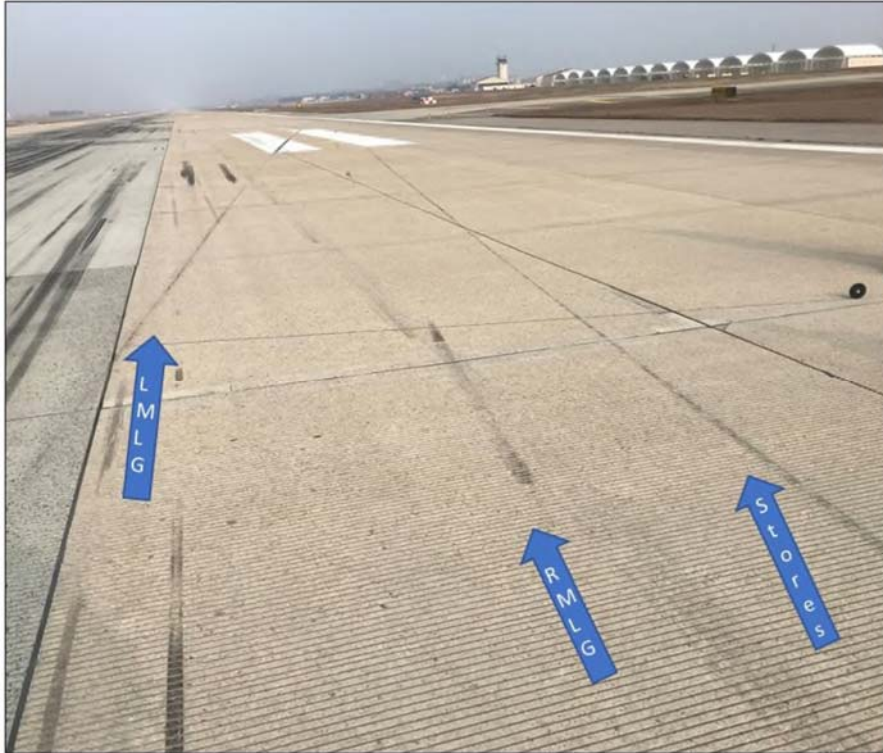
Due to the heavy rubber deposits in the runway touchdown zone, initial touchdown witness marks were not visible; however, the width of the first visible set of tire witness marks on the runway were measured at approximately 84 inches with a “skipping/wobbling” effect of the right tire witness marks (Image 5) (Tab J-21). Since the F-16 main gear “footprint” is 93 inches (outside left tire to outside right tire), this reduced landing gear width indicates the MA had a collapsed condition of the right main landing gear after touchdown (Tab J-21).

Image 5. Skipping Ground Track - RMLG (Looking North) (Tab Z-6)

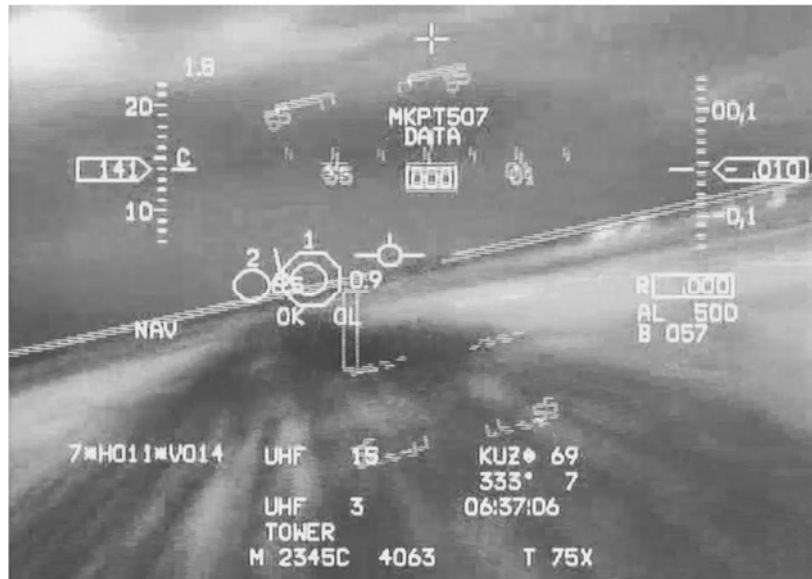
At 15:37:05.78L, when the MA settled back to the runway, the MA immediately began to yaw to the right towards the edge of the runway’s prepared surface (Image 6) (Tabs L-2, R-639). The MP increased power and input left flaperon and left rudder in an attempt to control the aircraft and take the MA airborne again (Tabs L-2, R-639).

Image 6. MA Right Yaw After Second Touchdown (Tabs L-2, Z-4)

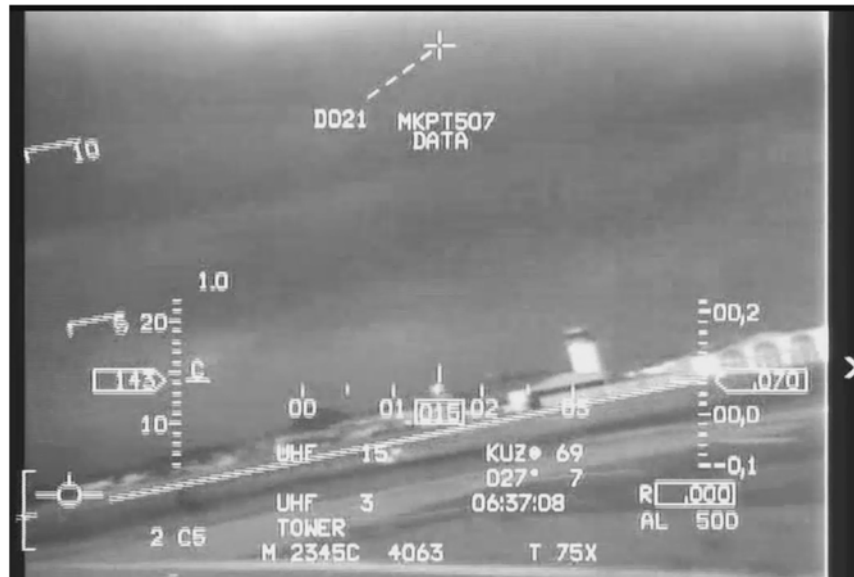
The MP was unable to control the MA and continued to approach the edge of the runway's prepared surface at approximately 143 KCAS (Image 7) (Tabs L-2, R-639).

Image 7. MA Approaching Edge of Runway's Prepared Surface (Tabs L-2, Z-4)

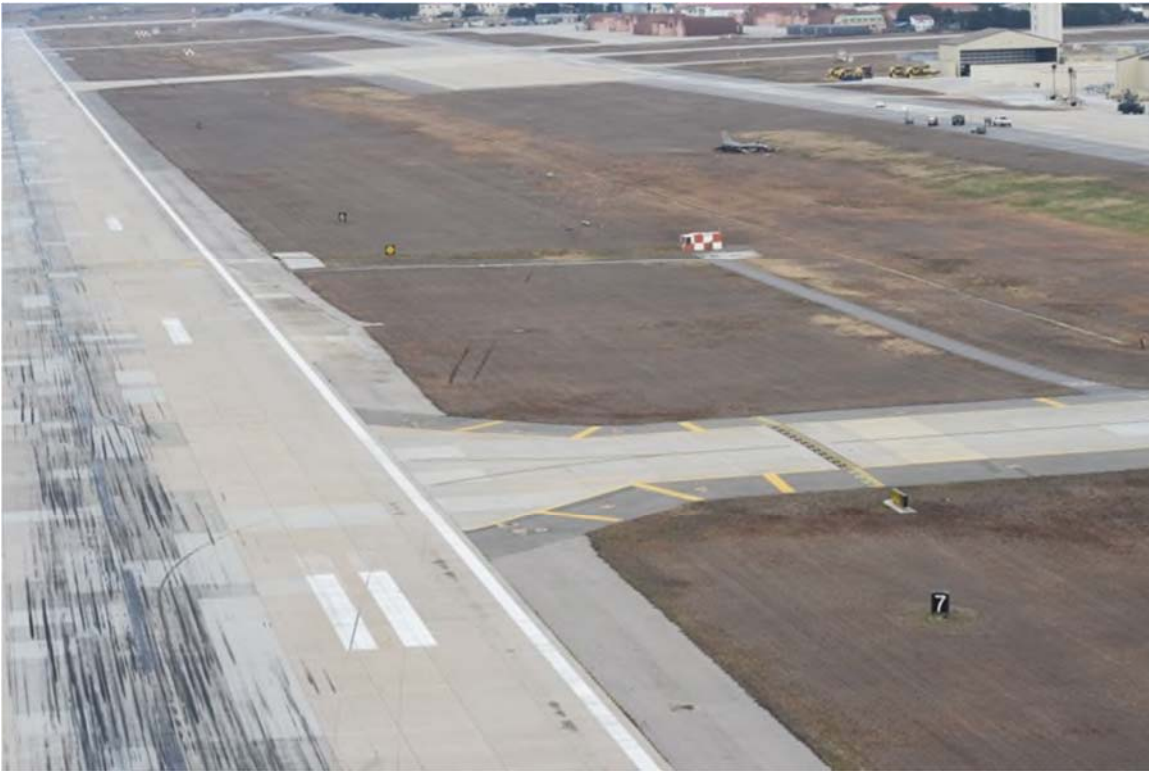
After the MA departed the runway's prepared surface, there was a brief period where the MA bounced and did not leave any tire witness marks (Image 10) (Tab J-18). The first set of tire witness marks in the grass were measured at 93 inches indicating the RMLG was no longer in a collapsed condition (Tab J-22).

Image 10. Mishap Site Looking North; Runway Witness Marks Leading Into the Grass (Tab Z-7)

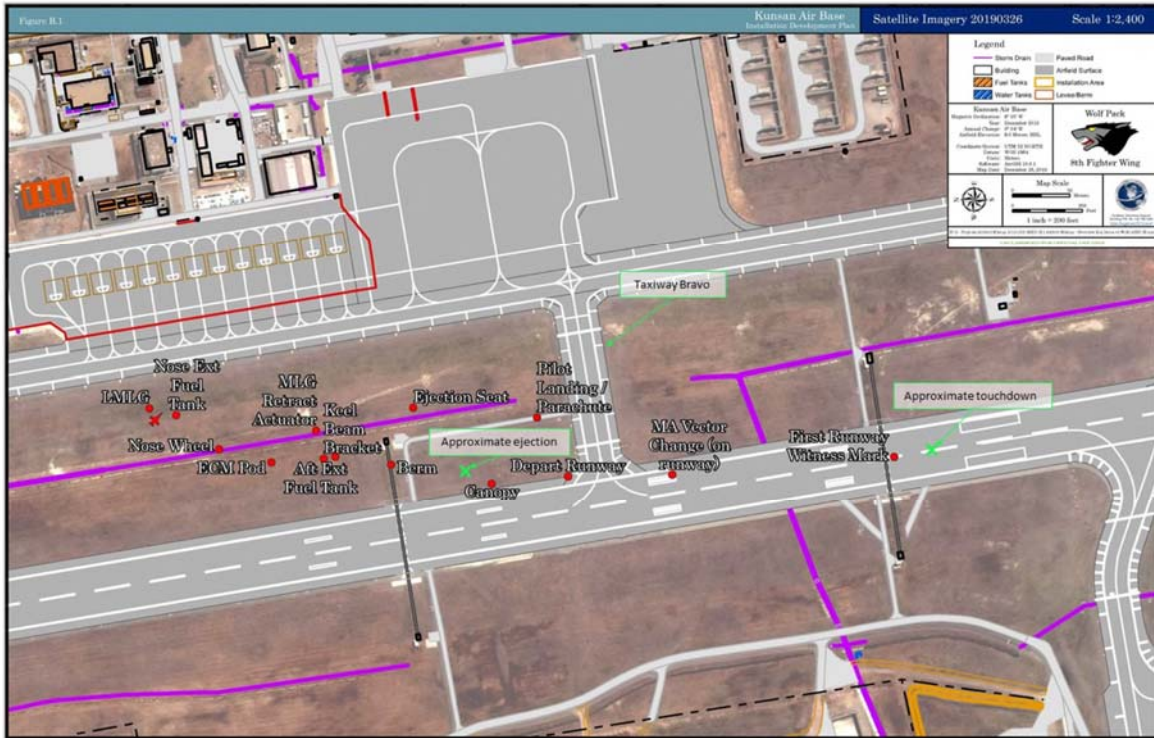
The MA continued across the infield with the RMLG now down and locked, and the engine running, until it came to rest approximately 2,200 feet from initial touchdown, having rotated approximately 150 degrees from runway heading (Tab J-20 to J-22).

Figure 1. Mishap Site Overview (Tab Z-8)

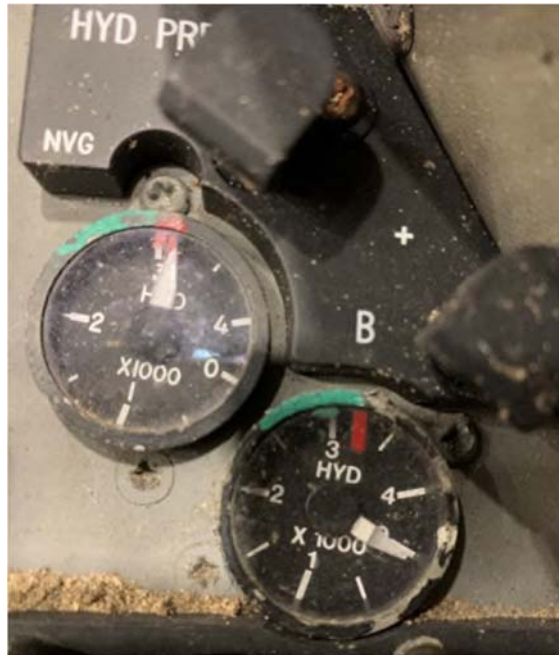
Post-mishap, the hydraulic system B gauge was reading 0 psi (see Image 11 below) (Tab J-26). After reviewing the CSFDR, it was concluded that the loss of the hydraulic system B pressure occurred post-ejection during the mishap and did not affect the normal operation of the landing gear during the MA landing (Tab J-26).

Image 11. Post-mishap Hydraulic System Pressure Gauges (Tab Z-9)

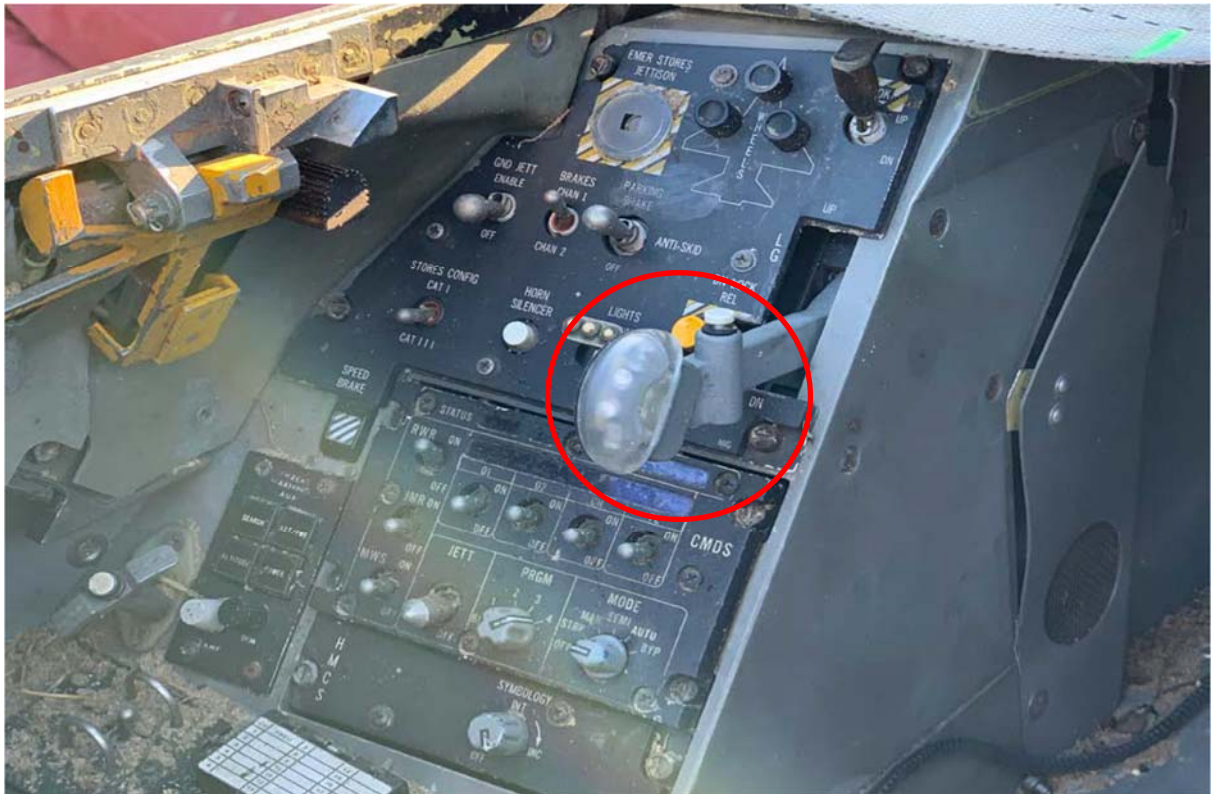
The first category is not applicable (Tab EE-15 to EE-16). The photographs of the MA cockpit and MP interview corroborate that the landing gear handle was in the down position (see Image 12 below) (Tabs R-638 to R-639, S-4). Examination of the HUD video showed pronounced roll and yaw to the right after touchdown (Tab L-2). The marks on the runway and in the grassy field show a constant Left Main Landing Gear (LMLG) track that indicates the LMLG was in the down and locked position (Tab J-21 to J-22).

Image 12. Landing Gear Handle (Tabs S-4, Z-9)

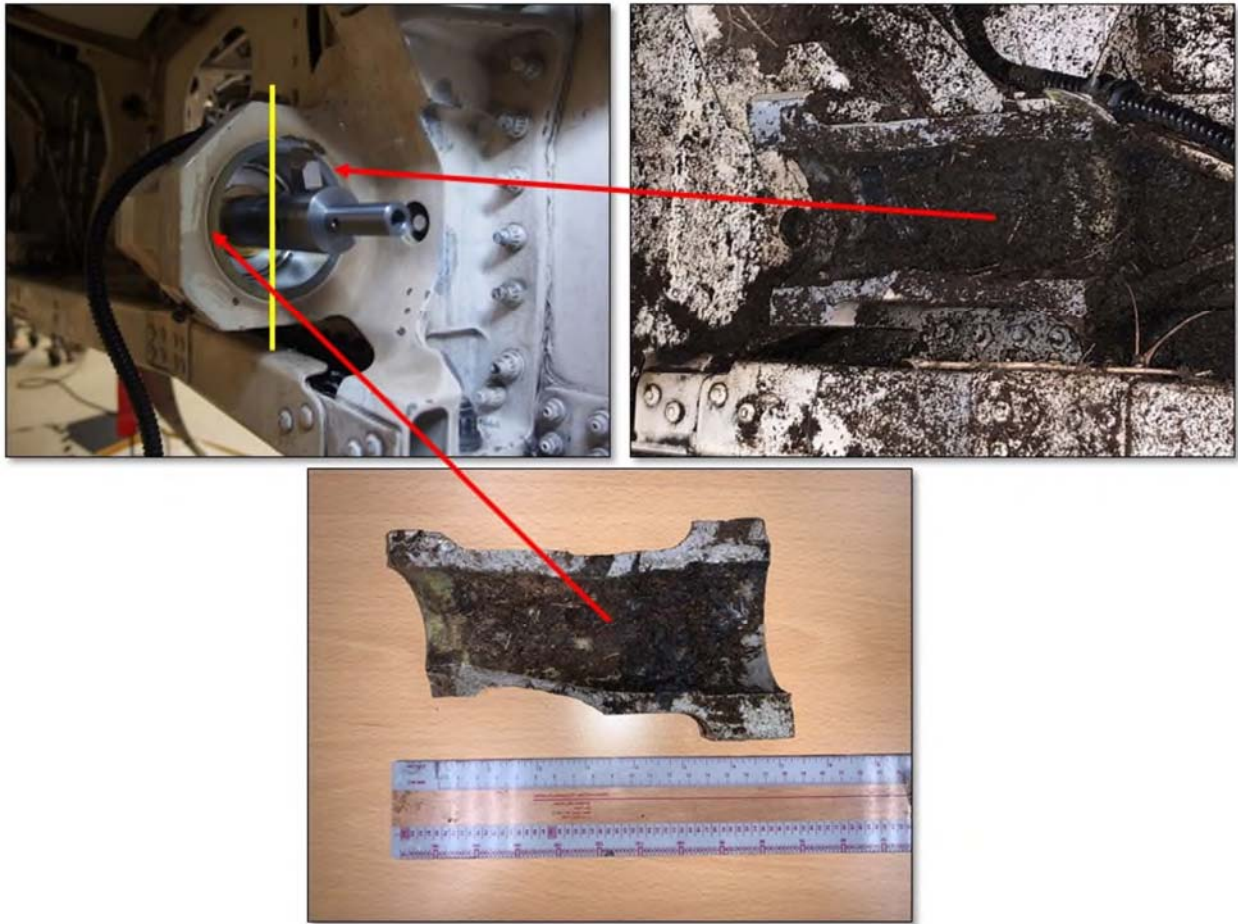
The second category is not applicable (Tab BB-8). Initial observations discovered that the drag brace failed at the keel beam attachment point (Tab BB-6 to BB-10). The MA showed a failure of the keel beam attachment point on the aircraft (see Image 13 below) (Tab BB-6 to BB-10).

Image 13. RMLG Wheel Well Keel Beam Attachment Point (Tab Z-10)

The outboard portion of the fitting was found approximately 1,716 feet past the MA touchdown and 515 feet before the main wreckage (Tab EE-15 to EE-16). Since the broken piece of the fitting attachment was found well past the touchdown location, it is likely the broken piece of the fitting attachment fell away from the MA near the point of failure (Tab EE-15 to EE-16). This indicates the failure of the keel beam attachment fitting occurred well after the initial touchdown point (Tab BB-6 to BB-10). Therefore, the drag brace did not fail at the keel beam fitting attachment during landing (Tab BB-6 to BB-10).

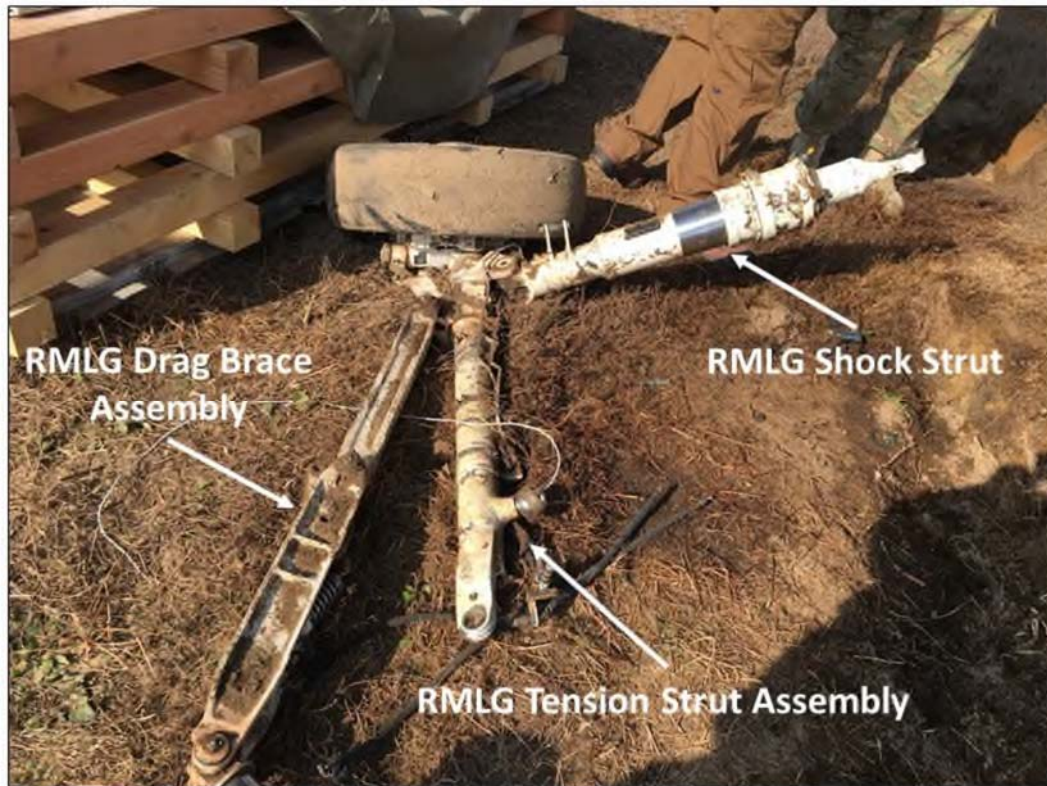
The third potential cause of the landing gear failure is that the drag brace failed to remain in the overlock position causing gear collapse (Tab EE-15 to EE-16). Normal distance between the MLG of an F-16 is 93 inches (Tab J-21). The measured width of the first visible MA tire marks on the runway were 84 inches with a “skipping/wobbling” effect of the right tire witness marks (Tab J-21). This indicates a collapsed condition of the RMLG after touchdown (Tab J-21 to J-22). The RMLG drag brace remained attached to the RMLG assembly and in the fully extended position (see Image 14 below) (Tab BB-6 to BB-10).

Image 14. RMLG Assembly (Tab Z-11)

I find, by a preponderance of evidence, this mishap was caused by a failure of the RMLG downlock actuator, causing the RMLG to collapse, making the aircraft uncontrollable during the landing phase of flight.

I find, by a preponderance of evidence, that the following factor substantially contributed to the mishap: DAF mandated time frame to implement TCTO 1F-16-2855, “Replacement of Main Landing Gear Downlock Actuators and Support Brackets and Hardware on all USAF F-16C/D Blocks 40/42/50/52 Aircraft.”

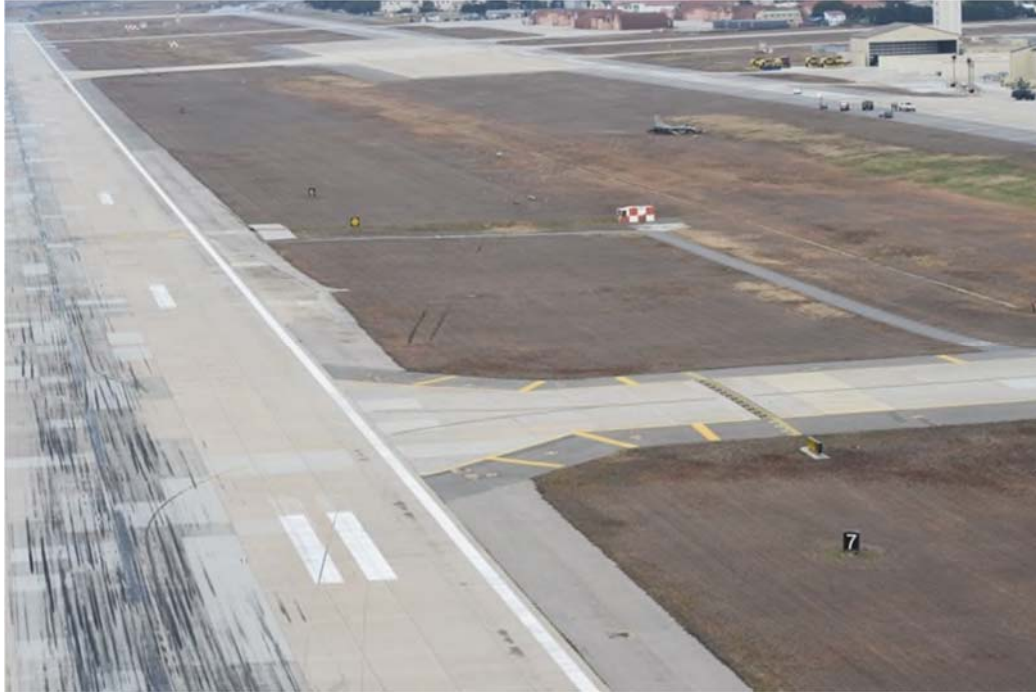
These inputs likely would have resulted in either a bounce or a removal of weight from the MLG (reduction of wing loads) while departing the runway's prepared surface which would allow the landing gear to re-extend (Tab EE-15 to EE-16). Physical evidence corroborates this with the absence of continuous tire witness marks from the runway edge into the grass (see Image 15 below) (Tab Z-7).

Image 15. Mishap Site Looking North; Runway Witness Marks Leading Into the Grass (Tab Z-7)
