UNITED STATES AIR FORCE
AIRCRAFT ACCIDENT INVESTIGATION
BOARD REPORT

F-16C, T/N 88-0496

311th FIGHTER SQUADRON
54th FIGHTER GROUP
HOLLOMAN AIR FORCE BASE, NEW MEXICO

DATE OF ACCIDENT: 31 JANUARY 2017

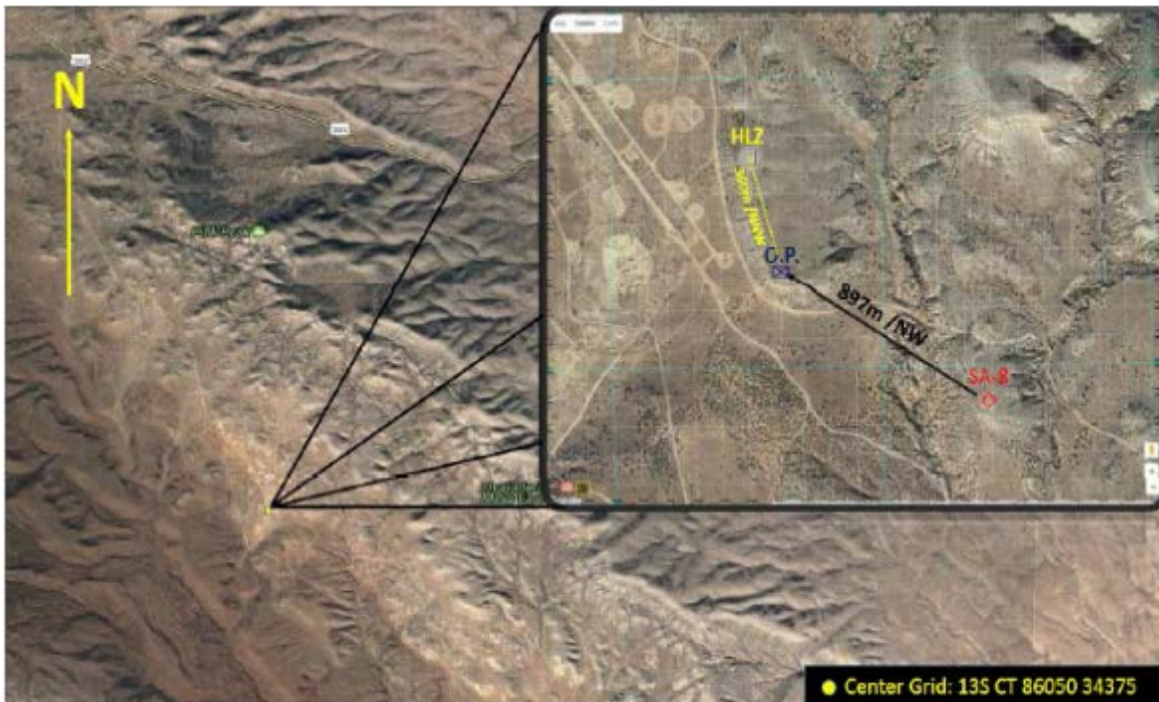
Figure 5: Overhead view of distance between the OP and the SA-8 training target (Tab S-9)

The AIB noted that the SA-8 training target and the OP are on similar geographical semicircular ridges with similar cleared out areas (Tab S-9 to S-10). The images from the TGP were similar in appearance between the friendly OP and SA-8 training target (Tab Z-5). The friendly OP and SA-8 training target area were 897 meters apart (Tab S-9).

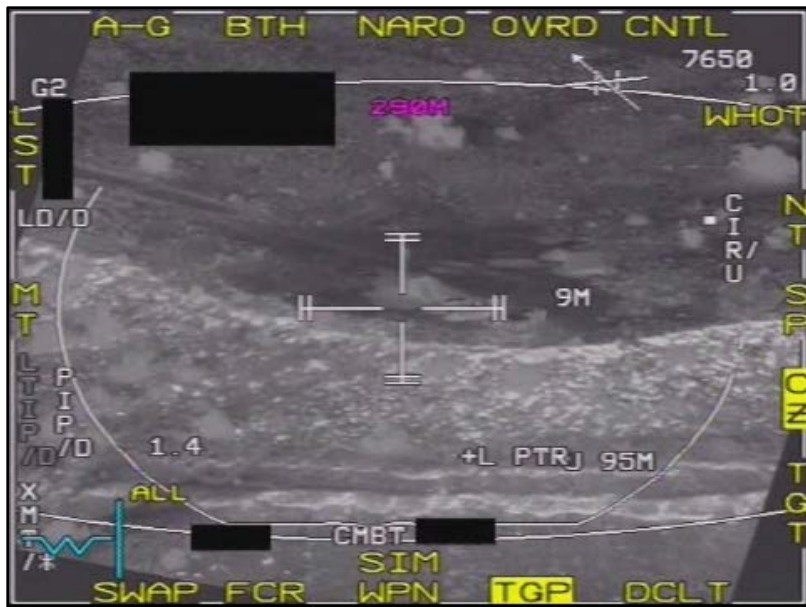
Figure 6: MP's targeting pod sensor on the friendly OP at 19:07:20 hours L (Tab Z-6)

their GBU-12 inert bombs (Tab L-3). At 19:08:15 hours L, the MP reset his TGP by pressing “CZ” (Cursor Zero) on the TGP multifunction display (Figure 6) (Tab BB-47 and BB-53). This action moved the MP’s sensors and steering data back to the intended SA-8 training target’s coordinates, and away from the JTAC’s position at the OP (Tab BB-53).

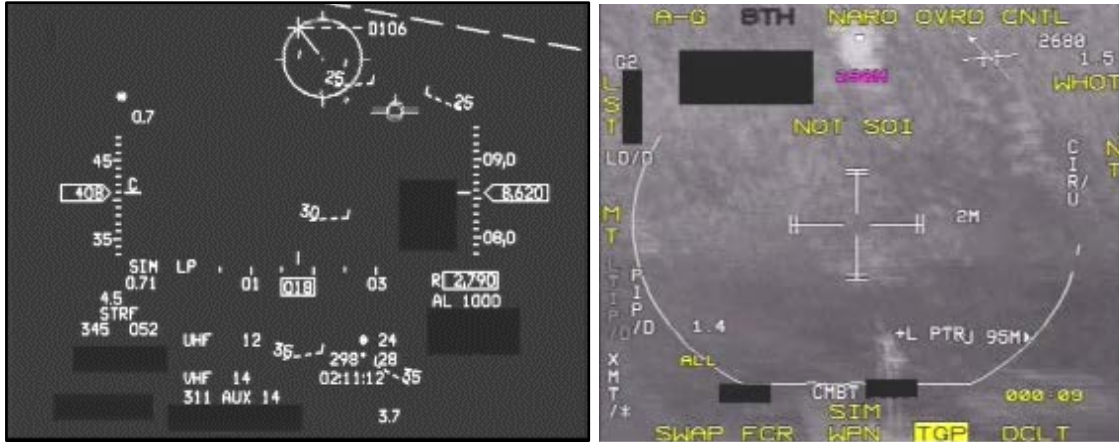
Figure 7: MP's heads up display & targeting pod sensor /First strafe attempt at 19:11:12 hours L (Tab Z-21 and Z-22)

Because the MP had his master armament switch in “SIM” (simulation mode), the gun did not fire (Tab BB-53). Right after he realized the gun was in SIM, the MP, at 19:11:22 hours L, moved the master armament switch to “ARM,” enabling the trigger to fire the gun (Tabs N-4 and BB-54). The internal cockpit voice recorder (also called a hot mic) captured the MP expressing frustration over the master armament switching error, but the cockpit recording provides no evidence that the MP was aware that he had nearly fired upon the friendly's position (Tab N-4).

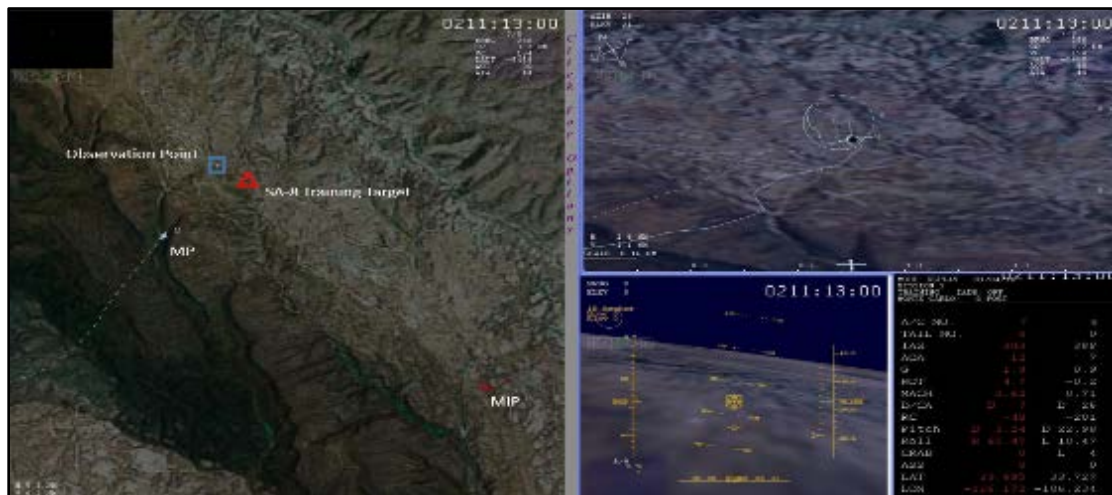
Figure 8: Digital reconstruction of MP's first strafe pass at 19:11:13 hours L (Tab Z-14)

Through this first high-angle strafe attack, the MIP was flying at approximately 15,000 feet in a right hand turn, orbiting over the SA-8 training target, between 3.5 and 4.5 nautical miles away from the MP, (Figure 8) (Tab Z-14). The MIP was marking the SA-8 for the MP by “sparkling and lasing” the training target (the MIP used both his TGP's IR pointer and laser to designate the target) (Tab BB-53). The IR pointer is visible through NVGs and the MP had synchronized his TGP sensor to pick-up the MIP's laser designator (the laser is not visible to the human eye, even with NVGs) (Tab BB-47). For this strafe attempt, the MP's aircraft steering data pointed at the correct target (SA-8 training target) (Tab BB-53).

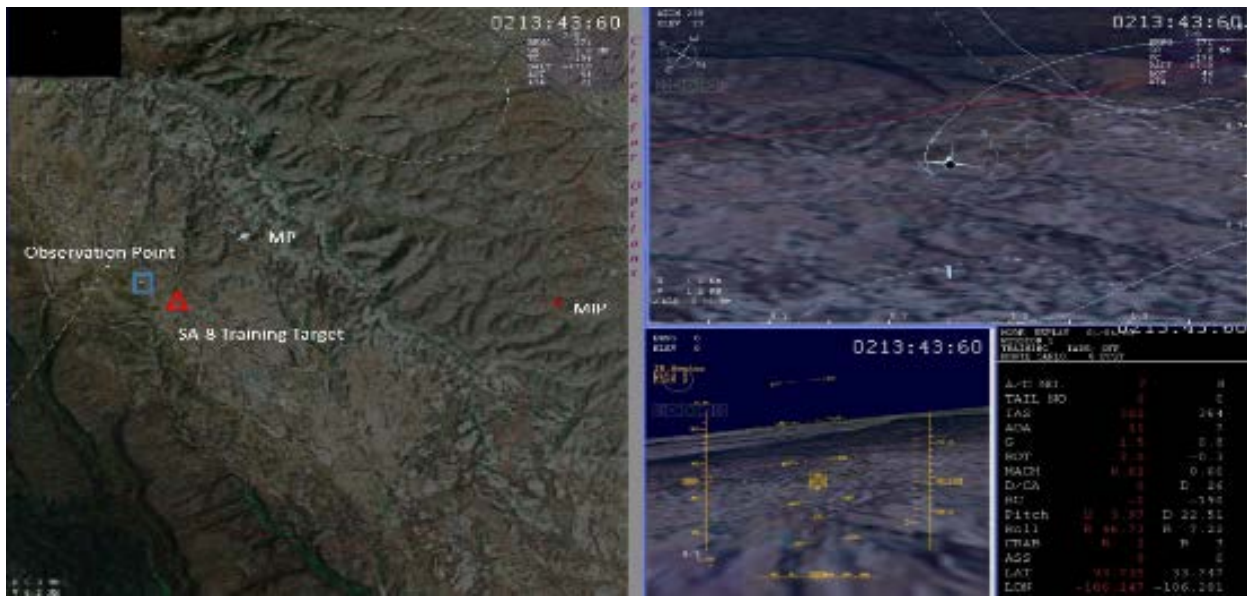
Figure 9: Digital Reconstruction of the MP's second strafe pass at 19:13:43 hours L (Tab Z-15)

On the second high-angle strafe pass, the MP flew in accordance with his aircraft's steering data and pointed the aircraft correctly at the SA-8 training target (Tabs Z-15 and BB-54). However, the MP aborted the attack and did not squeeze the trigger (Tab BB-54). The MIP subsequently queried the MP why he did not open fire during the pass and the MP responded over the intra-flight radio (heard only between the MIP and the MP) that "the sparkle just looked different so I did not want to shoot, I wasn't uhh, it wasn't as circular as I thought I saw, it looked like a light maybe on top of a building, I was wrong" (Tabs N-5 to N-6 and BB-54). The MIP did not respond to the MP's explanation or provide any cross monitoring to ensure his student pilot was on the correct target (Tabs N-6 and BB-54). When MJ1 asked over the primary radio for the reason the MP did not fire, the MIP, and not the MP, responded that "*Biggy 2*, he's, yeah he is going to setup for an attack, he is going to hold south while *Bolt* attacks" (Tabs N-6 and BB-54). MJ1 and the other ground element members, who were also monitoring the primary radio, were never told that the MP thought he saw something that looked like a light on a building (Tabs N-6 and R-6).

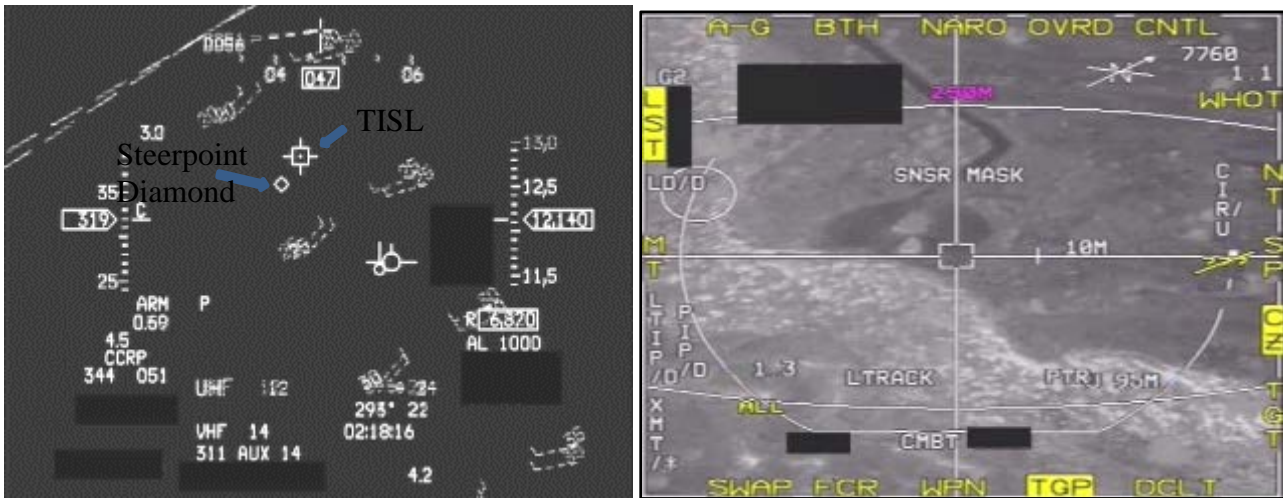
Figure 11: MP's heads up display and TGP sensor/third strafe pass 19:18:16 hours L (Tab Z-7 and Z-18)

before it reaches its rotational limit and needs to, momentarily, reset back to center (Tab BB-47 to BB-48). Once the MP straightened-out of his roll, pointing at the ground, the TGP automatically re-acquired the SA-8 training target (Figure 14) (Tabs Z-25 and BB-55). At 19:18:16 hours L, both the TISL and steer point diamond symbology, denoting the location of the SA-8 training target, were showing in the MP's HUD (Figure 11) (Tabs Z-7 and BB-55).

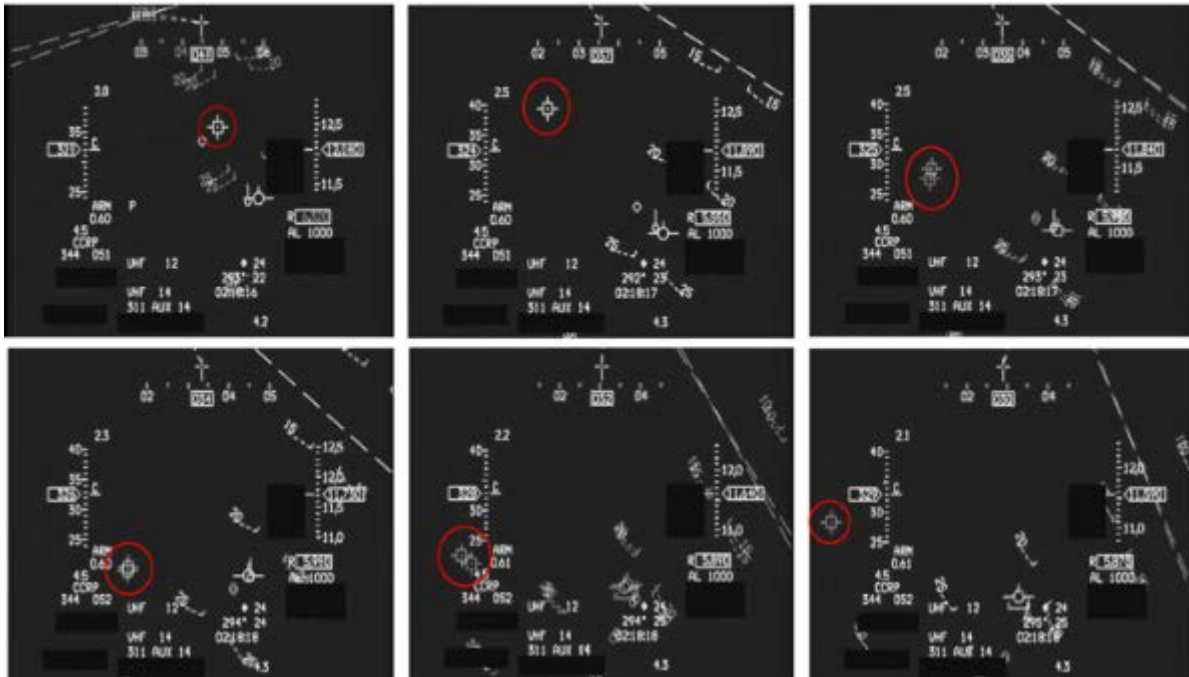
Figure 13: MP's targeting pod sensor showing TISL symbology moving (figure reads left to right, top to bottom) (Tab Z-5)

At 19:18:17 hours L, the TISL symbology in the MP's HUD moved up, then down to the left (Figure 13) (Tabs Z-5 and BB-55). At 19:18:18 hours L, the TISL symbology was no longer visible in the MP's HUD (Figure 14) (Tabs Z-20 and BB-55). Data from the MIP's targeting sensor showed that the MIP's laser target designator and IR pointer drifted away from the SA-8 training target (Tab BB-55). Data from the MP's TGP sensor showed the MIP's laser spot track moved approximately 15 meters east and 4 meters north of the SA-8 training target (Figure 14); at which time, the MP then maneuvered his aircraft further to the left to then point at the OP (Tabs Z-20 and BB-55). At 19:18:19 hours L, when the MP's heads up display no longer had the TISL container or the SA-8 training target steerpoint visible, the MP's TGP then reacquired the MIP's laser, at 19:18:25 hours L (Figure 15) (Tabs Z-21, Z-32 and BB-55).

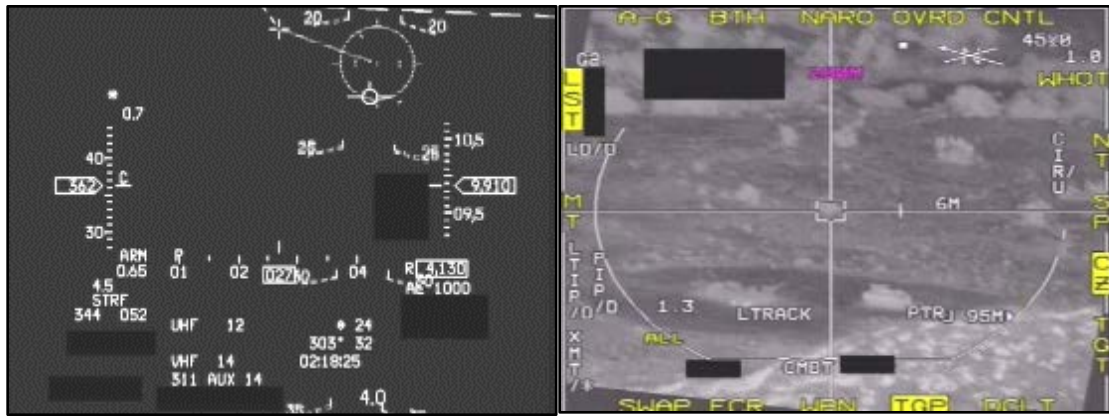
Figure 15: MP's heads up display and targeting pod sensor at 19:18:25 hours L (Tab Z-21 and Z-32)

At 19:18:25 hours L, the MP put his aircraft into air-to-ground strafe mode, causing strafe symbology to appear in his HUD (Figure 15) (Tabs Z-21 and BB-55). The AIB was unable to determine what the MP was looking at to aim his F-16 toward his intended target as the SA-8 training target was no longer in the MP's HUD; however, the SA-8 training target is in the field of view of the MP's TGP sensor (Figure 16) (Tabs Z-21, Z-32 and BB-55). At 19:18:30 hours L, the MP squeezed the trigger, firing 155 rounds of 20mm TP (Figure 16) (Tabs Z-22, Z-24, AA-46 and BB-55). The MP released the trigger at 19:18:32 hours L (Tab BB-55).

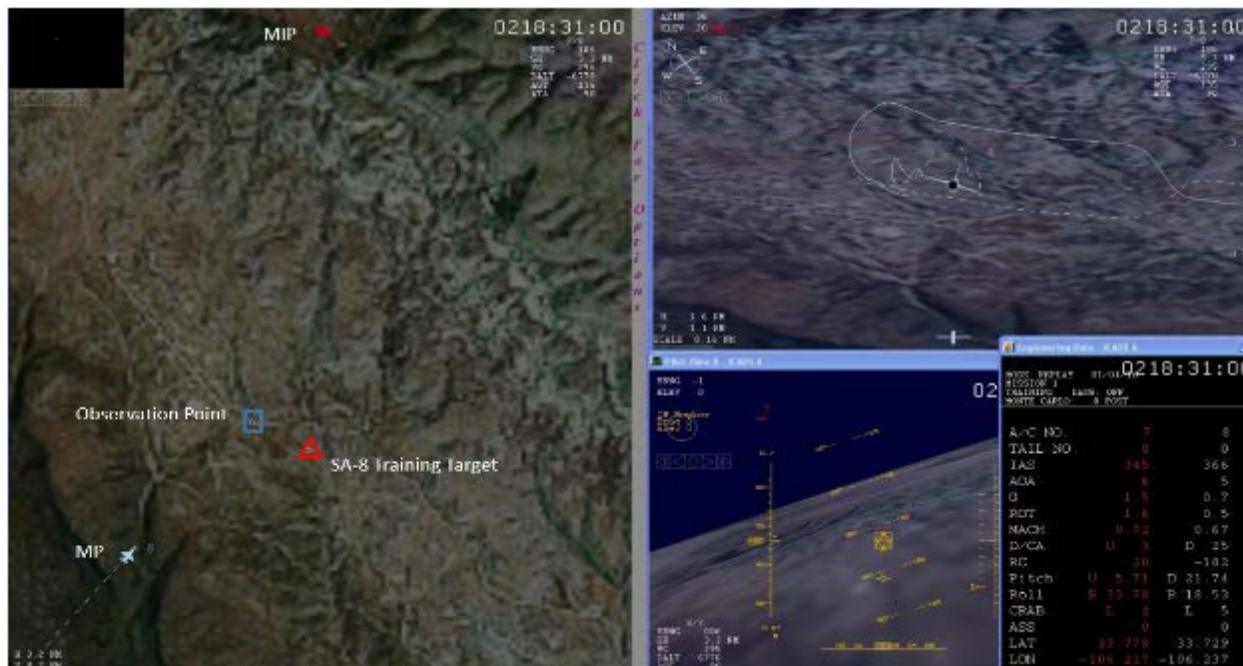
Figure 17: Digital Reconstruction of the mishap strafe pass at 19:18:31 hours L (Tab Z-16)

At 19:18:33 hours L, 155 rounds of 20mm TP impacted the ground element's location on the Red Rio OP (Tabs R-8 to R-9, R-30 and AA-46). The final attack heading was between 027-028 degrees magnetic from the time the MP squeezed the trigger until he released the trigger two seconds later (Figure 18) (Tabs S-10 and BB-55). An unknown number of 20mm rounds impacted the three vehicles (V1, V2, V3) parked on the OP (Figure 19) (Tab S-3). V2 subsequently caught fire and burned (Figure 19) (Tab S-5). Bullet fragments hit MJ1 in the upper left leg, left buttock, and left lower back (Tabs X-2 and V-22.6). Fragments also hit a Dutch JTAC (DJ2) who was standing behind V2, but he was not injured as the fragments hit him in an area protected by his body armor (Tab V-7.2). The MC, who was not wearing his body armor or helmet, suffered a wound to the back of his head (Tab X-1).

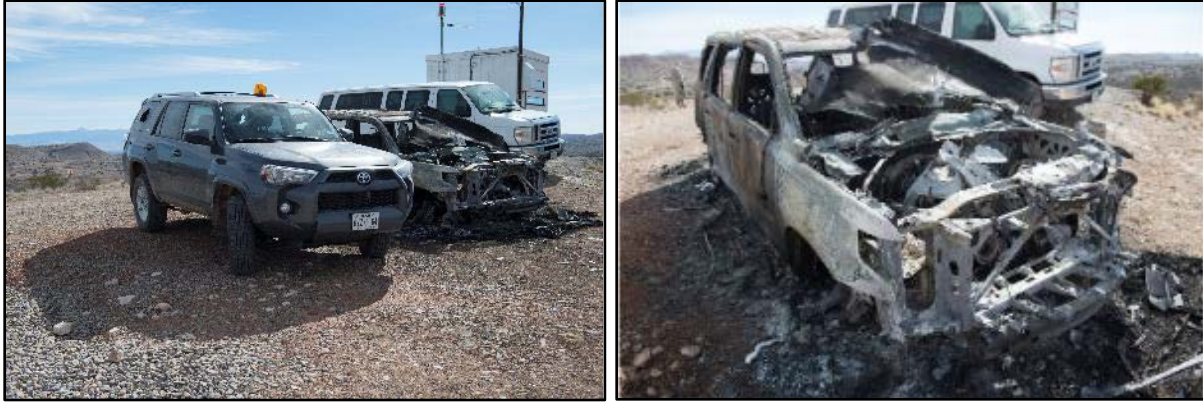
The 20mm rounds also damaged two rental vehicles and one government vehicle (Tab S-3). The mishap pilot (MP) was a student pilot enrolled in the F-16 Formal Training Unit (FTU) program and assigned to the 311th Fighter Squadron (311 FS), 54th Fighter Group (54 FG), 56 Fighter Wing (56 FW), Holloman AFB NM (Tab G-2). The MP was flying a night, close air support (CAS), live-fire, training mission under the supervision of the mishap instructor pilot (MIP) in an F-16D (two seat version of the F-16), with a student observer (MSO) in the rear seat (Tabs K-3 and T-19).

Figure 19: From left to right, V1, V2 and V3 the day after the mishap (Tab S-3 and S-5)

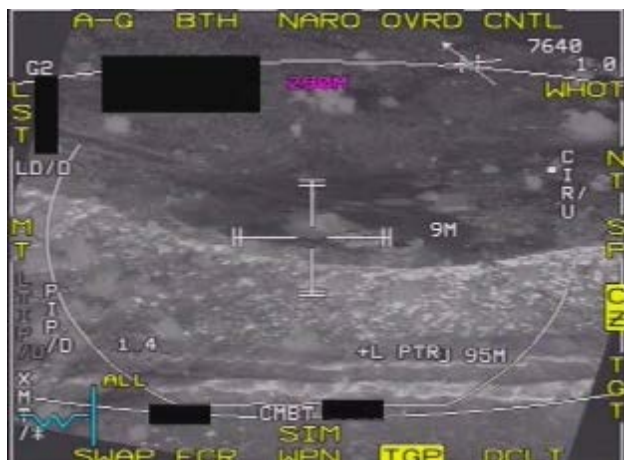
Figure 22: MP’s TGP sensor viewing the OP when he initially called “2 is capture the target” (Tab Z-6)

First error in perception: In preparation to prosecute a high-angle strafing attack on the SA-8 training target, the MIP used his TGP to laser spot and to IR mark the SA-8 training target for the MP and called “1 is lasing, sparkling the target” (Tab N-2). The MP responded, “2 is capture the target” (Tab N-2). At the time of his capture call, the MP’s TGP was not focused on the SA-8 training target but was focused at the friendly OP (Figure 22) (Tab Z-3). This was the only time the MP’s TGP was actually looking at the friendly OP during the mishap sortie (Tab BB-53). The MP never verbally acknowledged that his TGP was looking at the OP when he called capture (Tab N-2 to N-7). The MP chose not to provide testimony about this event, so the AIB does not know whether the MP realized he was looking at the OP (Tab V-28.2 and V-29.1). The MIP aborted the MP before the MP could begin this strafing attack, because MIP wanted to allow *Bolt flight* to make their initial attack on the SA-8 training target (Tab N-3).

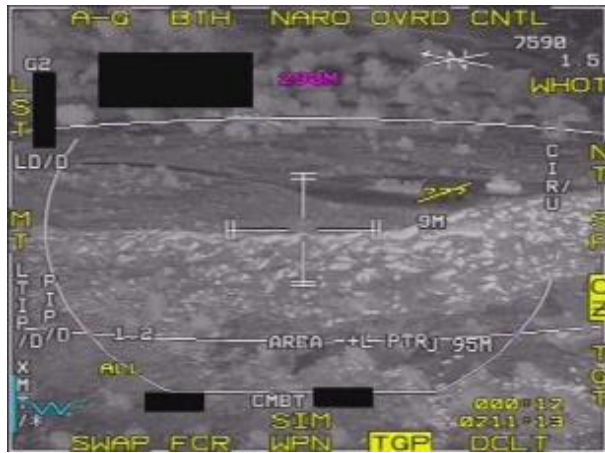
Figure 23: MP's TGP sensor viewing the SA-8 training target prior to his first strafe pass (Tab Z-6)

Second error in perception: Subsequent to the NMF’s attempted attack on the SA-8, the MIP gave terminal attack control of the MP to MJ1 to execute a high-angle strafing attack (Tab N-3). The MP called “2 is ready, capture target” (Tab N-4), at which point the MP’s TGP sensor was viewing the SA-8 training target (Figure 23) (Tab Z-3). The MJ1 cleared the MP to engage on the SA-8 training target (Tab N-4). However, the MP then pointed his F-16 at the friendly OP rather than the SA-8 training target and squeezed the trigger (Tab BB-53). The only reason that the MP did not fire on the ground element during this strafing attack was that the MP’s gun failed to fire; the MP failed to move the Master Arm switch from SIM to ARM (from simulation mode to armament mode) (Tabs N-4 and BB-53). After this failure to fire, the MP called “Biggy 2 is off dry, avionics” (Tab N-4). The MP expressed frustration with himself into his internal microphone (the MP was flying with a “hot” mic, which captured all his vocalized comments, but not all comments were transmitted over the inter-flight radio to the MIP or over the main radio to all the mission participants) and immediately moved the Master Arm switch to ARM (Tab N-4). The MP never verbally acknowledged to anyone that he had just pointed at the friendly OP during this strafing attack (Tab N-2 to N-7).

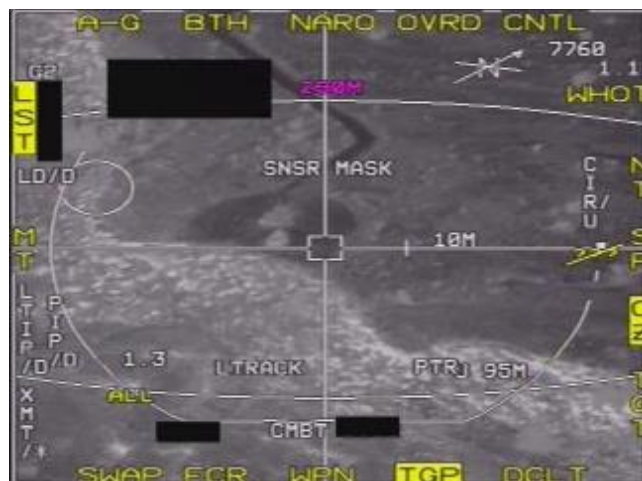
Figure 24: MP's TGP sensor viewing the SA-8 training target prior to the mishap strafe (Tab Z-7)

Fourth error in perception: Just prior to the MP’s final strafe attack, the *Bolt flight* successfully prosecuted an inert GBU-12 attack on the SA-8 training target (Tabs N-6 and BB-54). The MIP requested approval for the MP to do a high-angle strafe re-attack on any simulated enemy troops (squirters) leaving the area and received approval from MJ1 (Tab N-6 to N-7). The MIP told the MP, “1 is lasing, this is going to be TISL strafe” (Tab N-7). The MP replied, “2 is spot SA-8” (Tab N-7). At this point, the MP’s TGP was on the SA-8 training target (Figure 24) (Tab Z-7).

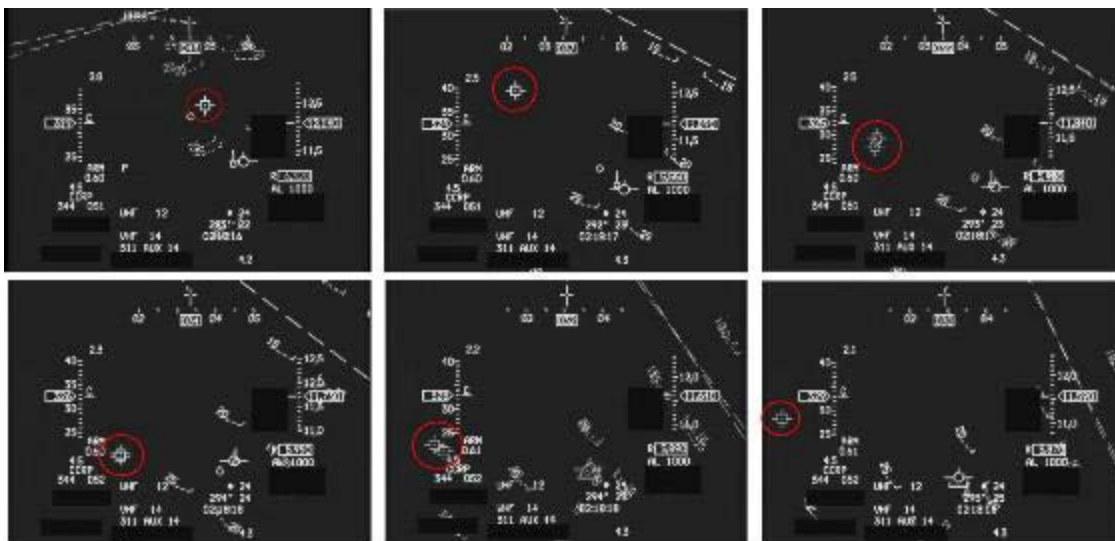
On the fatal mishap strafe pass, the MP’s HUD displayed the TISL symbology initially, but once the aircraft had rolled out and was pointed at the friendly OP, the MP’s HUD did not display the TISL symbology nor the steer point diamond, as they were out of the HUD’s field-of-view (Tab BB-55). The MP, in his written statement to the AIB, stated that when he rolled out on the mishap strafing attack, “The gimbal roll caused the TGP to lose the laser spot track (LST)” (Tab V-29.1). The MP asserted to the AIB that, “In the HUD, when a laser spot track is lost, the TISL (Target Identification Set, Laser) should begin flashing for as long as the TGP attempts laser reacquisition On the mishap strafe pass, the TISL should have begun to flash as soon as the TGP lost the laser spot track, but it did not. Instead, the TISL moves to the left in the direction of the OP and out of the HUD, leading me off the intended target” (Tab V-29.1). Figure 25 shows the MP’s described TISL movement (Tab Z-5).

However, the AIB conducted a close review of the MP’s HUD DVR and found that, while the gimbal roll caused the TISL to move as shown in Figure 25, (Tabs Z-5 and BB-55) the aircraft was no longer pointing at the SA-8 training target once the MP had rolled out and pointed his jet at the friendly OP (Tab BB-55). Because the TISL symbology was no longer in the MP’s HUD field-of-view, the flashing TISL container would not have been visible when the laser spot track was momentarily lost (Tab BB-55). The steer point diamond was also not in the HUD for the same reason—the MP’s aircraft was no longer pointing at the correct target (Tab BB-55). The mishap aircraft presented the MP with correct symbology regarding inertial navigation steer point data and

Figure 25: TISL symbol is circled in red. The images flow from left to right and top to bottom showing the TISL symbol moving up in the HUD and then down and to the left. (Tab Z-5)
