UNITED STATES AIR FORCE
AIRCRAFT ACCIDENT INVESTIGATION
BOARD REPORT

F-15C, T/N 86-0176

493RD FIGHTER SQUADRON
48TH FIGHTER WING
ROYAL AIR FORCE LAKENHEATH, UNITED KINGDOM

DATE OF ACCIDENT: 15 JUNE 2020

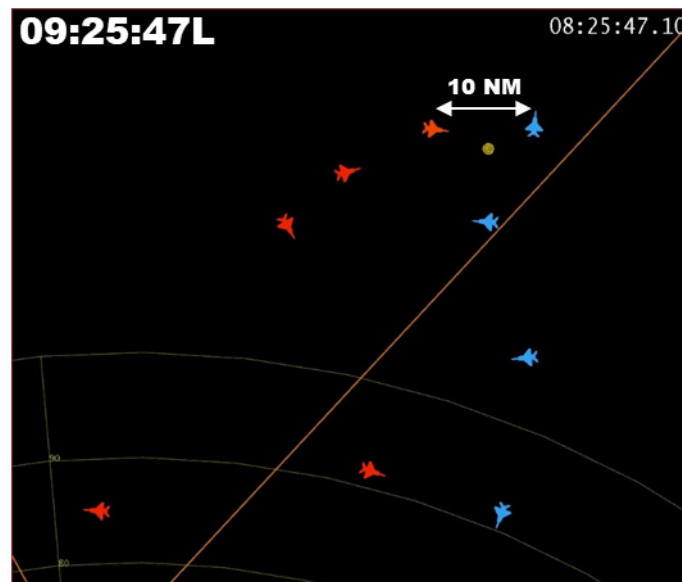
At 0925:47L (Figure 1), the MF and Red Air flight converged within 10 NM of each other, requiring a transition to more restrictive maneuvering for aircraft operating in IMC, IAW the TRs (Tabs L-3, Z-19, and BB-18). Separation between the MF and Red Air flight remained less than 10 NM throughout the mishap sequence (Tabs L-3, Z-19, and Z-35).

Figure 1 – 0925:47L, MF and adversaries less than 10 NM (Tabs L-3 and Z-19).

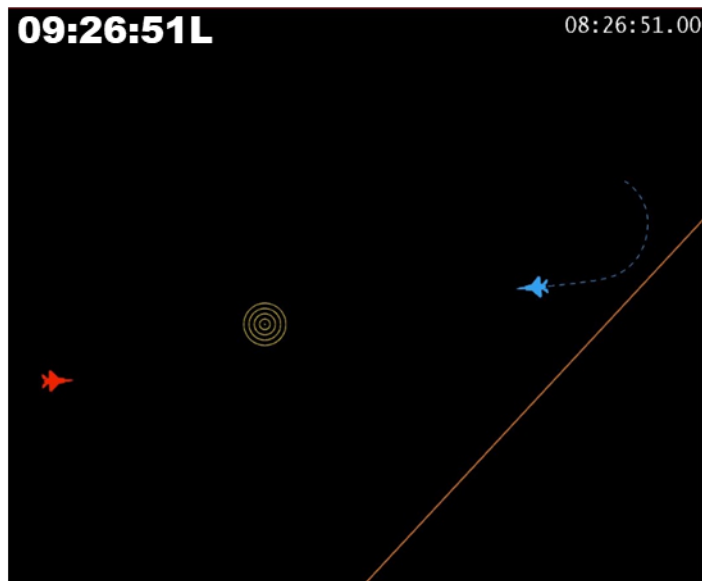
At 0926:51L (Figure 2), the MP fired a simulated air-to-air missile against the AA and made a radio call to inform RTO1 and the other pilots in the MF (Tab DD-8).

Figure 2 – 0926:51L, MP simulated missile employment on AA (Tabs L-3, Z-21, DD-8, and DD-15).

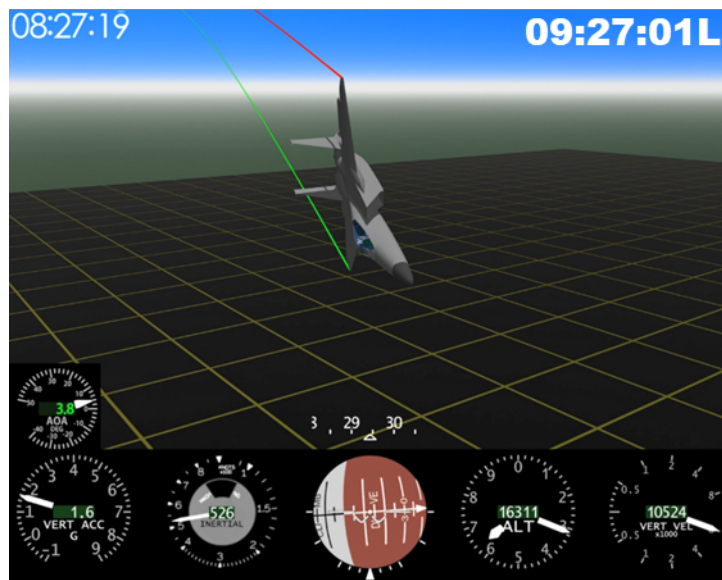
At 0927:01L (Figure 3), the MA reached a maximum bank angle of 94°, maximum pitch of 17° nose-down, and descent rate of 16,000 feet per minute (fpm) at 530 KTAS (Tabs L-3 and S-20). Passing 14,000ft, the MP initiated a left turn (to the west) and reduced the descent rate to 7,200 fpm (Tabs L-3 and S-20).

Figure 3 – 0927:01L, MA in maneuver to the northwest (Tabs S-20 and Z-3).

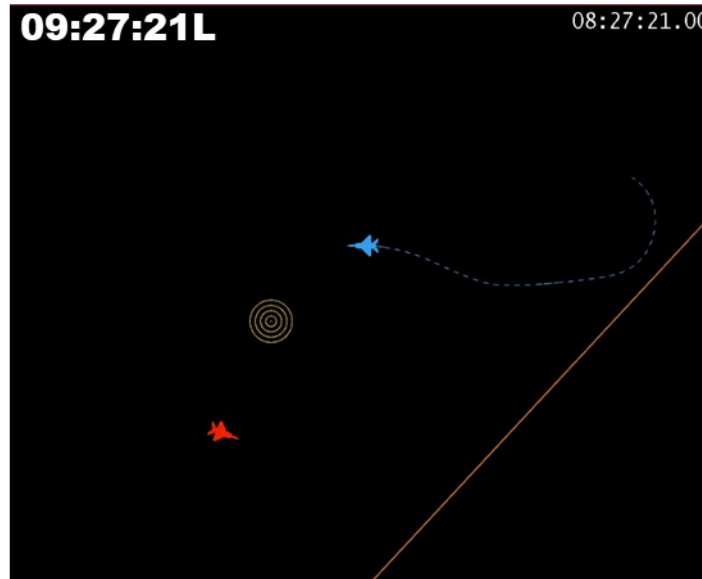
At 0927:21L (Figure 4), RTO1 responded to the MP with “P_k miss” (Probability of Kill: Miss), indicating that the simulated missile did not kill the AA (Tabs R-126, DD-8, and DD-15).

Figure 4 – 0927:21L, MA at the “P_k miss” radio transmission.
(Tabs L-3, R-126, Z-23, and DD-8).

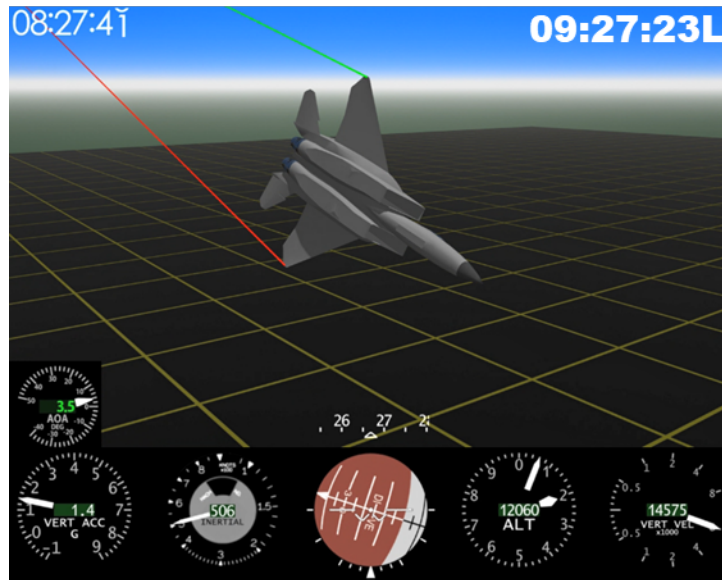
At 0927:23L (Figure 5), the MP began a roll to the left in the direction of the AA, which was 5.5 NM to the southwest (Tabs L-3, S-20, and Z-35). The MP was heading west (267°) at 12,000ft, 507 KTAS, with 107° of left bank, 17° of nose-down pitch, and descending at 15,800 fpm (Tabs L-3, S-20, and Z-35). Other aircraft in the MF had pilot-programmable altitude warnings set for the 10,000ft to 12,500ft range (Tab V-7.3, V-16.2, 17.2, and V-18.3); it is unknown at what altitude the MP set the warning during the MS.

Figure 5 – 0927:23L, MA rolled 107° left (Tabs S-20 and Z-5).

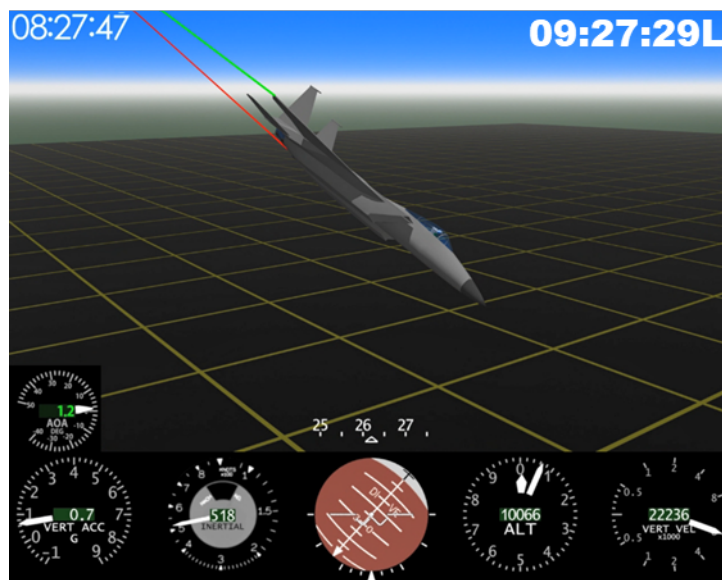
From 0927:24-0927:29L (Figure 6), the MP stopped the turn, reduced the bank angle to 21°, and decreased the G-forces to 0.3 to 0.8 (Tabs L-3, S-20, and Z-35). During this time, the pitch attitude lowered to 25° nose-down, descent rate increased to 22,800 fpm, airspeed increased to 520 KTAS, and the MA descended through 10,200ft (Tabs L-3, S-20, and Z-35).

Figure 6 – 0927:29L, MA at the end of G-unload maneuver (Tabs S-20, Z-7, and Z-35).

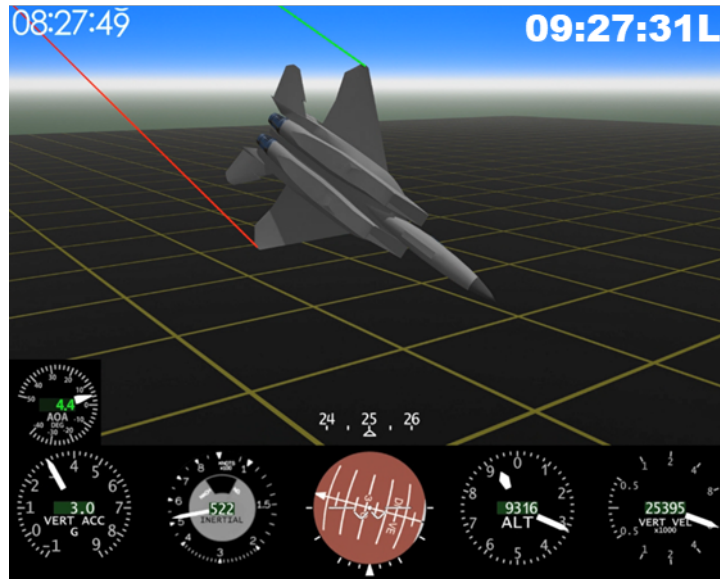
At 0927:29L, the MP increased G-forces and resumed the turn in the direction of the AA. (Tabs L-3, S-20, and Z-35). The bank angle was initially increased to 107° then slowly reduced, the pitch attitude lowered to 42° nose-down, and the MA's airspeed and descent rate increased (Figure 7) (Tabs L-3, S-20, and Z-35). The MP sustained between 1.1 and 3.8 G-forces from this point until 0927:45L (Tabs L-3, S-20, and Z-35).

Figure 7 – 0927:31L, MA established in maximum bank (107°) after resuming turn. (Tabs S-20, Z-9 and Z-35).

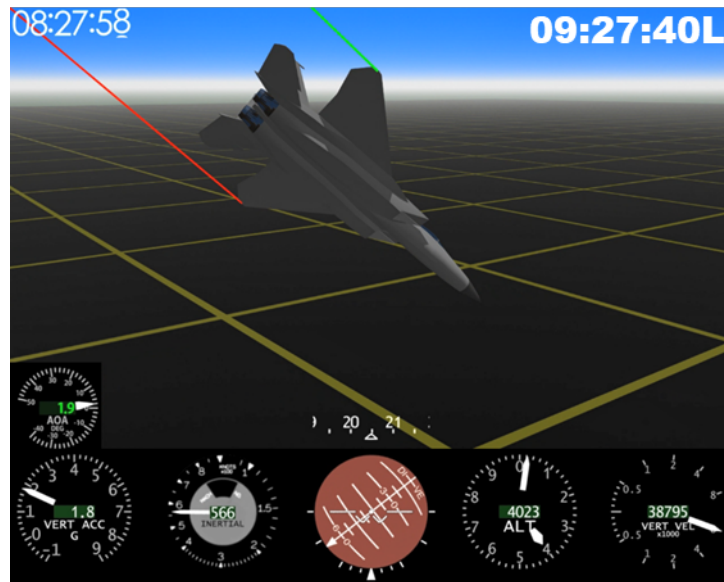
At 0927:40L (Figure 8), the MA breached the 4,000ft training floor (Tabs L-3, S-20, and Z-35). The training floor was the minimum altitude established in the SPINs and coordination brief for tactical execution during the MS (Tabs V-16.2, V-17.4, and AA-7). At the training floor, the MA was heading southwest (205°), 566 KTAS, with 52° of left bank, 41° of nose-down pitch, and descending at 38,800 fpm (Tabs L-3, S-20, and Z-35).

Figure 8 – 0927:40, MA breached the 4,000ft training floor (Tabs S-20, Z-13, and Z-35).

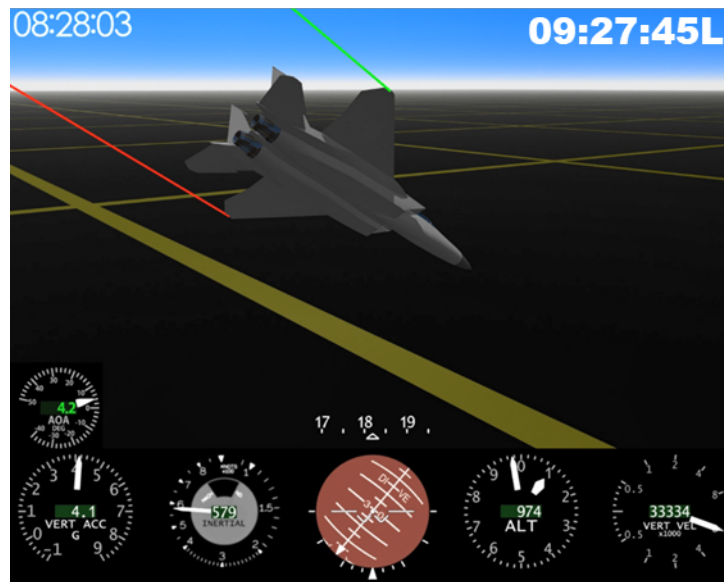
At 0927:45L (Figure 9), passing 1,000ft the MP abruptly reduced bank and pitch angles and rapidly increased G-forces to 8.2 (Tabs S-20 and Z-35). The MA was heading south (182°), 579 KTAS, with 40° of left bank, 31° of nose-down pitch, and descending at 33,300 fpm (Tabs J-114, L-3, S-20, and Z-35).

Figure 9 – 0927:45, MP rapidly reduced bank and pitch (Tabs S-20, Z-15, and Z-35).

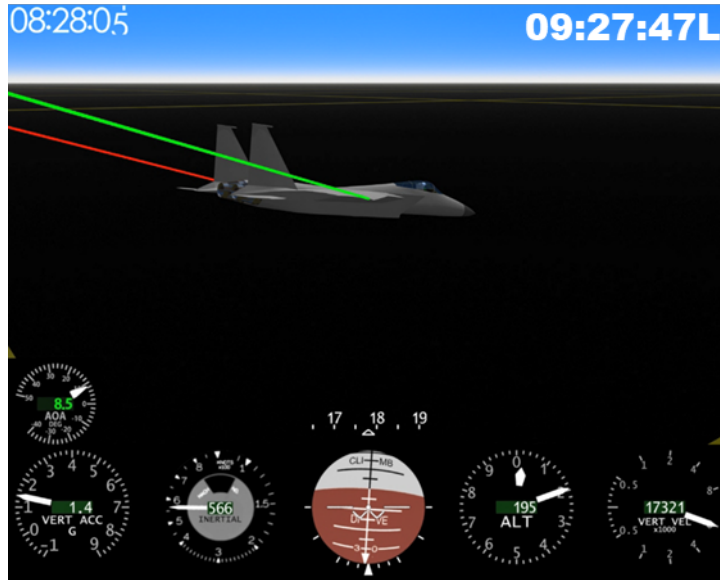
At 0927:47L (Figures 10 and 11), the MA impacted the water at 054°21.7'N, 001°40.5'E, heading south (178°), 566 KTAS, with 4° of left bank, 10° of nose-down pitch, and descent rate of 17,300 fpm (Tabs L-3, J-34, and Z-35).

Figure 10 – 0927:47, MA attitude at impact (Tabs S-20, Z-17, and Z-35).

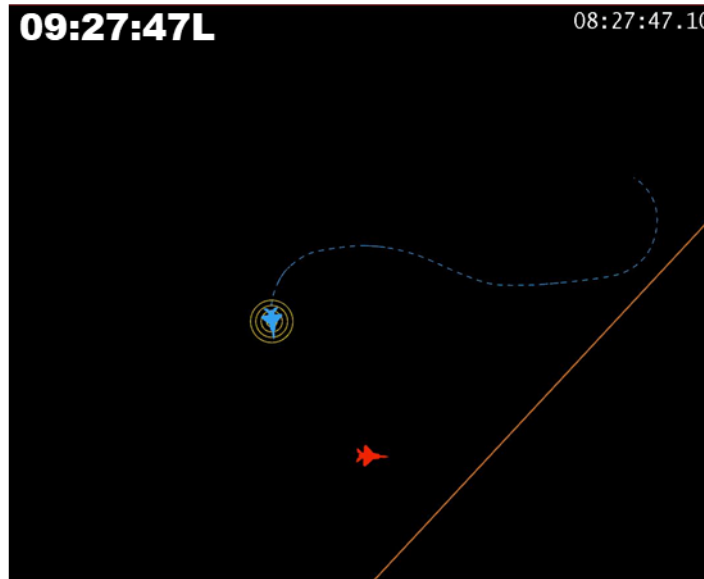
Figure 11 – Final position of MA at impact (Tabs L-3, Z-25, and Z-35).

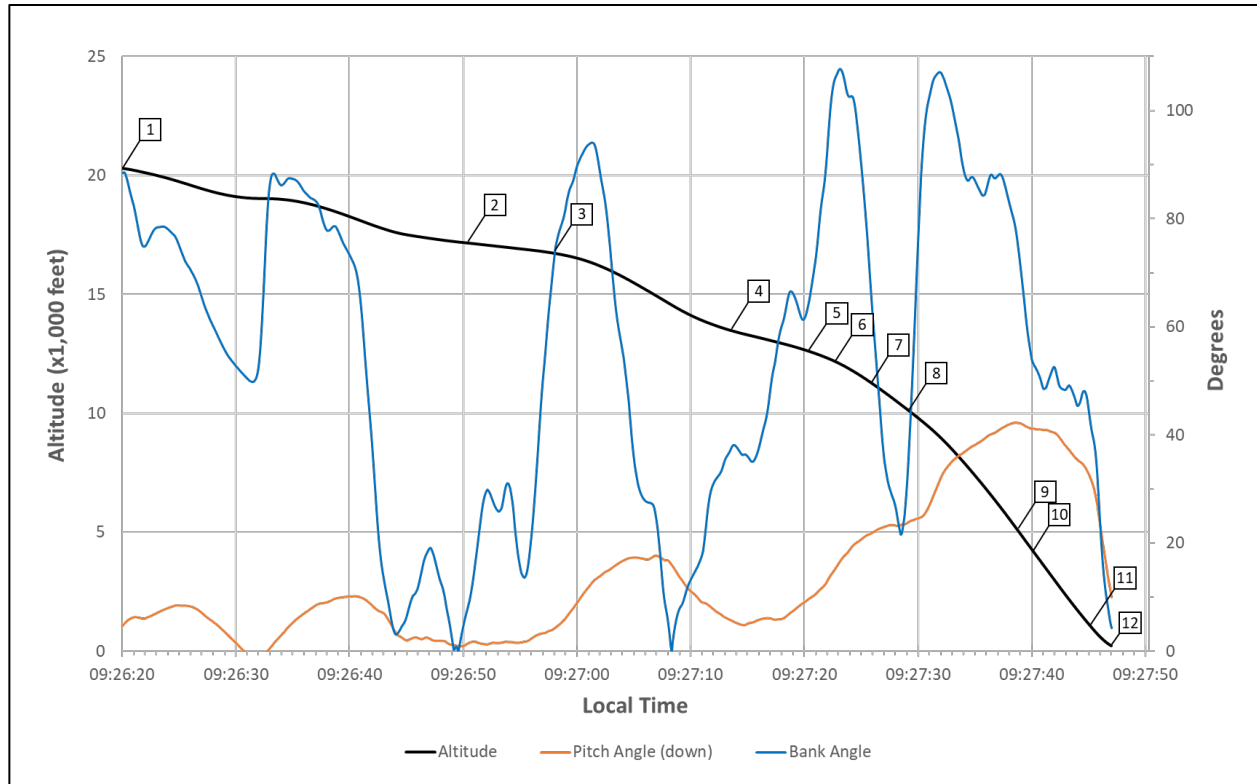
Figure 12 – Altitude, pitch, and bank over time (Tabs L-3, Z-27, and Z-35).
See Table 1 for Event Index.

Table 1 – Event Index. The event index corresponds to the callouts in Figure 12. The ICADS and Global Positioning System (GPS) times reflect the source time for the 2D and 3D animations, respectively (Tabs L-3, S-20, Z-35, and DD-8 to DD-15).
