UNITED STATES AIR FORCE
AIRCRAFT ACCIDENT INVESTIGATION
BOARD REPORT

C-130J-30, T/N 11-5736

**37TH AIRLIFT SQUADRON
86TH AIRLIFT WING
RAMSTEIN AIR BASE, GERMANY**

DATE OF ACCIDENT: 23 APRIL 2020

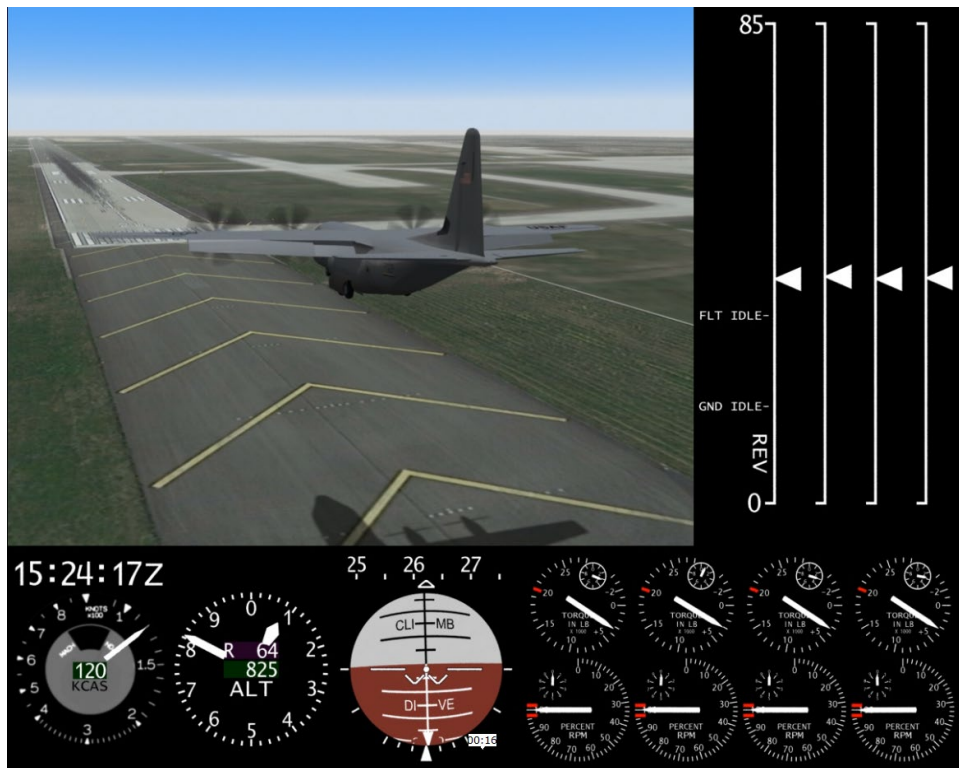
Figure 8: Beginning of power pull (Tab DD-20)

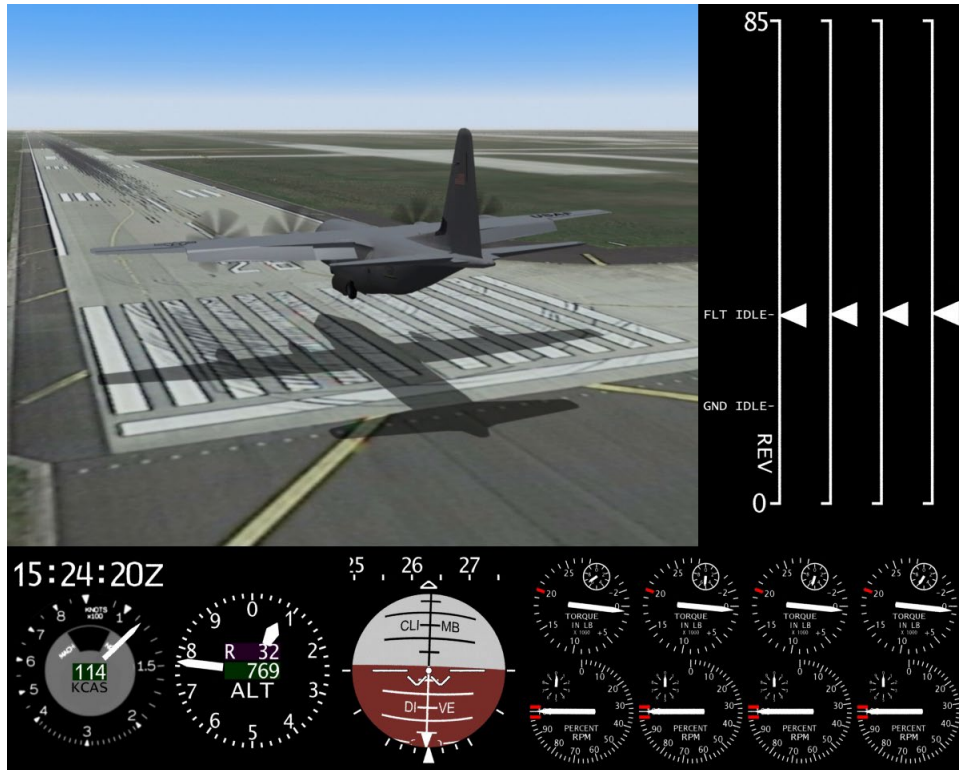
Figure 11: MP2 begins saying "Add power" and concurrent MP1 power increase (Tab DD-22)

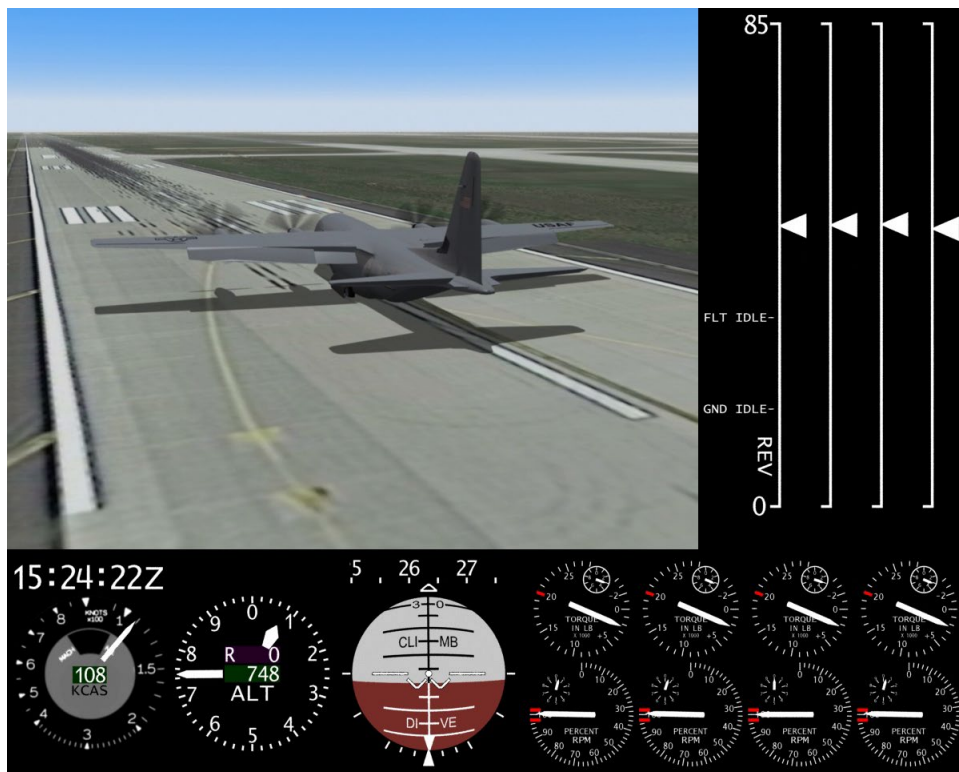
Figure 12: Touchdown and "Go-around" call by MP2 (Tab DD-22)

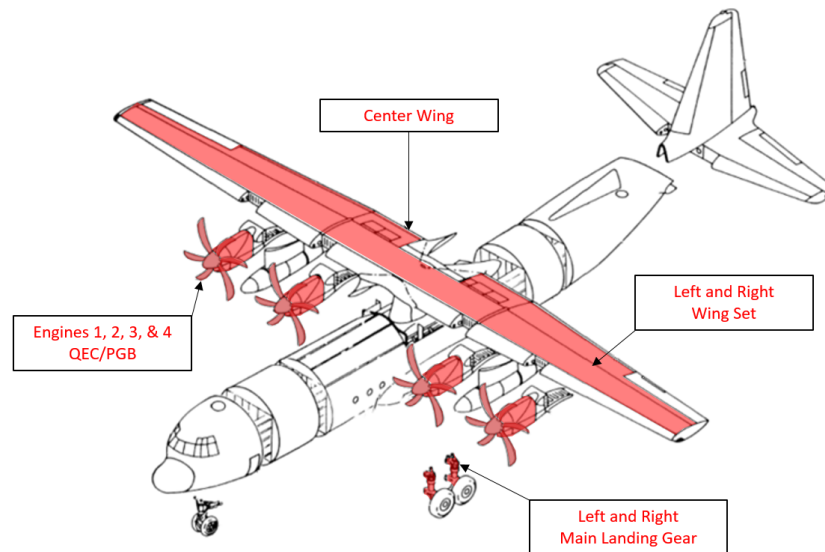
Between 23 April 2020 and 15 May 2020, multiple inspections of the MA and analysis data were conducted and determined the following aircraft structures and components exceeded design load limits upon experiencing the hard landing and required replacement (Figure 17: Identification of Major Components Requiring Replacement or Inspection and Tabs EE-4 to EE-10 and U-185 to U-189):

Figure 17: Identification of Major Components Requiring Replacement or Inspection (Tab J-3)

Additional inspections and analyses are required to determine airworthiness of the following (Tabs EE-3 to EE-10 and U-185 to U-189):

- (1) Analyze stress on Flight Station 588 vertical beam
- (2) Analyze stress on aft shelf brackets
- (3) Complete analysis on Quick Engine Change (QEC) structures
- (4) MLG ball screws
- (5) Hard landing inspection on all 4 engines (repeat inspection requirements due after 500 engine flight hours)

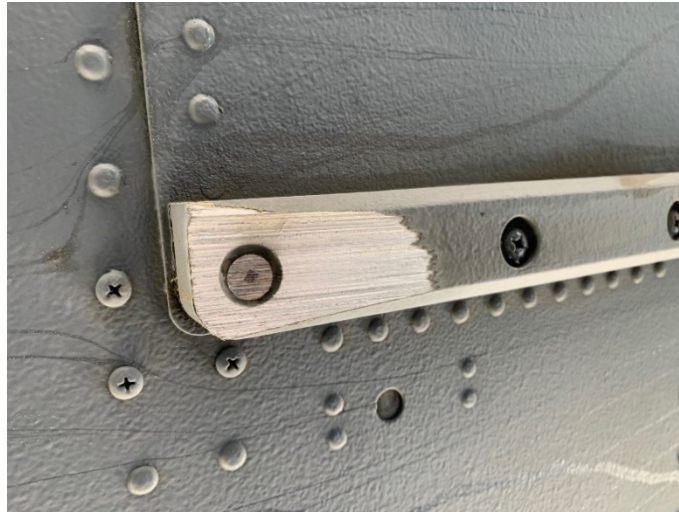
Figure 18: Right Hand Tail Skid Plate Impact Damage (Tab S-7)

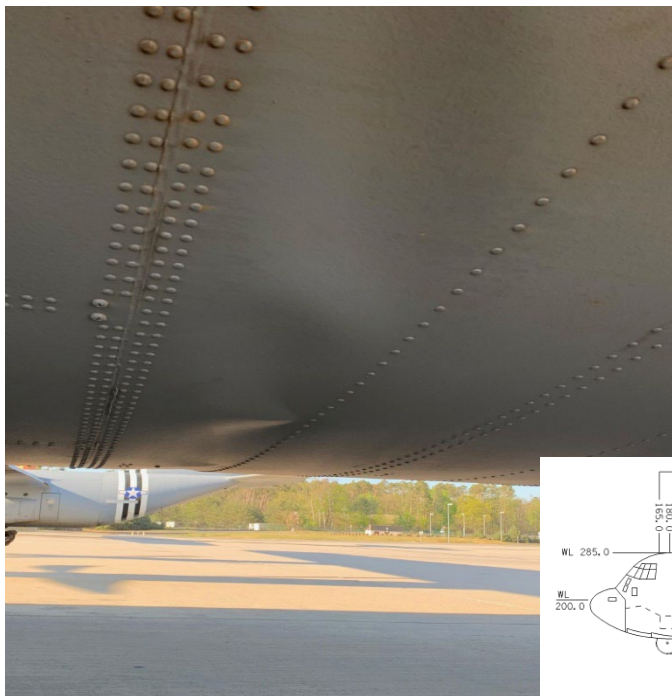
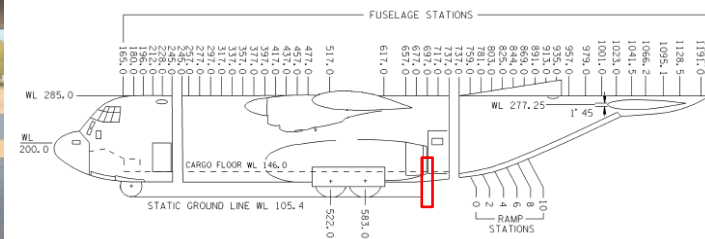
Figure 19: Lower Fuselage Buckling at FS700 (aircraft left to right perspective)(Tab S-8)

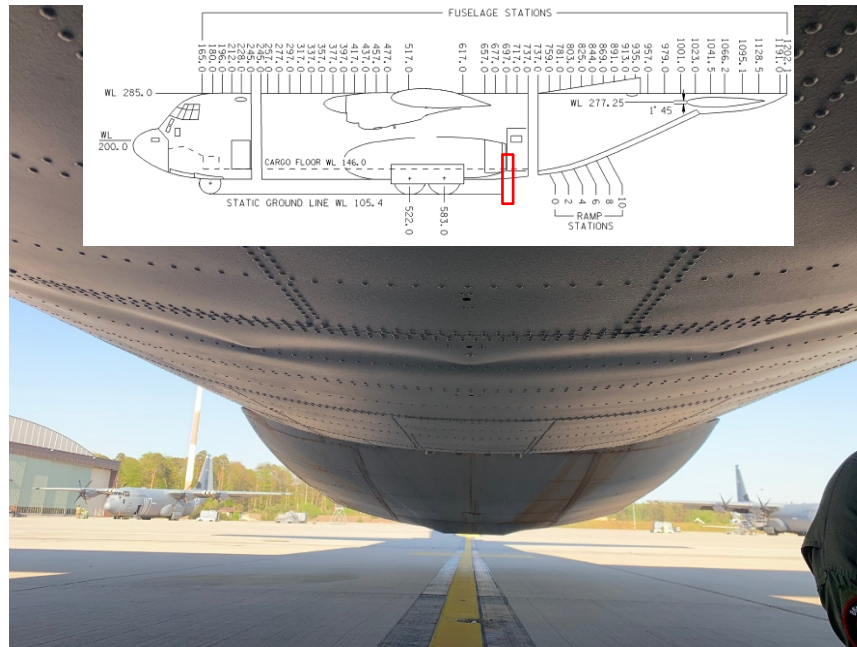
**Figure 20: Lower Fuselage Buckling at FS700 (aircraft forward to aft perspective)
(Tab S-9)**

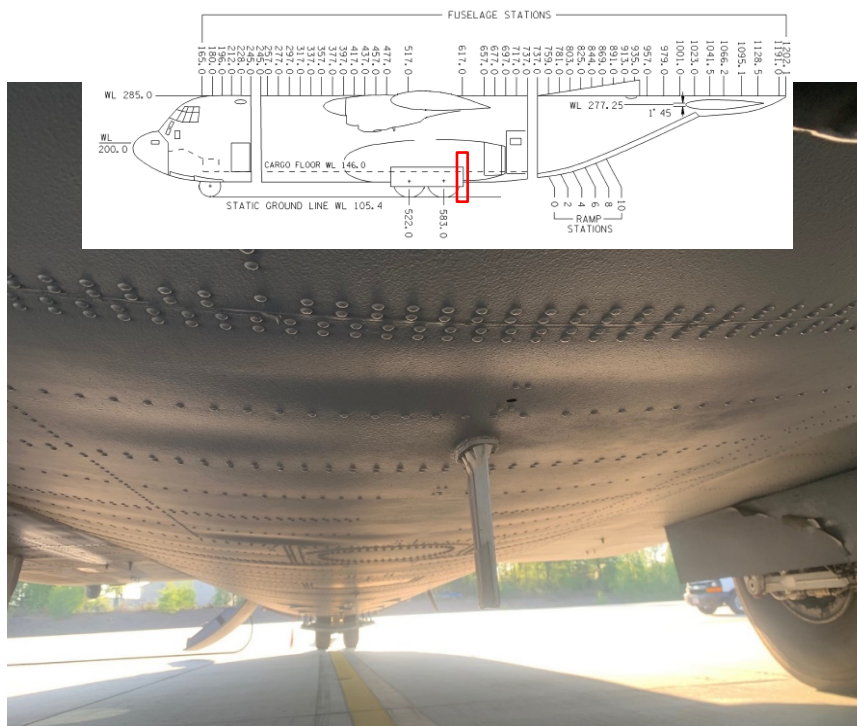
Figure 21: Lower Fuselage Buckling at FS617 (forward to aft perspective) (Tab S-10)

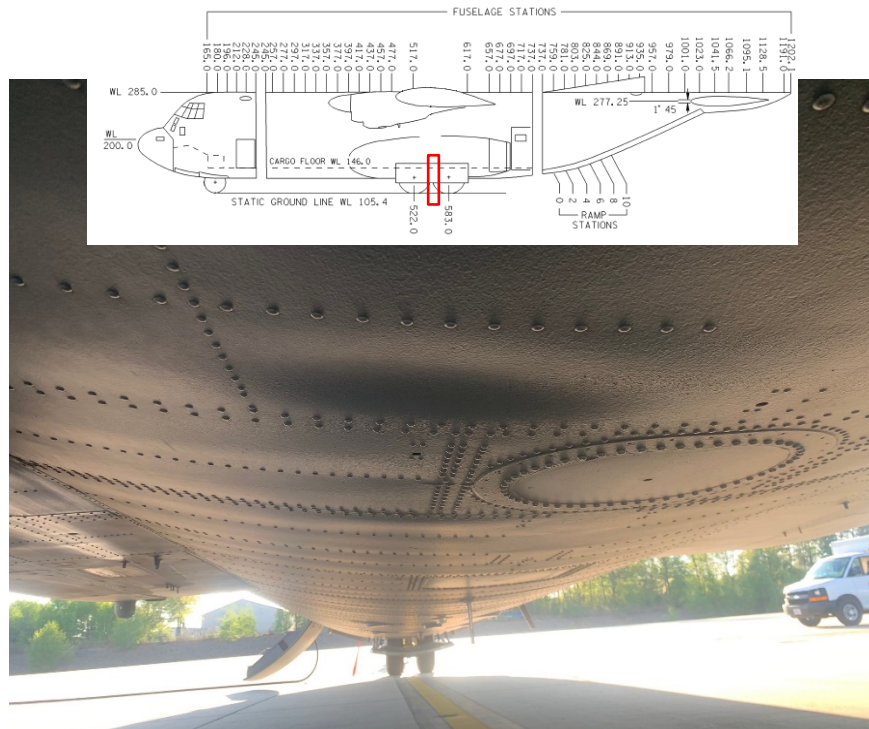
Figure 22: Lower Fuselage Buckling at FS550 (forward to aft perspective)(Tab S-11)

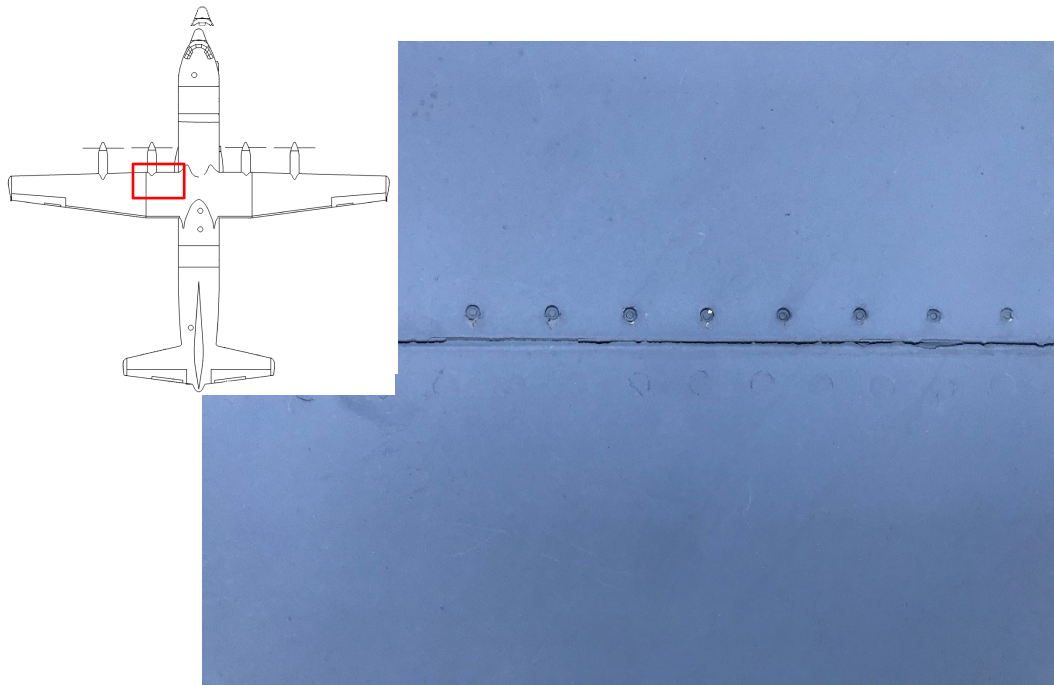
Figure 23: Left Hand Aft Wing Box at FS 617, Pulled Rivets (aircraft forward to aft perspective) (Tab S-13)

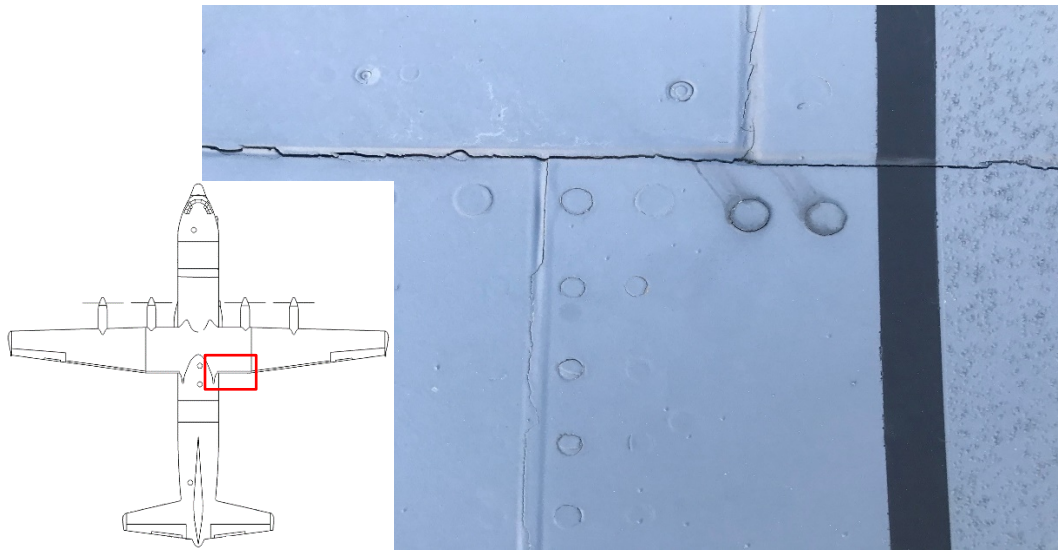
Figure 24: Right Hand Aft Wing Box at FS617, Cracked Sealant (aircraft forward to aft perspective) (Tab S-15)

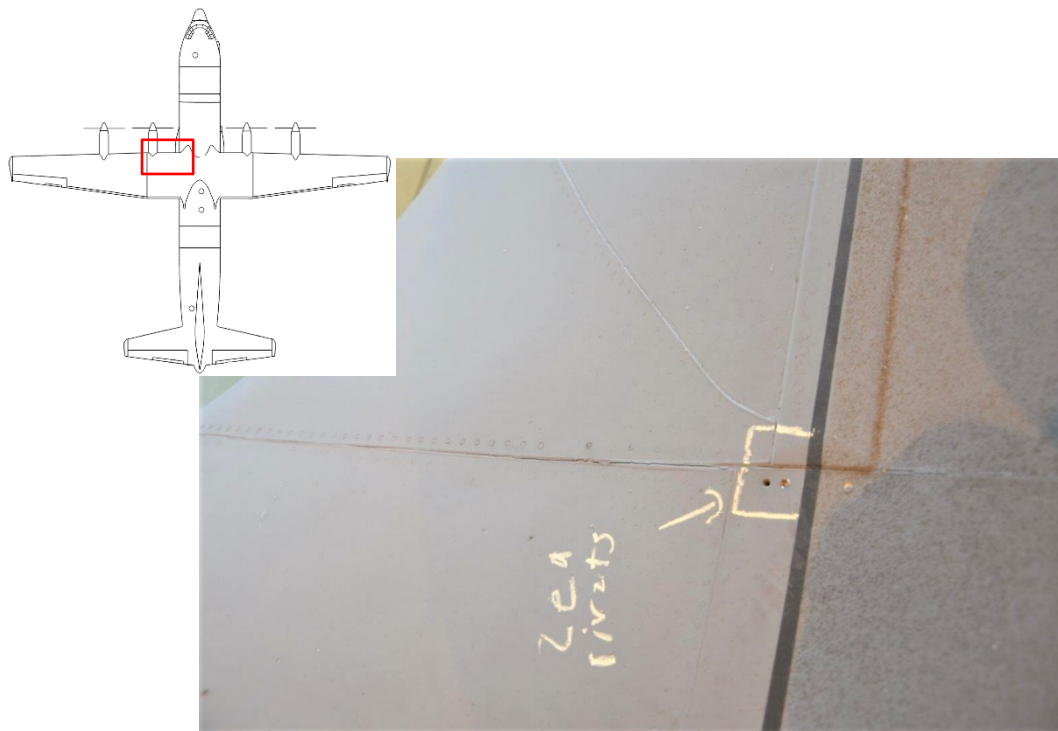
Figure 25: Left Hand Forward Wing Box at FS517, Pulled Rivets (aircraft aft to forward perspective) (Tab S-17)

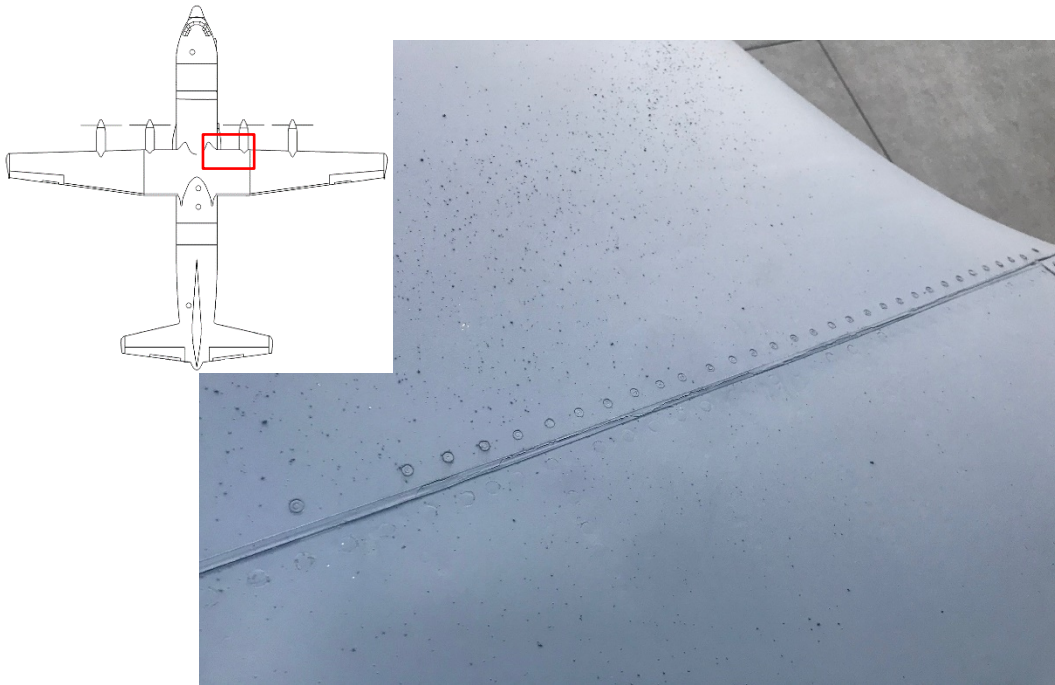
Figure 26: Right Hand Forward Wing Box at FS517, Pulled Rivets (aircraft aft to forward perspective) (Tab S-18)

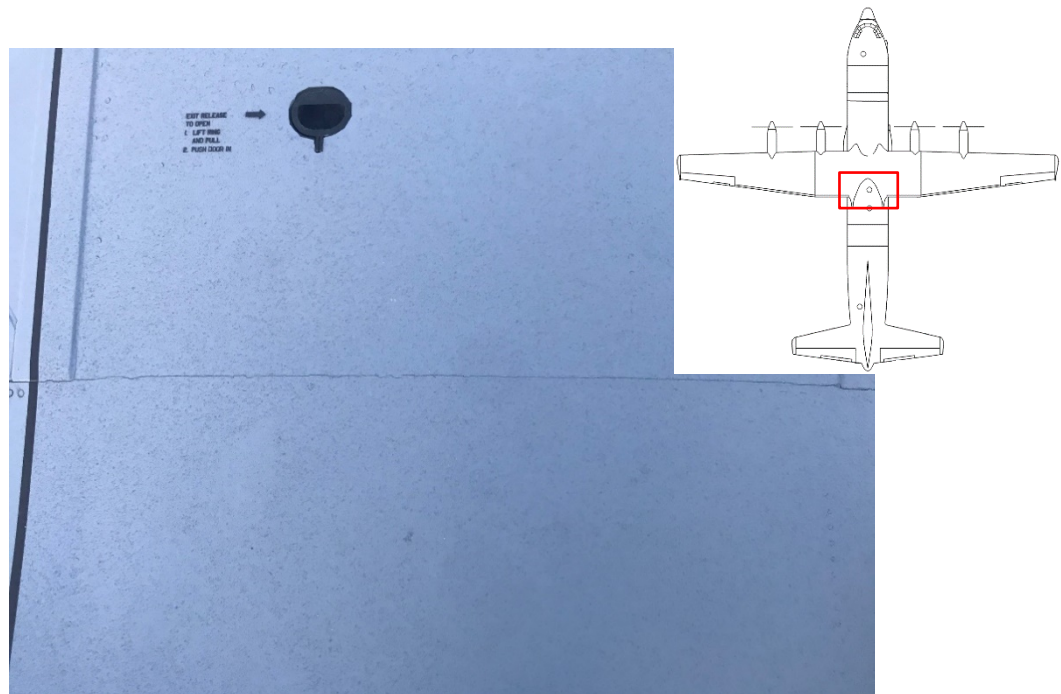
Figure 27: Aft Wing Box at FS 617, Cracked Sealant (aircraft forward to aft perspective) (Tab S-14)

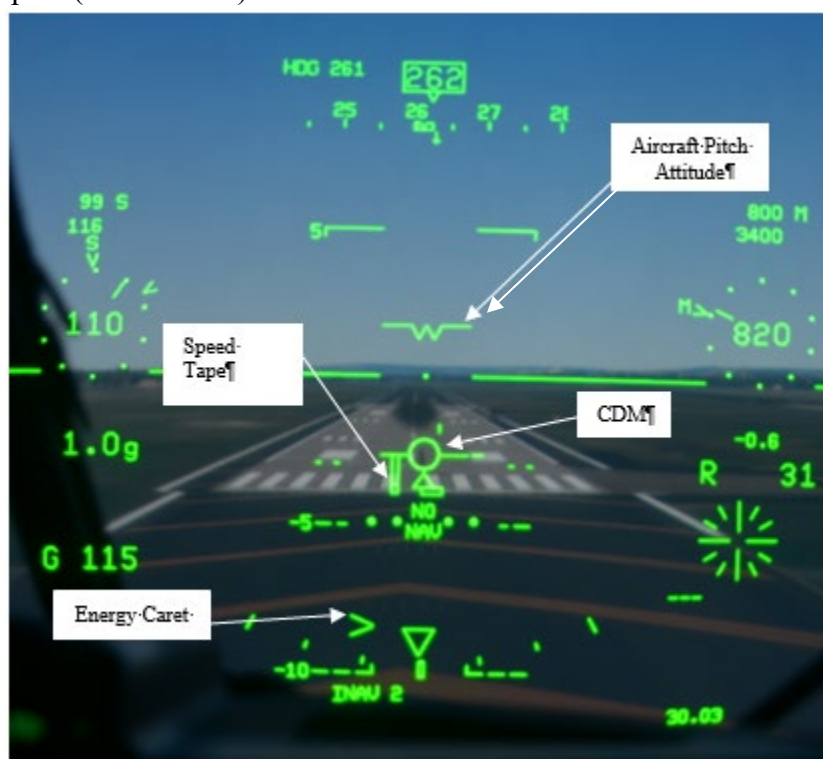
Analysis of the HUD in the WST revealed that in order to maintain the aim point inside the painted LZ, the pitch of the aircraft had to rise nose up considerably with a power pull initiated at 70 feet AGL (and fully FLT IDLE at 45 feet AGL) (Tab DD-7 to DD-8). The pilot member had to increase backpressure (pull up) on the yoke to maintain the aim point inside the LZ (Tab DD-7 to DD-8). Doing so caused the CDM (aim point) and pitch attitude to travel farther apart as shown in Figure 28 on page 33 (Tab DD-7 and DD-26). Figure 28 below, shows the AIB pilot member maintaining an aim point inside the painted LZ while having to pitch the simulated aircraft to roughly 2 degrees nose up (Tab DD-6 to DD-7). This indicates that a power pull initiated at 70 feet and a nose down pitch attitude would result in the MA aiming shorter and shorter (closer to the beginning of the runway) (Tab DD-7).

Figure 28: HUD of the WST with highlighted references at 31 feet AGL after mimicking the mishap throttle position and maintaining aim point (Tab DD-26)
