UNITED STATES AIR FORCE
GROUND ACCIDENT INVESTIGATION
BOARD REPORT

Polaris Ranger Model 800 Crew All-Terrain Utility Vehicle
VIN: 4XAWH76A8D2707361

386TH EXPEDITIONARY LOGISTICS READINESS SQUADRON
386TH AIR EXPEDITIONARY WING
ALI AL SALEM AIR BASE, KUWAIT

TYPE OF ACCIDENT: Motor Vehicle Fatality

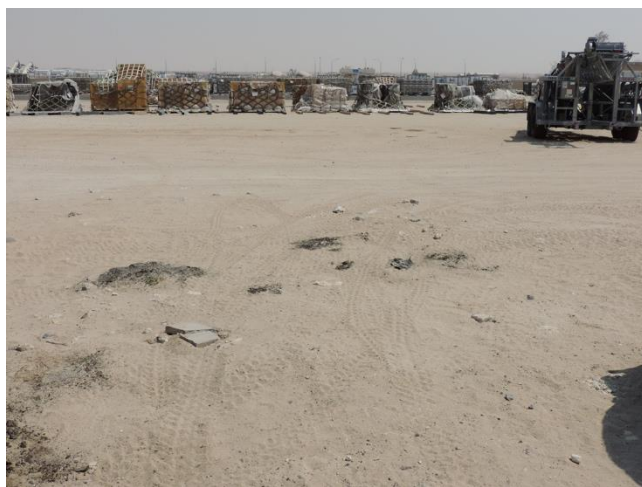
Figure 7 – MV's Tracks Pulling out of Terminally Parked Location (Tab S-9)

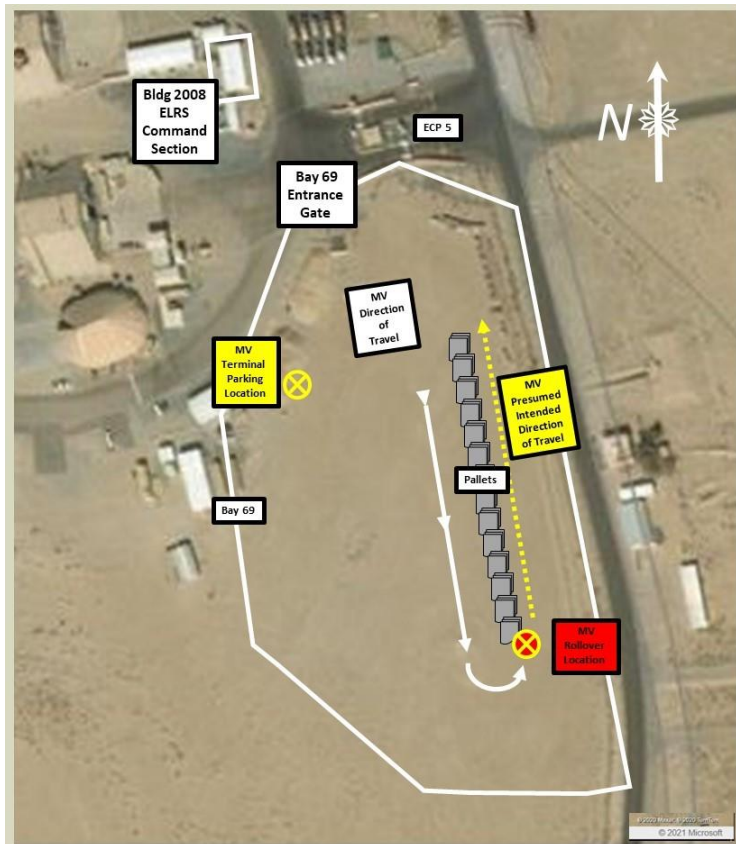
On 14 September 2020, at approximately 1700L, the MVO lost control of the MV while making a 180-degree left hand turn on the sand surface of the southeast corner of Bay 69, with the MA riding in the front passenger seat (Tabs N-3, N-5, R-164 to R-165, S-11, and V-21.3 to V-21.4). The MVO reported taking his foot off of the gas prior to the turn (Tab R-164 and R-194). He did not recall using the brake (Tab R-164 and R-194). The MVO estimated he was going approximately 15 miles per hour (mph) at the time (Tab R-164).

Figure 8 – MV's Direction of Travel (Tab Z-9)

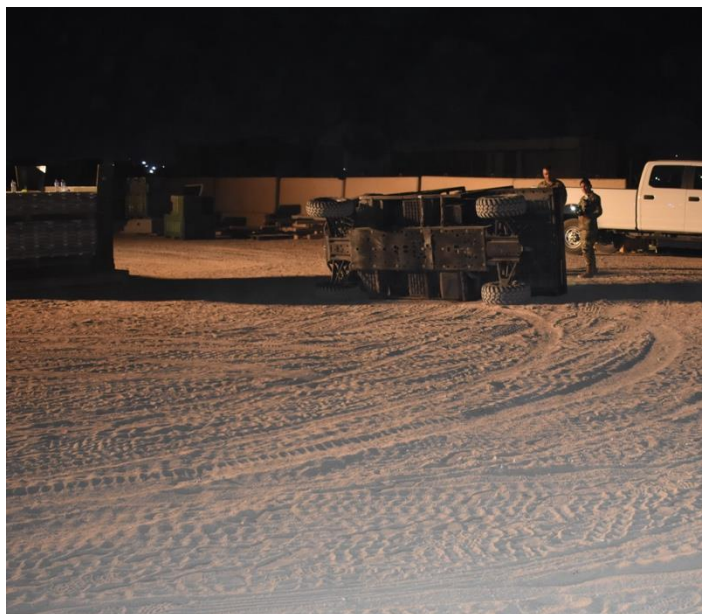
Figure 9 – MV's Tire Tracks While Attempting Left Hand Turn (Tab S-5)

becoming smooth after executing approximately 90 degrees of the turn, which INV2 evaluated as the moment when danger was first detected by the MVO and likely when he slammed on the brakes and caused the vehicle to “drift” (note: drifting is when the rear tires swing out past the front tires of the vehicle and is caused by excessive speeding, braking, and turning all at the same time) (Tab V-24.6, V-24.16, and V-24.20 to V-24.21). In noting the depth of the tracks,

INV1 and INV2 also observed the abruptness of the angle of the turn being suggestive of a tight

and fast turn, especially for the type of vehicle being driven and the sand surface being driven on (Tab V-21.4 to V-21.5, V-24.10, and V-24.19). Multiple sources who observed the tracks on scene remarked on the apparent sharp nature of the turn that was being attempted (Tab V-16.5, V-18.3, V-20.9, V-21.4 to V-21.5, V-21.14 to V-21.15, V-23.4, V-24.10, V-24.20, V-25.4, V-28.4, and V-28.9). Approximately 120 degrees into the turn, there were no longer two tracks indicating a vehicle traveling on four (4) wheels, but instead only one set of tracks leading up to where the MV was resting on its passenger side (Tabs O-11, S-13, and Z-11). Based on the track measurements and tire marks, INV2 later calculated the speed of the MV to be between 25 and 35 mph (Tabs O-17, O-19, V-24.5, 24.10, and V-24.18). The speed limit in all areas near the cargo lot and the flight line was 5 mph (Tabs V-2.24, V-4.16, V-15.13, Z-13 and Z-15).

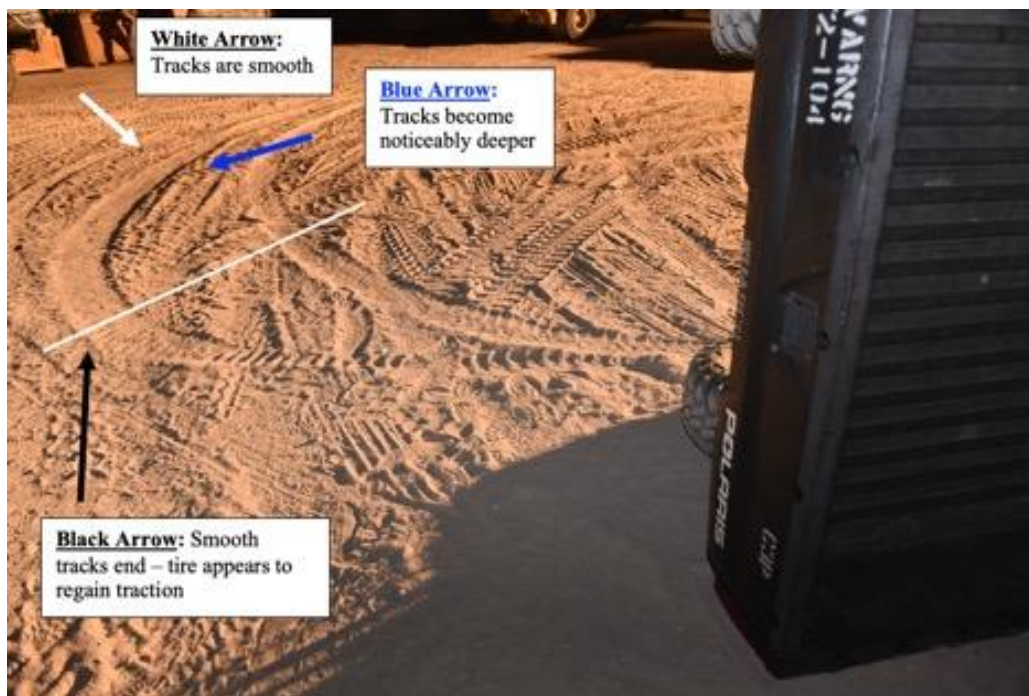
Figure 10 – Depth and Smoothness of MV Tire Tracks (Tab Z-11)

section on the west side of the lot (Tab S-9). For much of the distance between the initial track markings near the Jeep and the final turn, the tracks were undetectable (Tabs O-11, V-24.6, and V-24.13). However, matching tracks again appeared leading up to the MV at the south end of Bay 69, demonstrating the final 180-degree turn of the vehicle (Tabs O-11, O-17, O-19, V-21.4, V-24.10, and V-28.4).

The final track length was approximately 30 feet following along the curve of the turn (Tabs O-17, O-19, O-21, and V-24.14). The tracks became noticeably deeper while simultaneously

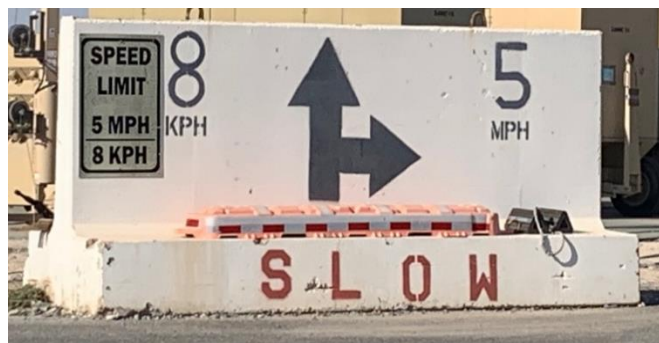
Figure 11 – Speed Limit Sign in W Pad (Tab Z-13)

In accordance with 386 AEWI 31-218, the speed limit on ASAB is 12 mph unless otherwise posted (Tab BB-46). In and around the 386 ELRS facilities, including W Pad, the posted speed limit is 5 mph (Tab Z-13 and Z-15). The Polaris Owner's Manual states operators should "never operate at excessive speeds. Always travel at a speed proper for the terrain, visibility and operating conditions, and your experience" (Tab BB-130). Additionally, the Owner's Manual states "always follow proper procedures for turning. Practice turning at slow speeds before attempting to turn at faster speeds. Never turn at excessive speeds" (Tab BB-130). The Owner's Manual also warns operators to "avoid sharp turns or turns while applying heavy throttle" (Tab BB-128). Lastly, operators should "reduce speed and use extreme caution when carrying passengers" (Tab BB-128). 386 AEWI 31-218 states the maximum speed limit for an OGMVC (i.e. a Polaris Ranger) is 25 mph, however, "drivers will obey all speed limits indicated in this instruction" (Tab BB-50). While calculations made by INV2 estimated the MV was traveling at a speed between 25 and 35 mph, the MVO also indicated he was traveling too fast for the turn and the terrain (Tabs O-13, O-15, R-139, V-24.5, V-24.10, V-24.18, and V-29.4).

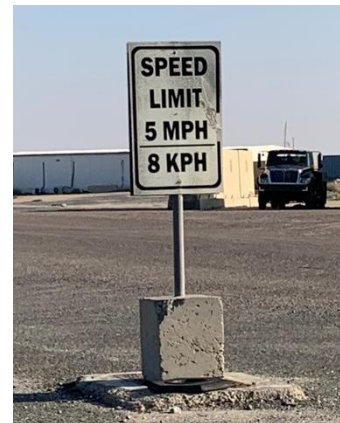
Figure 12 – Speed Limit Sign Near Flight Line (Tab Z-15)

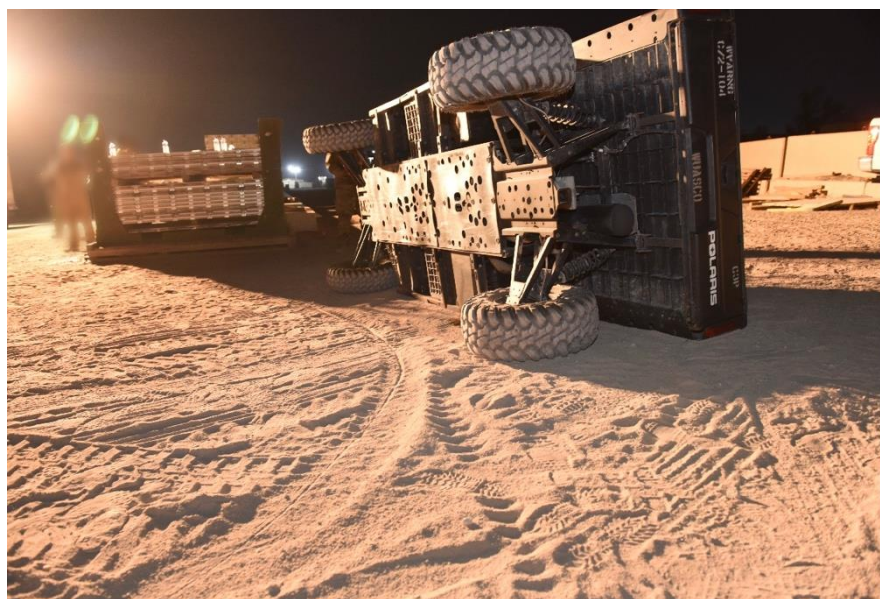
The only obvious damage to the vehicle after the mishap was a few small scuff marks on the vehicle frame on the passenger side (Tabs P-3, V-21.4, V-24.12, and Z-21). Additionally, the

Figure 13 – Landing Position of MV in Front of Cargo Pallets (Tab S-13)

plastic cover of the emergency brake handle had broken off and was lying on the ground next to the MV (Tabs R-194 and S-17). When the MV came to rest, it landed approximately six (6) to fifteen (15) feet from the end of a row of concrete slab with cargo pallets piled on top (Tabs O-17, O-19, S-13, and V-24.11). The location of the MV upon coming to its final resting position was such that if the MV were to have continued on its course, it would have run directly into the pallets (Tabs O-17, O-19, S-13, and V-24.11). INV1 and INV2 indicated there were no other obvious hazards found along the path of the tire tracks or in the surrounding area of the MV (Tab V-20.4, V-24.10, V-24.18, and V-27.5). Immediately following the mishap, INV1 spoke with SUP1, who stated it was not uncommon for A-Flight members to drive “toys” around anytime they could get their hands on them (Tab V-21.7 and V-21.20). SUP1 also stated that “anytime they get equipment, they take it for a ride” (Tab V-21.7 and V-21.20). Neither INV1 nor INV2 were able to interview the MVO at the scene, as he had already been released and taken to the clinic prior to their arrival (Tabs V-21.6, V-21.8, V-21.10, and V-24.16).

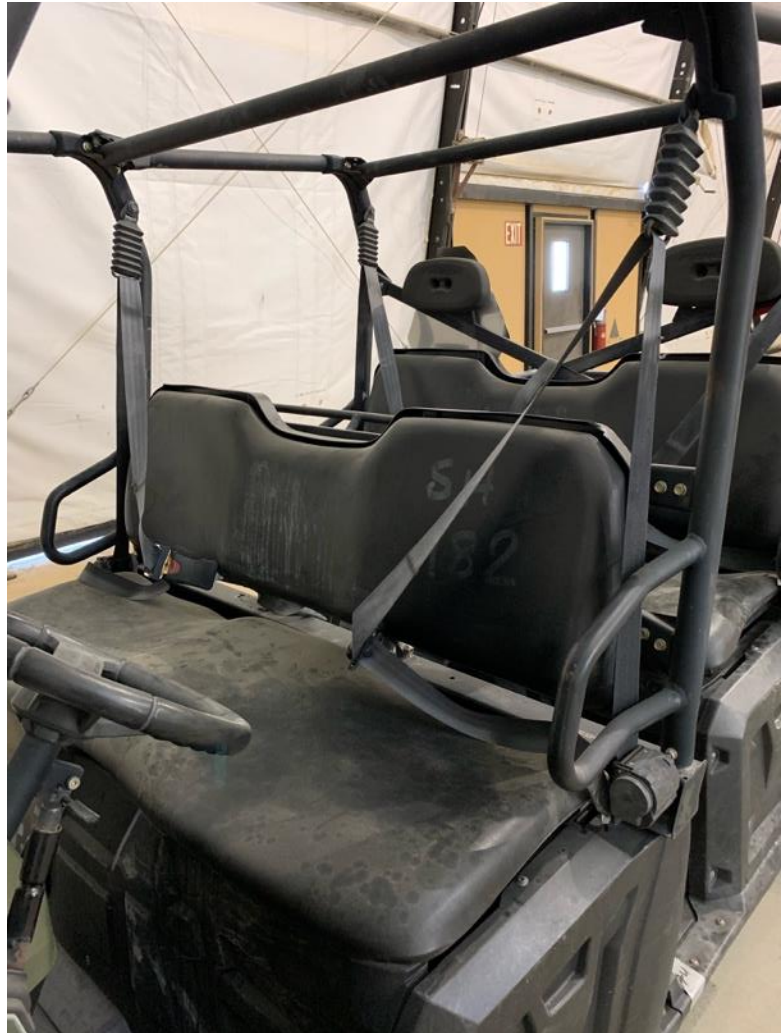
Figure 18 – MV Post-Mishap with All Shoulder Straps Securely Fastened (Tab Z-27)

GAIB was able to securely fasten all four (4) shoulder seatbelts on the MV (Tab Z-27 and Z-29). The Polaris Owner's Manual also states that "riding in this vehicle without using the cab nets increases the risk of serious injury or death in the event of an accident or overturn. Always use cab nets while riding in this vehicle." (Tab BB-131). There were no cab nets installed on the MV at the time of the mishap (Tab S-19).

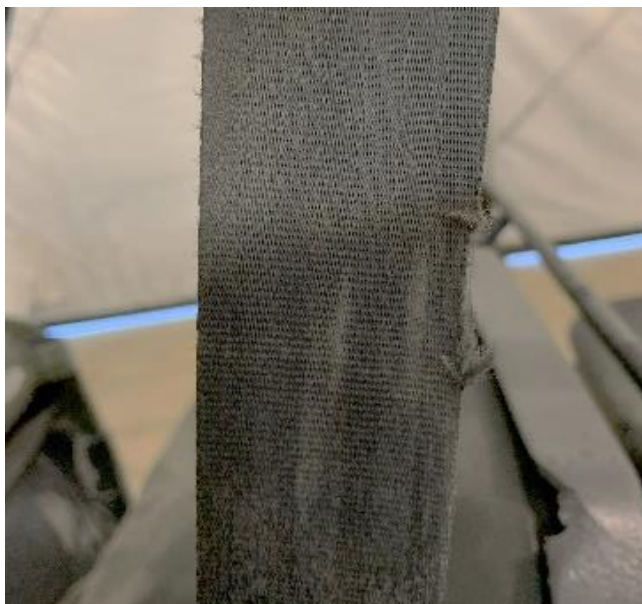
Both the MVO and the MA violated these regulations when they failed to wear their seatbelts (Tabs R-165, V-21.6, V-28.3, and DD-9). During inspection of the MV, the GAIB tested the seat belts to determine whether or not they were in working condition. Despite slight fraying in several locations on the seat belts, the

Figure 19 – Fraying on MV Seatbelt (Tab Z-29)
