UNITED STATES AIR FORCE
AIRCRAFT ACCIDENT INVESTIGATION
BOARD REPORT

F-16C, T/N 86-0317

DATE OF ACCIDENT: 8 DECEMBER 2020

SUMMARY OF FACTS AND STATEMENT OF OPINION
F-16C, T/N 86-0317
HIAWATHA NATIONAL FOREST, MICHIGAN
8 DECEMBER 2020

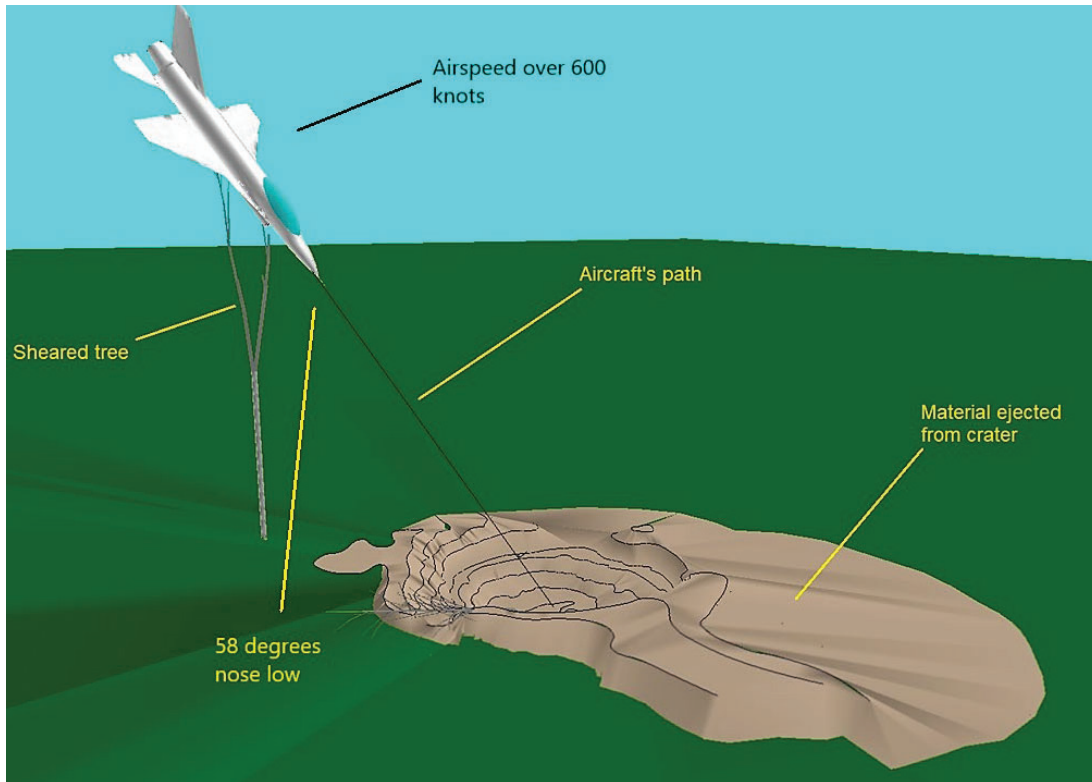
Figure 3: Recreation of MA at Impact (Tab T-27)

The MA impacted the ground in Hiawatha National Forest at 19:17:37L (Tab T-42). The MP did not attempt to eject (Tab J-14). At the time of impact, the MA was approximately 58 degrees nose low, with over 20 degrees of right bank, heading 205 degrees, and traveling over 600 kts (Tabs T-21 to T-38 and T-42). The MA terminated with controlled flight into terrain (Tabs J-14 and T-27). Controlled flight into terrain is described as unintentional flight into the ground and typically the pilot is unaware of the impending impact (Tab J-14). Subject matter expert (SME) analysis revealed the MA's nose and right wing tip both struck the ground, leaving recognizable cratering (Tab T-25). Tree shearing at the mishap site verified the steep AOA and heading at impact (Tabs T-21 to T-38). The impact destroyed the MA, and the MP suffered fatal injuries (Tabs J-14 and O-2 to O-3).

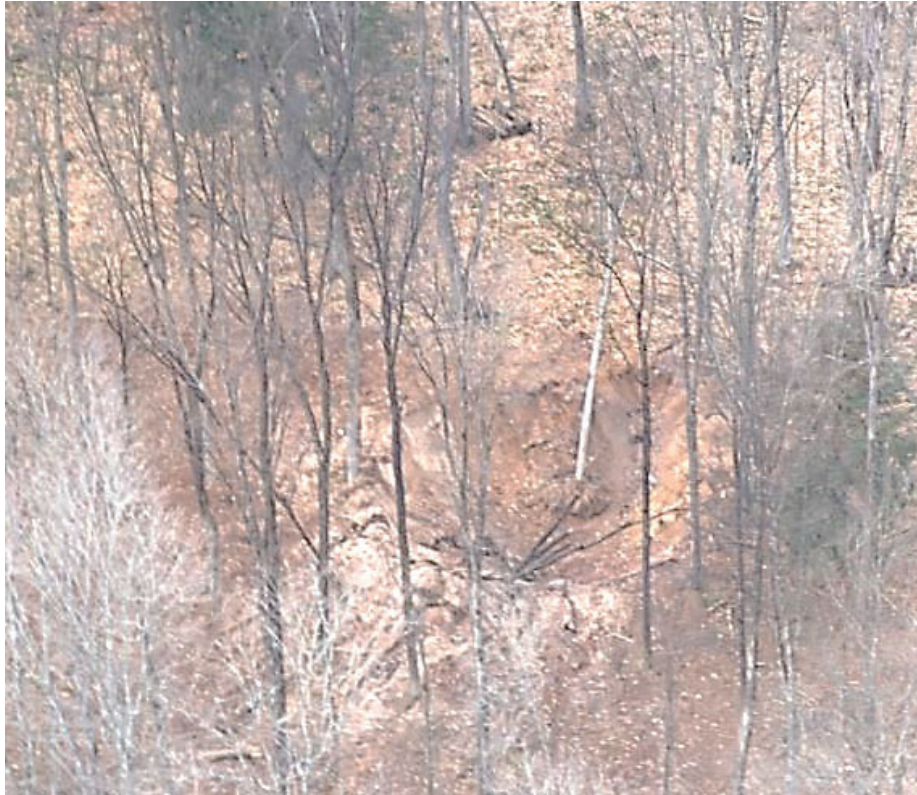
Figure 4: Overhead View of Mishap Site (Tab S-6)

Impact with the ground at Hiawatha National Park caused total destruction of the MA (Tabs S-6 and T-42). Initial investigators recovered fragmented parts and secured them for analysis (Tabs J-2 to J-14).

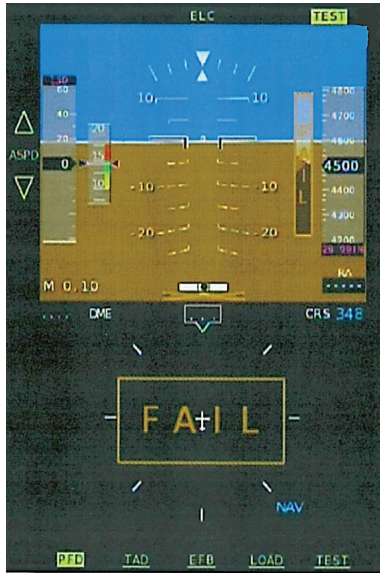
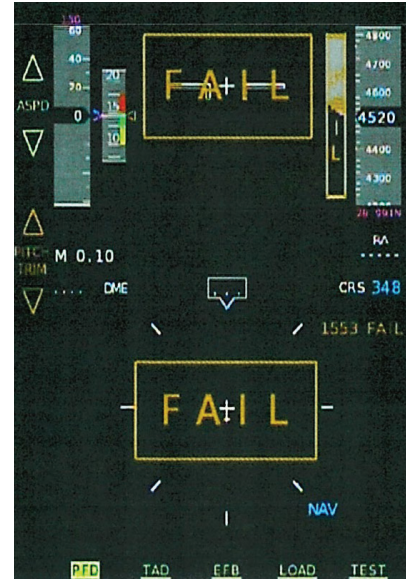
Figure 8: Simulated PFD and HUD in INS INFLT ALIGN Position with GPS NTRK (Tab T-17)

The EGI system was not recovered intact, leaving it unknown what position the MA's INS switch was placed in during the mishap event (Tab T-41). Figure 8 (below) provides a simulation of the cockpit displays when the INS is in the INFLT ALIGN position prior to a completed alignment (Tabs T-15 to T-19). Figure 9 (below) provides a simulation of the cockpit displays when the INS is in the OFF position (Tabs T-17 to T-18). In either switch position (OFF or INFLT ALIGN), primary flight data available to the MP is reduced (Tab T-17).

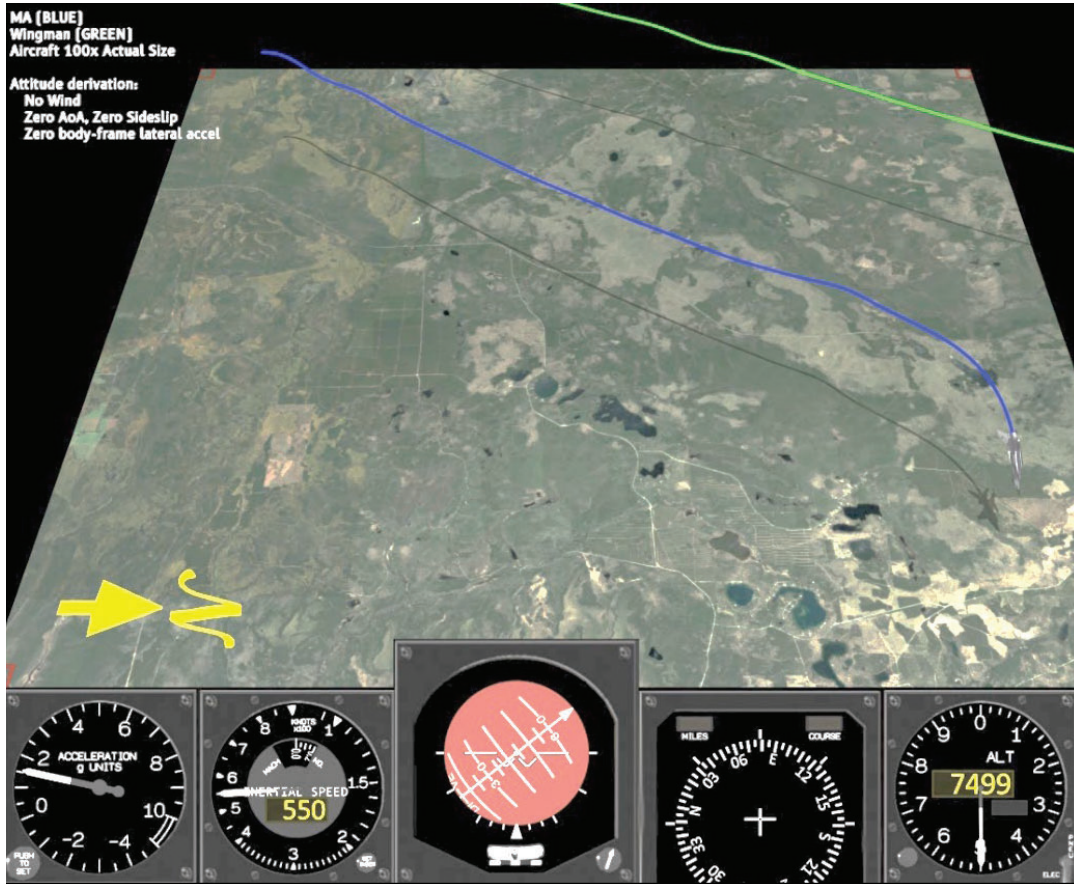
Figure 10: Simulated Flight Path (Tab T-42)

Recreation of the mishap event showed the MA at one point in a 45 degree descent at 7,500 ft MSL and 550 kts (Tab T-42). According to TO 1F-16C-1, *Dive Recovery Chart*, had the MP recognized the unusual attitude and immediately initiated a wings level, 7G pull to the horizon in idle thrust and speedbrakes fully extended, the MP would have recovered in approximately 2,000 ft (Tab BB-4).

Recreation shows the MP pulling an estimated maximum of 4Gs (Tab T-42). Under the previously stated conditions, the MP's exertion of 4Gs would have increased the altitude lost in the recovery to approximately 3,500 to 4,000 ft (Tab BB-4). Due to a lack of recoverable evidence, the MP's thrust and speedbrake settings are unknown throughout the mishap event (Tab T-42). However, at speeds above 350 kts, thrust settings above idle will generally increase the altitude required to recover (Tab BB-26). Additionally, recreation shows the MA continued in an increasingly steeper dive, up to about 90 degrees, and the MA's airspeed increased to over 600 kts (Tab T-42). These conditions would exponentially increase the altitude lost during an attempted recovery (Tab BB-4).

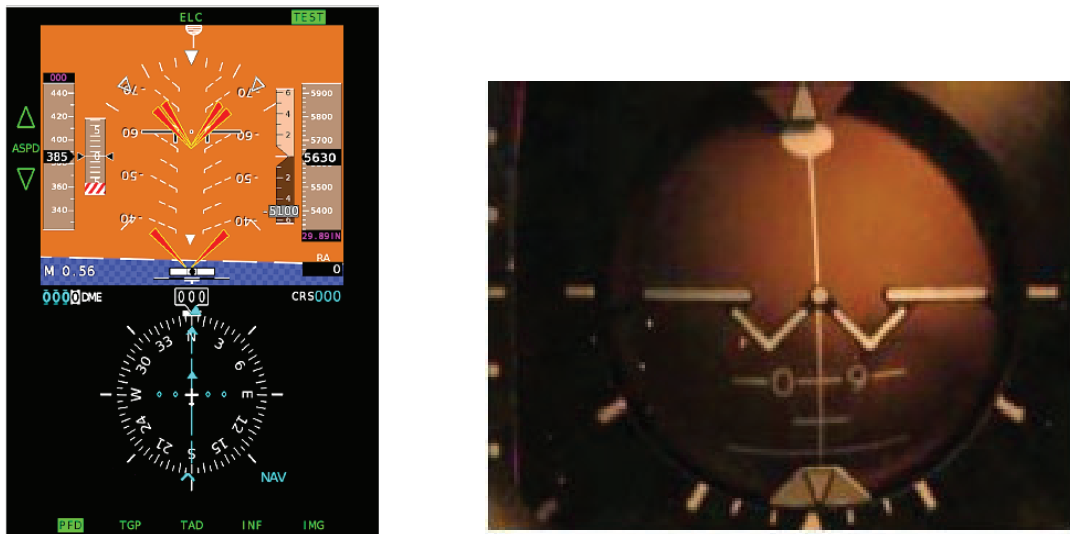
Figure 11: PFD and Standby ADI in Steep Dive with INS INFLT ALIGN (Tabs T-15 and T-20)

climb or dive (Tabs BB-10 to BB-11). Additionally, a dashed horizon line is presented at the edges of the PFD to aid the pilot in recovering toward the horizon (Tab T-15). This is in contrast to the standby ADI, which is the basic instrument always available to the MP (Tabs T-16 to T-17). What was displayed to the MP in the PFD at the time of the mishap cannot be established (Tab T-43). Nonetheless, if attitude information was displayed to the MP, the chevrons would have appeared in an indicated steep dive (Tab T-15). Prior to the mishap event and confirmed through radio communications, the MP verified the standby ADI was available (Tab T-40). Figure 11 (below) depicts a PFD and standby ADI in a steep dive, similar to what the MP may have encountered if the INS was in the INFLT ALIGN position with attitude information present in the PFD (Tabs T-15 and T-20). Figure 12 (below) depicts a PFD and standby ADI in a steep dive, similar to what the MP would have encountered if the INS was in the OFF position (Tabs T-18 and T-20).

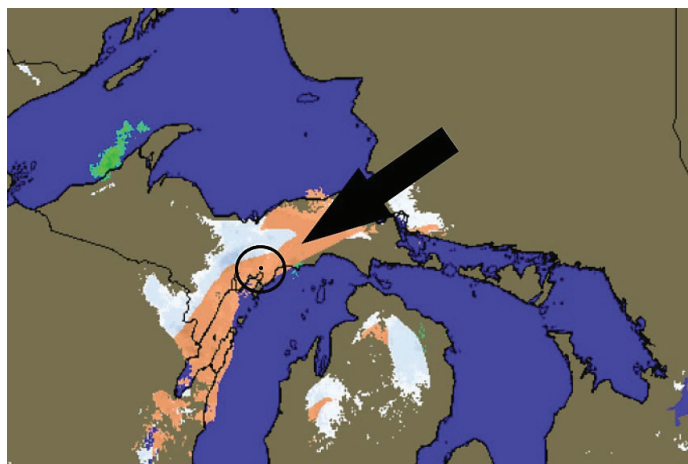
Figure 14: Local Precipitation at 18:20L (Tab F-7)

Illumination conditions at Hiawatha National Forest were low (Tab F-8). Further, the areas surrounding Hiawatha National Forest experienced moderate rain and light snow (Tab F-7). Figure 14 (below) shows the precipitation in the areas surrounding the mishap site (Tab F-7).
