UNITED STATES AIR FORCE
AIRCRAFT ACCIDENT INVESTIGATION
BOARD REPORT

F-22A, T/N 06-4109

LOCATION: NELLIS AIR FORCE BASE, NEVADA

DATE OF ACCIDENT: 30 OCTOBER 2020

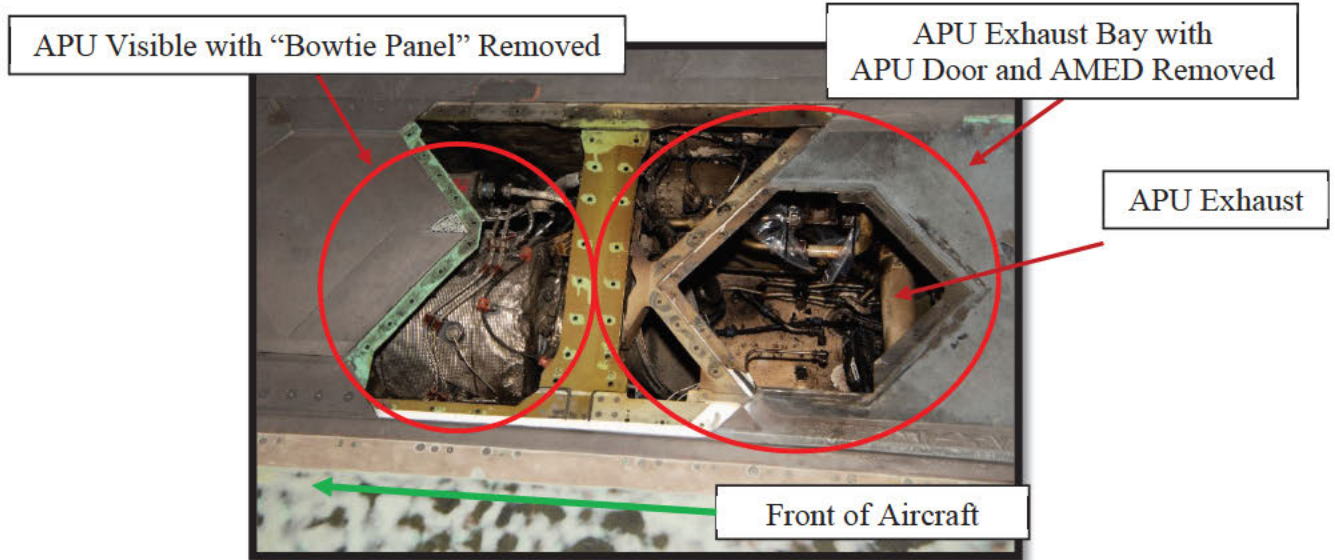
Figure 7: APU Exhaust Bay, Bowtie Panel, and AMED (Tabs Z-7 and EE-6)

The APU Exhaust Bay houses the APU and associated components, as seen in Figure 7 (Tab EE-6). The MA sustained damages to airframe, systems, wiring, hydraulics and surrounding structure and components of the APU exhaust bay from an overheat event (Tab J-6). Temperatures within the exhaust bay reached 600-700 degrees Fahrenheit for less than 10 minutes (Tab J-6). This bay was in serviceable condition prior to the mishap with no documented damage in its last post-flight inspection (Tabs U-11, EE-3 and EE-6).

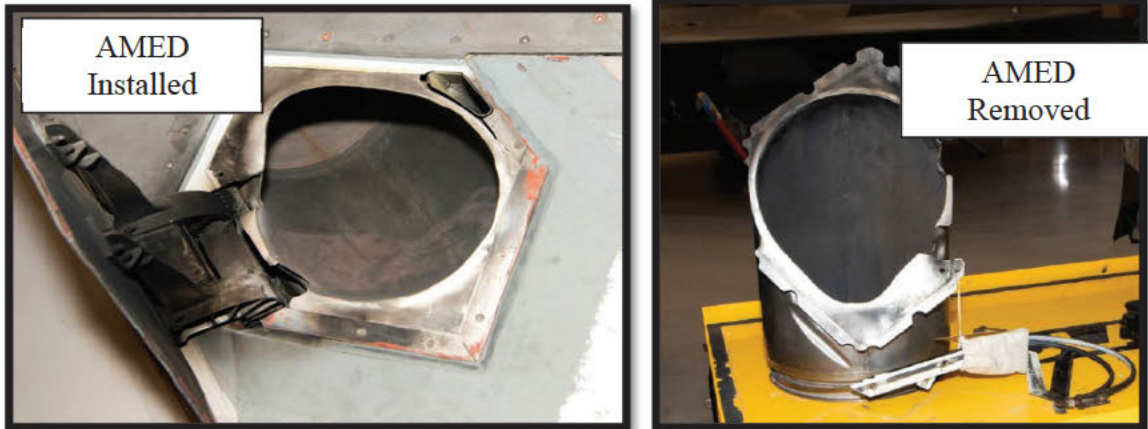
Figures 9-10: AMED Installed and Removed (Tabs Z-9 to Z-10 and EE-6)

The AMED provides the final stage of exhausting the combusted by-product of the APU (Tab BB-57). The duct is made of Inconel, a material capable of withstanding temperatures of up to 1800 degrees Fahrenheit (Tab BB-57 and BB-75). One end of the duct is coupled to the APU secondary exhaust duct (Tab BB-57). The other end of the duct mounts to aircraft structure under the APU exhaust outlet door (Tab BB-57).

I find by a preponderance of the evidence, the cause of the mishap was improper maintenance procedures resulting in the start of the APU while the AMED was removed.

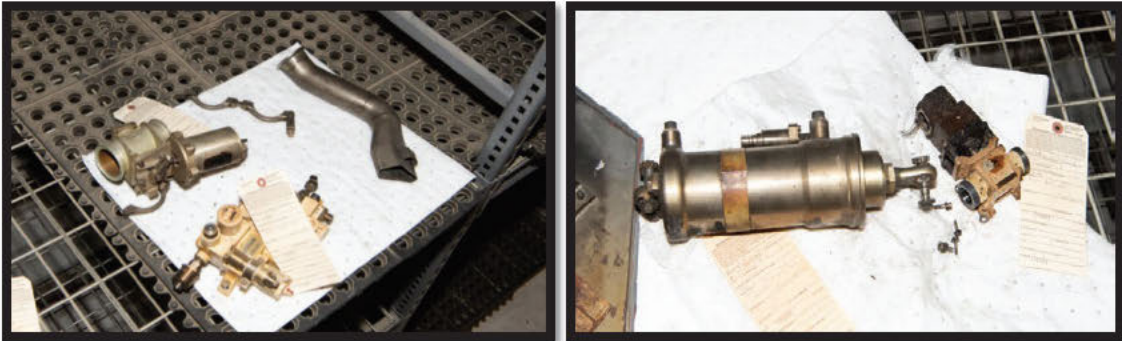
Figures 11-12: Damaged APU Exhaust Bay Components (Tab Z-11 to Z-12)

The following parts required replacement due to overheat: firewall shutoff valve, Auxiliary Power Generating System (APGS) valve assembly, APU inlet/exhaust door actuator, and APU surge control valve (Tab J-7).

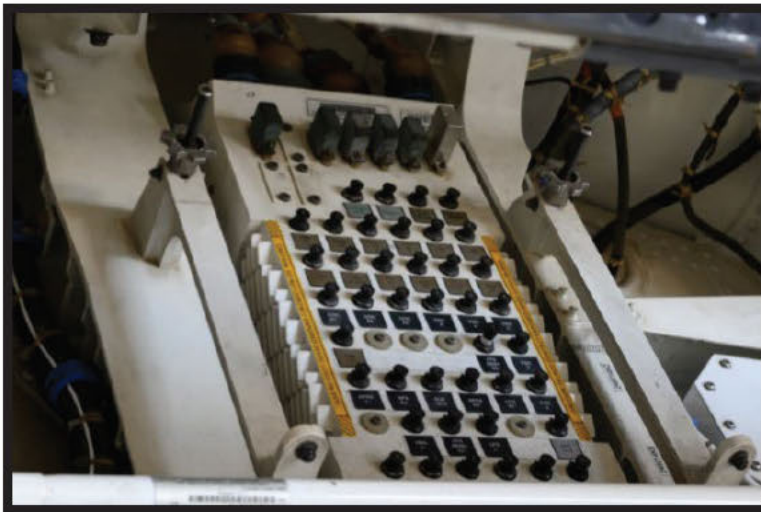
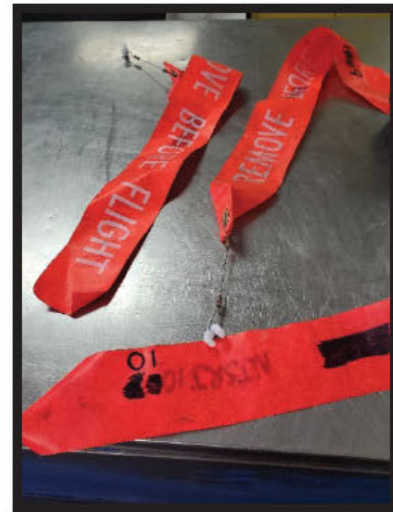
Figures 15-16: PDC #4, Circuit Breaker Collars (Tab Z-15 to Z-16)

PDC #4 houses the CBs associated with the AMED (Tab BB-65). CB collars would be used in this area, and usually include a large orange “REMOVE BEFORE FLIGHT” streamer, as seen in Figure 16 (Tabs Z-16, BB-65, and EE-5). CB collars are small plastic “C-shaped” clips that snap around a CB when pulled out as seen in Figure 16 (Tabs Z-16 and EE-5). CB collars are required IAW TO guidance and prevent CBs from being inadvertently reset, or “pushed in” (Tabs EE-5, EE-7 and BB-65).

During the investigation, the AIB learned that the failure to use CB collars and inconsistent use of digital warnings was not isolated to this mishap. Of eleven MXMs surveyed, nine testified that they did not install CB collars at the Raptor Aircraft Maintenance Unit (AMU). Of eight MXMs surveyed on Raptor AMU’s culture, seven reported a widespread lack of CB collar use. MXM1 did not to use CB collars on 28 October 2020, despite clear guidance directing the use of CB collars on PDC #4. MXM1 was fully qualified in the AMED removal and certified he completed the task IAW TO guidance. Likewise, MXM2 indicated she did not observe the use of CB collars for that particular task, and in terms of the Raptor AMU, she stated, “We don’t use them here.” Additionally, MXM8 stated he did not even know what CBs collars were. Therefore, I find by a

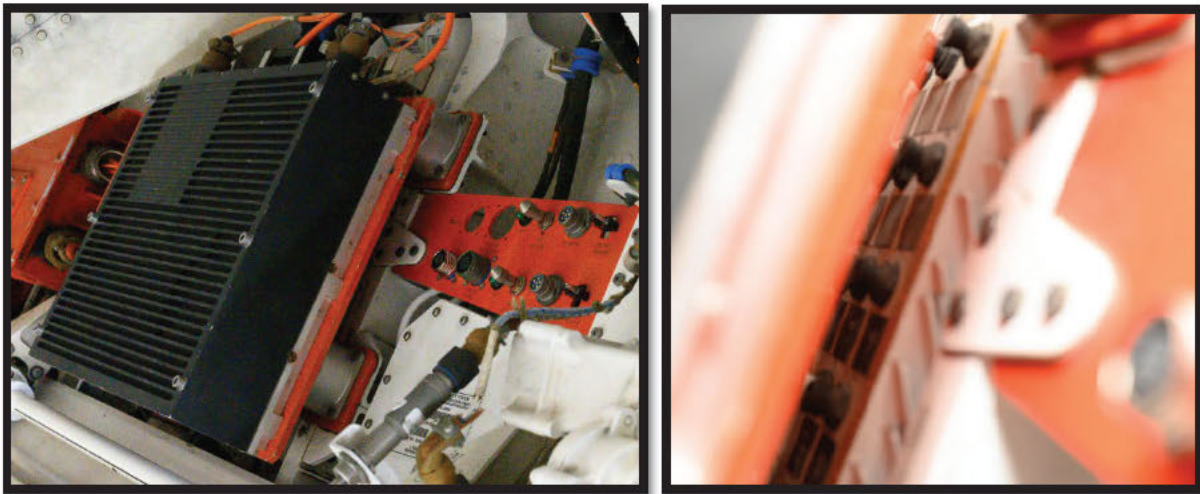
Figures 17-18: Test Instrumentation Installed Over PDC #4 (Tab Z-17 to Z-18)

The Instrumentation Test Equipment refers to specialized equipment utilized on the MA (Tabs Z-17 to Z-18, and EE-6). The Instrumentation Test Equipment power supply is located on top of PDC #4 and obstructs its access (Tabs V-15.13, V-16.3 and 16.4, Z-17 to Z-18, and EE-6). The clearance between the PDC #4 and the power supply is approximately one inch (Tabs Z-17 to Z-18, V-15.13, V-16.3, and EE-6). In order to confirm the position of CBs, to change their configuration (to “push in” or “pull out”), or to install CB collars, maintainers must contort around much of the airframe structure and use a combination of flashlights, mirrors, and other tools to complete these challenging tasks (Tabs V-15.13 to V-15.14, V-10.20 to V-10.21 and EE-6). Installing CB collars is particularly challenging (Tabs V-15.13 to V-15.14 and EE-6). According to MXM15, a Quality Assurance (QA) Inspector, it is very difficult to install CB collars on PDC #4, and characterized it as “not normal” to use CB collars there (Tabs V-15.13 to V-15.14, and EE-6). In reference to that location, he said, “The collars are brutal” (Tabs V-15.13 to V-15.14 and EE-6).

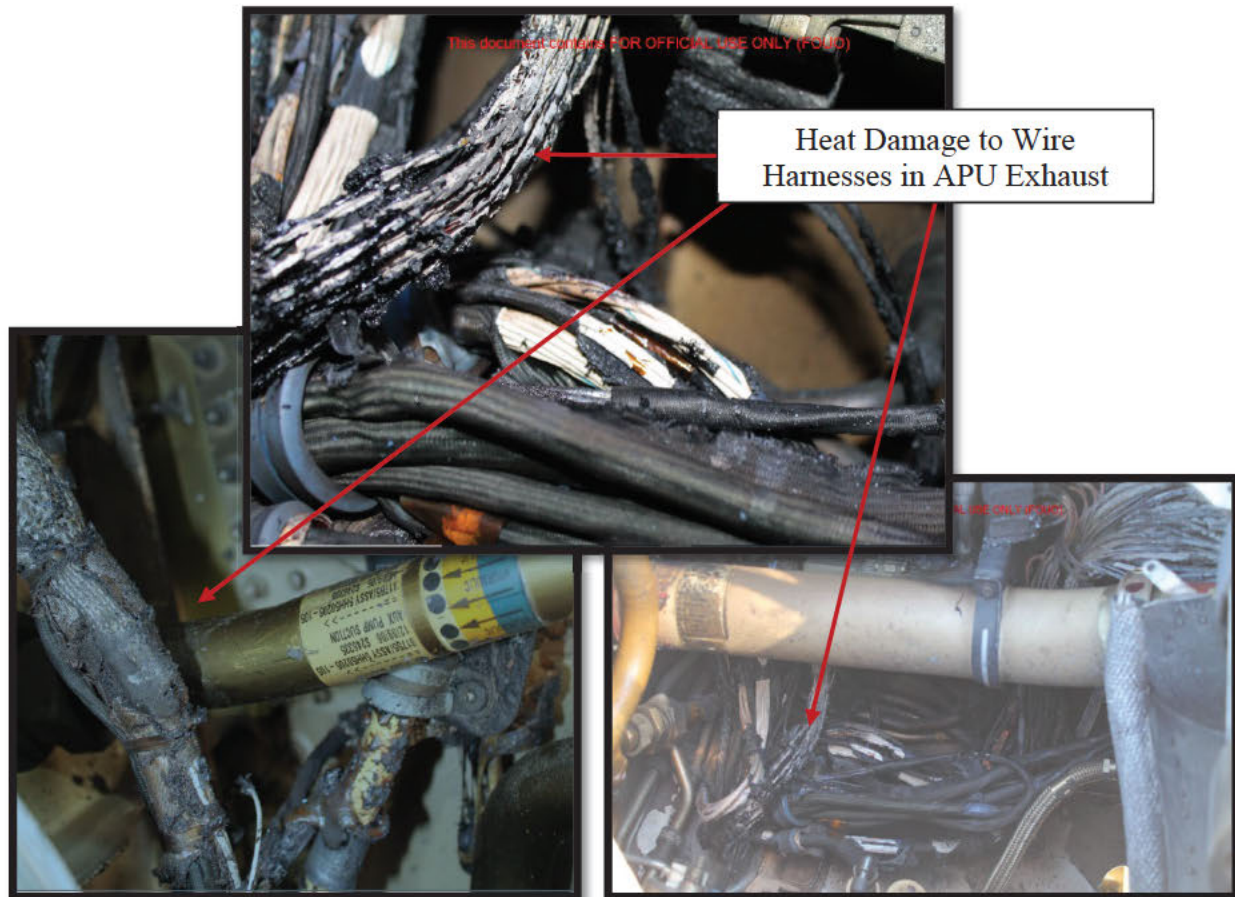
Figures 22-24: Components Damaged in APU Exhaust Bay (Tabs Z-22 to Z-24 and EE-6)

The firewall shutoff valve, APGS valve assembly, APU inlet/exhaust door actuator, and APU surge control valve were all contained in the APU exhaust bay (Tab J-7). These parts along with 47 wire harnesses and miscellaneous aluminum brackets in the bay needed replacement (Tab J-7 and J-8).
