UNITED STATES AIR FORCE
AIRCRAFT ACCIDENT INVESTIGATION
BOARD REPORT

UH-1N, T/N 69-6666

37TH HELICOPTER SQUADRON
90TH MISSILE WING
F.E. WARREN AIR FORCE BASE, WYOMING

DATE OF ACCIDENT: 30 AUGUST 2023

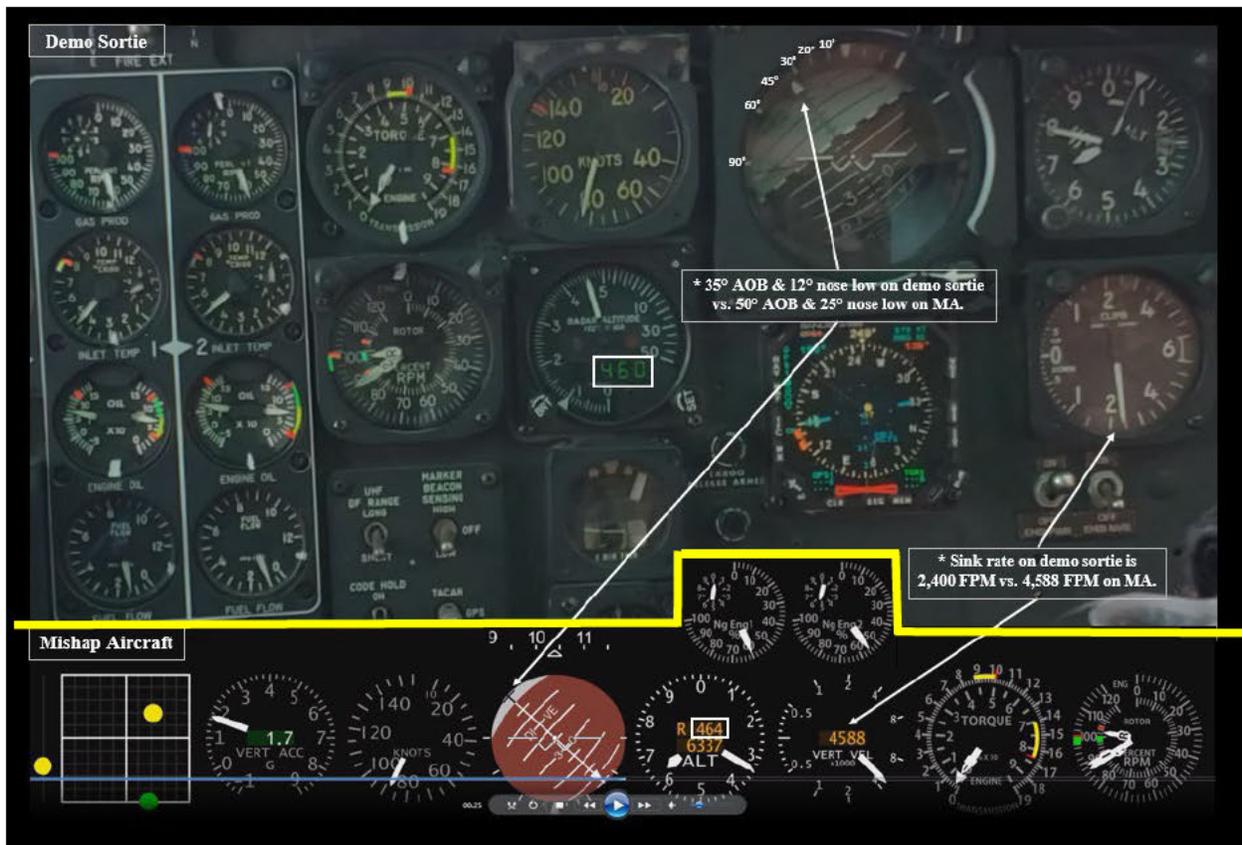
**Figure 4-1 (Tab DD-12)
MA and Demo Sortie Comparison – Sink Rate and Nose Low - 1**

At approximately 680 feet AGL, the MIP called, “watch your nose down” (Tabs DD-12 and EE-35). At this point, the MA had a sink rate of approximately 3,300 feet per minute (FPM) (Tab DD-12). The MP stated that after the MIP made this call, he “brought the nose up” (Tab R-42). According to the Integrated Data Acquisition Recorder (IDAR), there are no indications the MP ever made this control input (Tab DD-12). The sink rate and nose down attitude of the MA continued to increase over the next four seconds of the autorotation (Tab DD-12). According to AFMAN 11-2UH-1NV3, “at the first indication of an excessive sink rate, aircrew WILL terminate autorotations and initiate a power recovery” (Tab BB-137) (emphasis added). The AFTTP 3-3.H-1, defines a normal sink rate as “less than 3,000 FPM (Tab BB-141).”

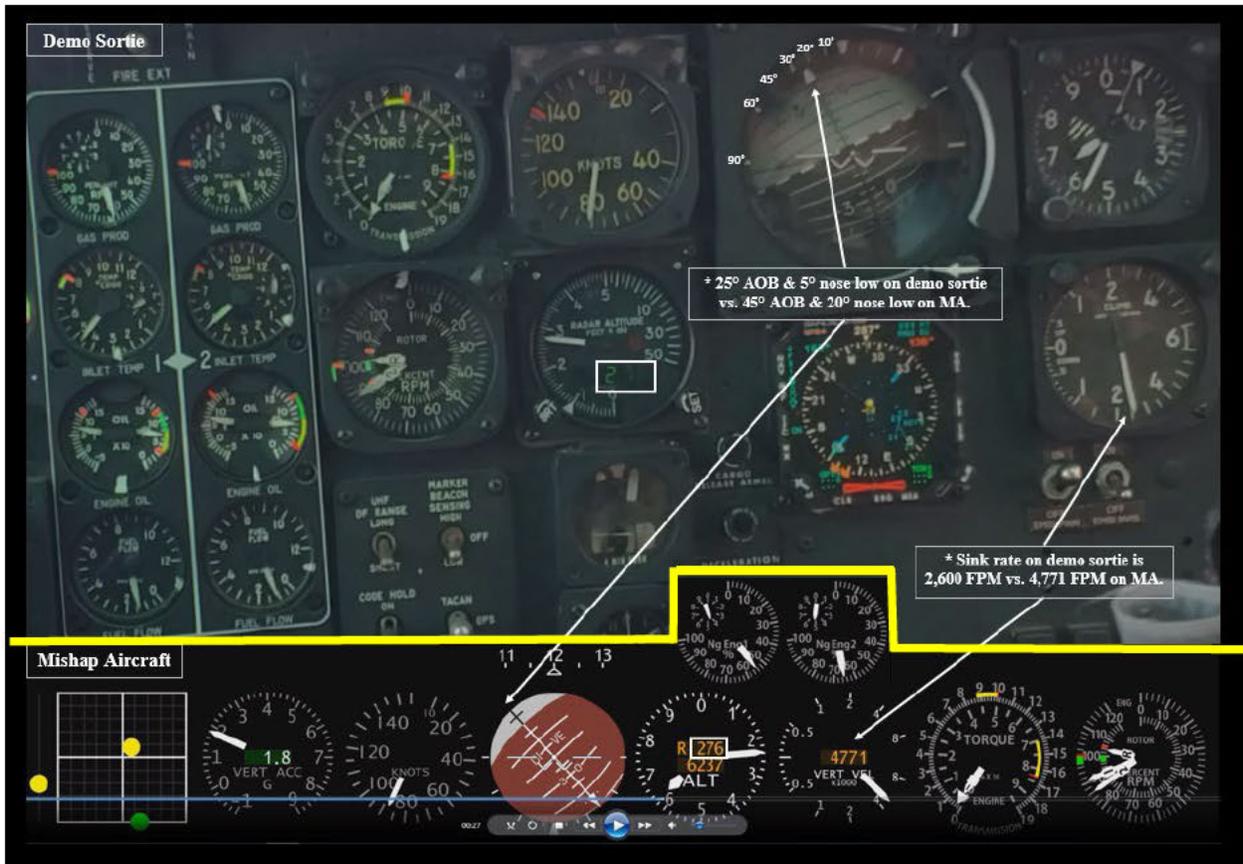
**Figure 4-2 (Tab DD-13)
MA and Demo Sortie Comparison – Sink Rate and Nose Low – 2**

At the request of the AIB, the demo pilot (DP) utilized an already scheduled EP sortie to record data during a 180-degree autorotation (henceforth, “demo sortie”) (Tab V-6.2 and V-6.5). This 180-degree autorotation adhered to all the parameters outlined in the AFMAN 11-2UH-1INV3 and AFTTP 3-3.H-1 (Tabs BB-137 to BB-138, BB-141, and DD-11). As the MA passes through 500 feet AGL, a side-by-side comparison of the MA’s sink rate and nose low attitude, versus the demo sortie’s sink rate and nose low attitude, illustrate just how excessive these two parameters were in the MA (Tab DD-12).

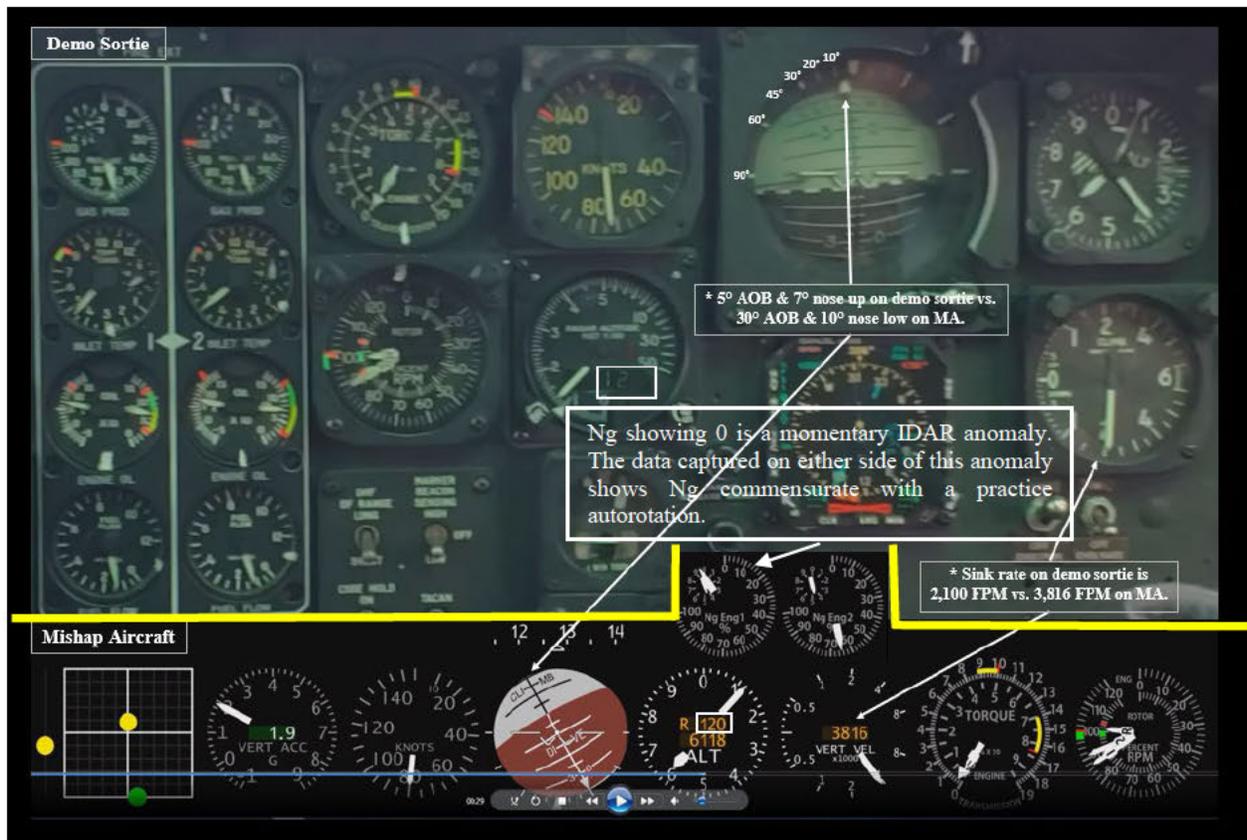
**Figure 4-3 (Tab DD-23)
MA and Demo Sortie Comparison – Sink Rate and Nose Low – 3**

During the post mishap interviews, both the MIP and the MP reported having an extreme nose down attitude and excessive sink rate (Tab R-38 and R-44). MIP stated, “it was through the turn I noticed we were extremely nose down (Tab R-38).” And the MP said, “as we turned right, as we started to view the runway, we still had a pretty honkin sink” (Tab R-44). At no point throughout the maneuver did a member of the MC call “power recovery”, which is the standard call made to terminate an autorotation and roll the throttles to full open in order to engage the rotor (Tabs N-3 and BB-142). It was not until approximately 200 feet AGL that a “go around” call was made by the MP (Tabs N-3 and DD-12). A “go around” implies the aircraft already has power (throttles full open), so when collective is applied, the aircraft will climb away from the ground (Tabs V-7.10 to V-7.11 and BB-165). In the case of the MA, when the go around was called, the throttles were at flight idle, and therefore did not have power when the MC applied collective (Tab DD-13). Shortly after the go around call was made, the MIP took the flight controls in an effort to recover the aircraft (Tab V-1.11 to V-1.13).

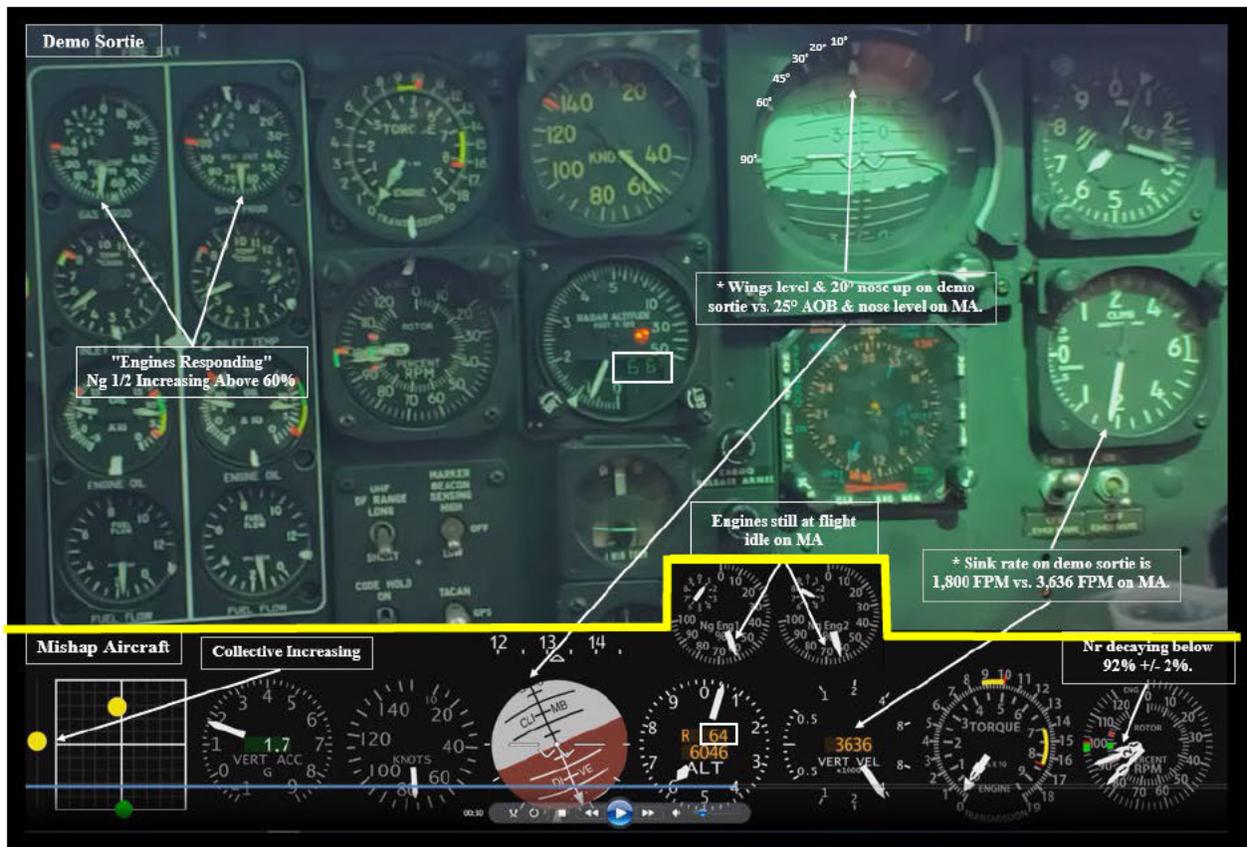
**Figure 4-4 (Tab DD-15)
MA and Demo Sortie Comparison – Instrument Readings -1**

According to AFMAN 11-2UH-1NV3, “When performing any autorotation, prior to descending below 150 feet AGL, aircrew must maneuver the aircraft to wings level, have a minimum of 60 KIAS, have rotor revolutions per minute (RPM) within limits, and be aligned within 30 degrees of the landing/recovery heading. If any of these conditions are not met, aircrew will initiate a power recovery immediately (Tab BB-138).” At 120 feet AGL, the MA still had 30 degrees of bank and a 10-degree nose down attitude (Tab DD-12). Additionally, the MA had a 3,816 FPM sink rate, and no throttle application had been made (Tab DD-12 and DD-23). Of note here, is the significant difference in sink rate and nose down attitude between the MA and demo sortie as noted in the above figure (Tab DD-12 to DD-13).

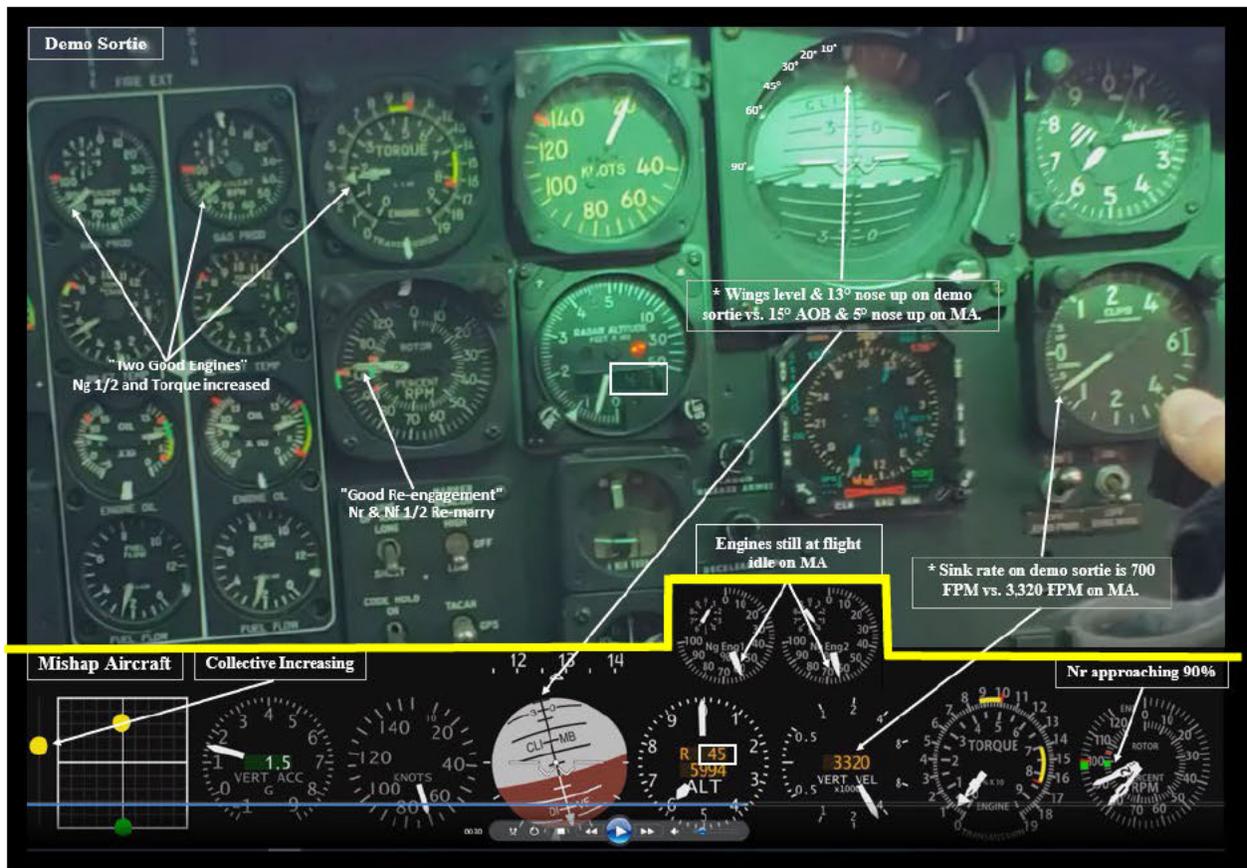
**Figure 4-5 (Tab DD-16)
MA and Demo Sortie Comparison – Instrument Readings -2**

At approximately 100 feet AGL, the MC gets the rotor RPM low warning audio alert, which comes on when Nr drops below 92% +/- 2% (Tabs BB-139, DD-12, and DD-16). This is a result of collective being applied while throttles are still at flight idle (Tab DD-13). The MP stated that as he started to see the “ground come up,” and knew the MA was going to impact the ground, he instinctively pulled up on the collective despite the MIP having the controls (Tabs R-45 and V-2.12 to V-2.13). At 65 feet AGL, the MA is still in a 25-degree bank turn and nose level attitude as the MIP attempts to get the MA lined up with runway 13 (Tab DD-13 and DD-23). The most notable differences between the MA and demo sortie at this juncture are the lack of throttle application on the MA and the ineffectiveness of the flare on the MA with a nose level attitude compared with a 20-degree nose up attitude on the demo sortie (Tab DD-13 and DD-24).

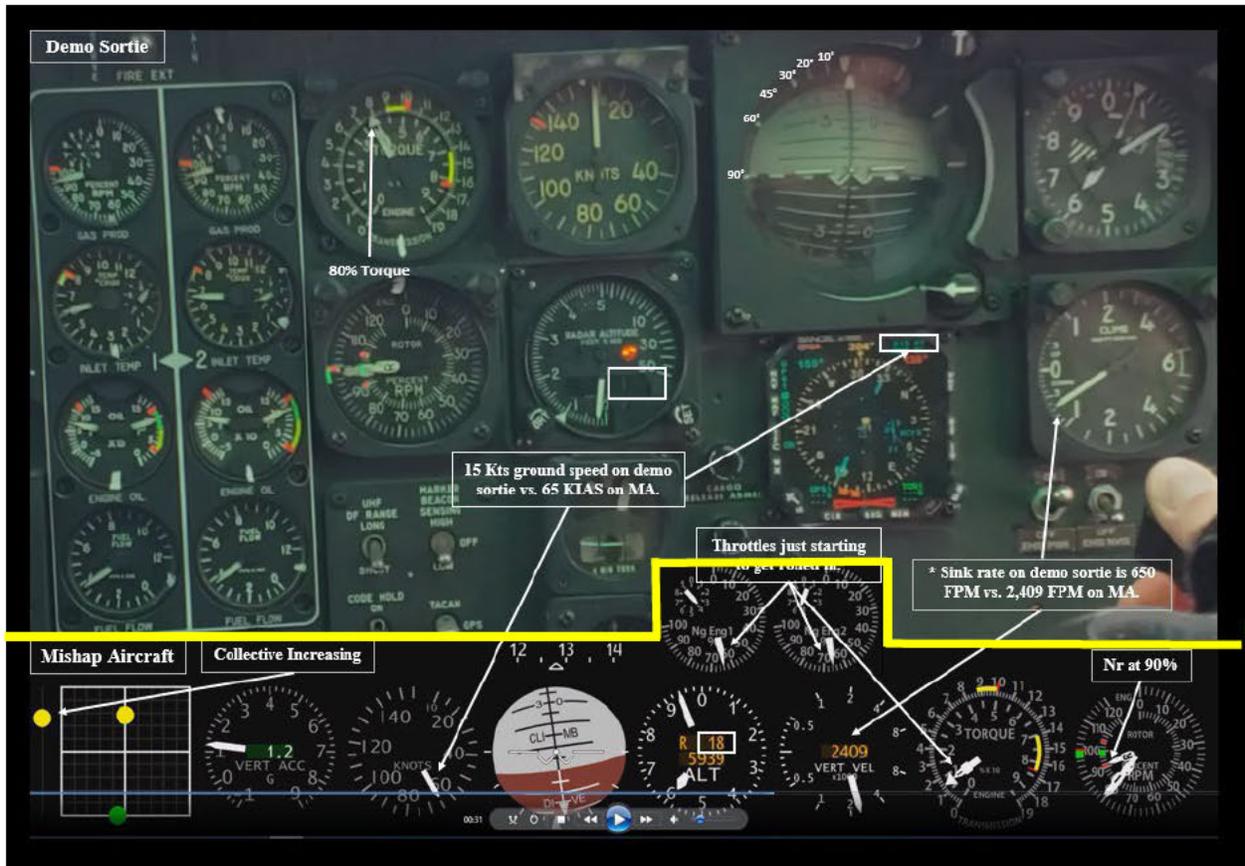
**Figure 4-6 (Tab DD-17)
MA and Demo Sortie Comparison – Instrument Readings -3**

As the MA passes through 50 feet AGL, the first indications of a “flare” are seen on the attitude display indicator (ADI), when the pitch of the aircraft reaches 5-degrees nose up (Tab DD-13 and DD-24). A flare just before touchdown reduces airspeed and decreases rate of descent (Tab DD-13). The flare is accomplished by applying aft cyclic, which changes the attitude of the rotor disk in relation to the relative wind (Tab DD-14). This attitude change increases the resultant lift of the rotor system, which in turn, slows forward airspeed and reduces rates of descent (Tab DD-13). This ultimately enables the helicopter to attain a safe landing speed and attitude, as collective pitch is applied in order to cushion the landing (Tab DD-14).

However, passing through 50 feet AGL, the MA is still in a 15-degree right bank turn with a high sink rate of 3,320 FPM (Tab DD-13). The rotor continues to decay and is approaching 90% Nr (Tab DD-13). Throttles still have not been rolled in and the aircraft is doing 70 KIAS (Tab DD-13). At this point in the mishap sequence, there is a vast difference in sink rate, Nr, and torque between the MA and demo sortie (Tab DD-13).

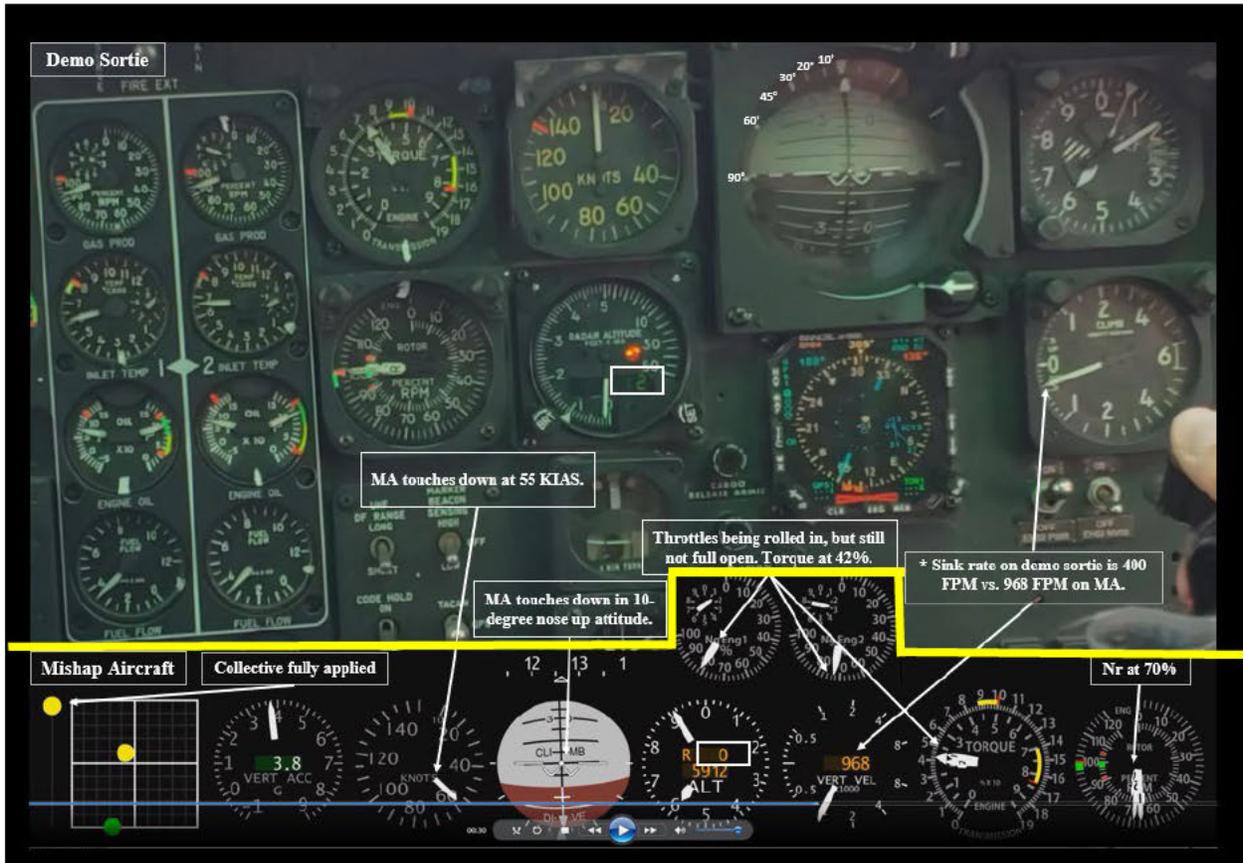
**Figure 4-7 (Tab DD-18)
MA and Demo Sortie Comparison – Instrument Readings -4**

As the MA approaches 15 feet AGL, the nose-up attitude of the aircraft reaches 8-degrees (Tab DD-13). The sink rate is decreasing, but still indicating 2,409 FPM, which is over 40 feet per second (Tab DD-13). It is at this altitude that the first signs of throttle application can be seen, as Ng's increase past 65%, and torque increases to 15% (Tab DD-13). As can be seen in the side-by-side graphic, the demo sortie has 80% torque applied and 100% Nr, which allows them to arrest their sink rate (650 FPM) and terminate the maneuver no lower than 5 feet AGL (the minimum altitude for terminating a 180-degree autorotation per AFMAN 11-2UH-1NV3) (Tabs DD-13 and BB-137). Due to the MA's high sink rate, high forward airspeed (65 KIAS), and lack of power and rotor speed, the MC was unable to recover the MA above the 5 feet AGL minimum altitude and descends into the ground (Tab DD-13 and DD-25).

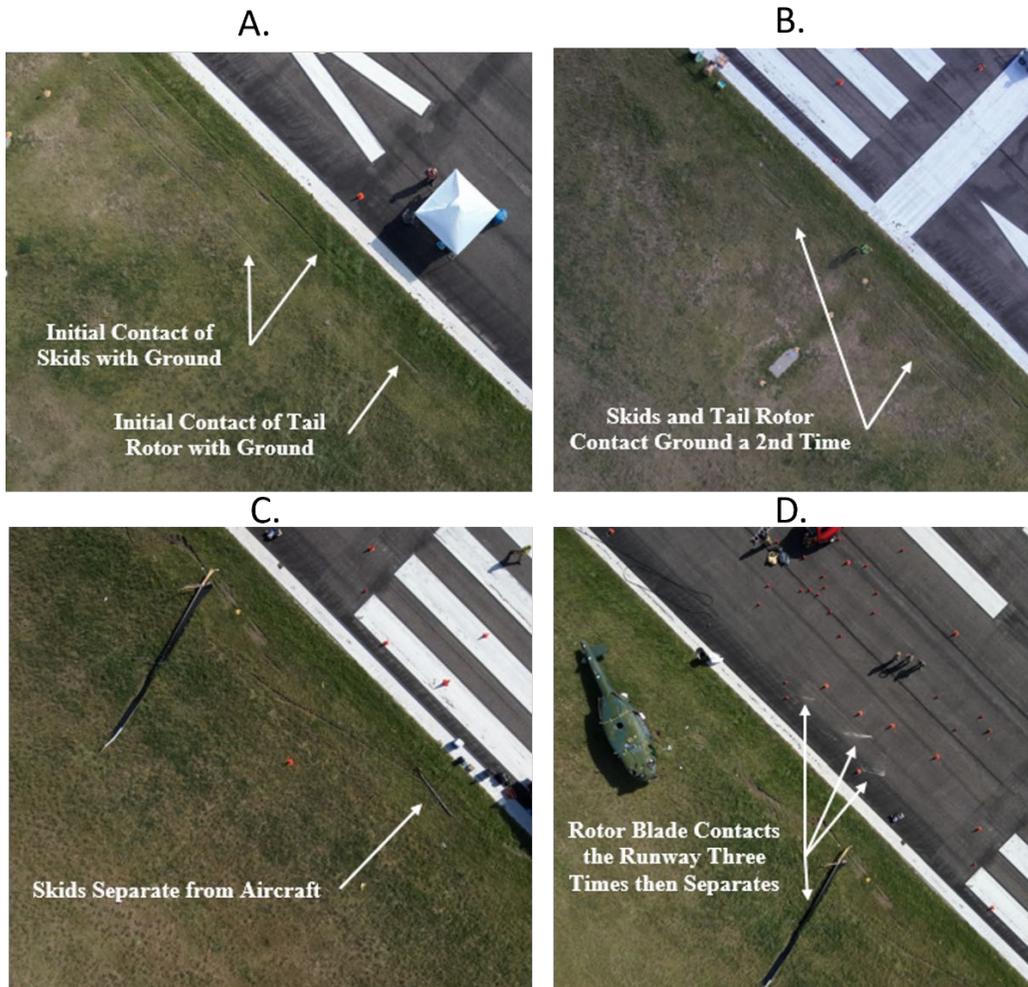
**Figure 4-8 (Tab S-4 to S-7)
Crash Site Photos**

The MA impacted the ground 20 seconds after the practice 180-degree autorotation began (Tab DD-14). This occurred just prior to the runway 13 threshold and off the left side of the runway on a heading of 126 degrees (Tabs S-4 and DD-14). The MA touched down with a 10-degree nose up attitude, wings level, approximately 968 FPM sink rate, and 55 KIAS (Tab DD-14). Due to the nose up attitude of the aircraft, the tail boom impacted the ground first, which then propelled the nose of the aircraft into the ground at a force of 3.8 Gs (Tabs H-10, BB-163 and DD-14). The MA completed two full iterations of bouncing back and forth between the tail boom and skids, at which time, the tail boom and skids separated from the aircraft (Tabs DD-14, DD-32 to DD-37, and S-5).

The tail rotor provides anti-torque for the aircraft and counteracts the rotation of the main rotor blade, which in turn, keeps the aircraft from spinning (Tabs BB-164 and BB-196). When the tail boom departed the aircraft, so did the anti-torque system (Tab DD-14). This resulted in the MA spinning to the right and rolling over onto its left side (Tab DD-14). The rolling motion caused the main rotor blades to contact the runway three times before separating from the aircraft (Tab S-4 and DD-14). The aircraft spun a total of 540-degrees before coming to a stop, upside down, just off the left edge of runway 13 (Tab DD-14). All three MC members remained strapped into their seats during the impact and rollover sequence (Tab R-34, R-38, and R-44).

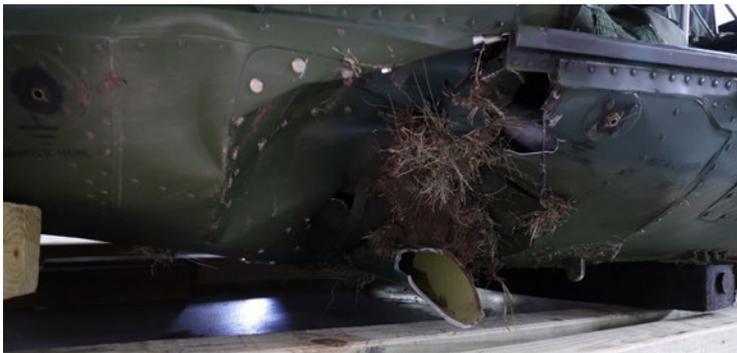
**Figure 6-1 (Tab H-5)
Right Rear Cross Tube Damage**

Both the right-hand and left-hand skids were separated from the MA (Tab H-4). The left-hand skid was found attached to the forward and aft cross tubes, which had been fractured immediately above the saddle mounts (Tab H-4). The right-hand skid was found with the forward cross-tube saddle mount sheared off and no attached forward cross tube, as well as the aft saddle mount and attached aft cross tube which had been fractured just above the saddle (Tab H-4).

Remaining parts of the forward and aft cross tubes were found in place under the MA fuselage (Tab H-4). Both the aft cross tubes were found fractured approximately at the aircraft outer mold line (OML) (Tab H-4). The forward cross tube was found fractured on the left-hand side at the aircraft OML and fractured on the right-hand side just outboard of the bearing support under the butt-line (BL) 14 beam (Tab H-4). Total rotation of the aft cross tube was found to be approximately 90-degrees counterclockwise when viewed from the left-hand side (Tab H-4). Rotation of the forward cross-tube was found to be approximately 45-degrees counterclockwise when viewed from the left (Tab H-4). Significant amounts of grass and dirt were found forward of the right side of the aft cross-tube, supporting a primary aft right-hand side landing impact (Tab H-4).

The MA vertical velocity prior to impact was estimated to be -16 feet per second (Tab H-16). The horizontal velocity prior to impact was 60 knots (Tab H-16). The conditions of the impact exceeded the ultimate design criteria for the aircraft cross-tubes (Tab H-16).

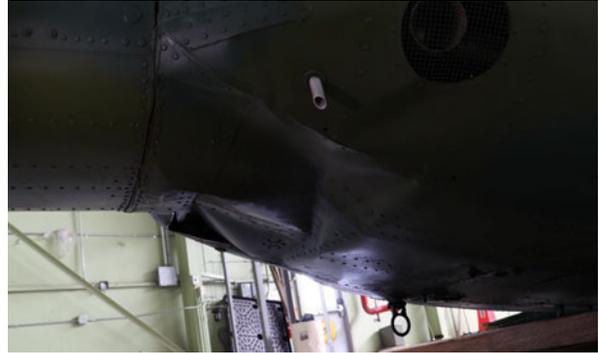
**Figure 6-2 (Tab H-5)
Fuselage Underside Damage**

Crippling of the underside skin just forward of the tail boom to fuselage interface was noted with a 2.5” deep ripple on the left-hand side, and 3.0” depth on the right-hand side (Tab H-5). No dirt, grass, or witness marks were noted on the underside skin near the tail boom/fuselage interface (Tab H-5). The upper-right fuselage side tail boom attach fitting was found pulled through the aft fuselage bulkhead (Tab H-5). No other fuselage side tail boom attach fittings

were found pulled or pushed through (Tab H-5). Crippling of the underside skin, along with the pull through of the upper-right fitting indicates a downward vertical acceleration event (Tab H-5).

Witness marks primarily in the fore-aft direction were found on the right underside skin between forward and aft cross-tubes (Tab H-5). Additional witness marks running fore-aft were also noted under the copilot door (Tab H-5). Significant crumpling of the lower copilot door and skin was overserved with large amounts of grass and dirt (Tab H-5). Underside wire strike does not show any accumulation of grass or dirt (Tab H-5).

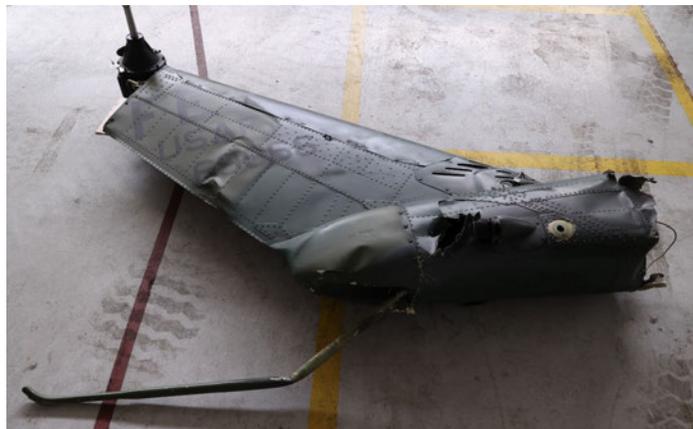
**Figure 6-4 (Tab H-7)
Right Side Tailfin Damage**

The tail rotor blade assembly was no longer attached to the tail rotor (Tab H-7). Fore-aft witness marks and impacted structure were discovered on the forward right underside of the separated tail boom and tailfin section (Tab H-7). On top of the tail boom and tailfin section opposite of the impacting, the upper part of the BS 194 bulkhead was completely crushed, indicating a primarily vertical impact with the tail rotor driveshaft (Tab H-7). The driveshaft in this section was not connected to the 42-degree gearbox (Tab H-7). On the aft-most tail boom

section still connected to fuselage, there was a matching impact area on the right-hand underside with fore-aft witness marks at the fracture plane (Tab H-7). Like the separated aft tail boom/tailfin section, the matching side on the fuselage connected tail boom, had the upper portion crushed from impact with the tail rotor driveshaft (Tab H-7). The elevator was discovered with the outboard half of the left portion separated during the mishap (Tab H-7).

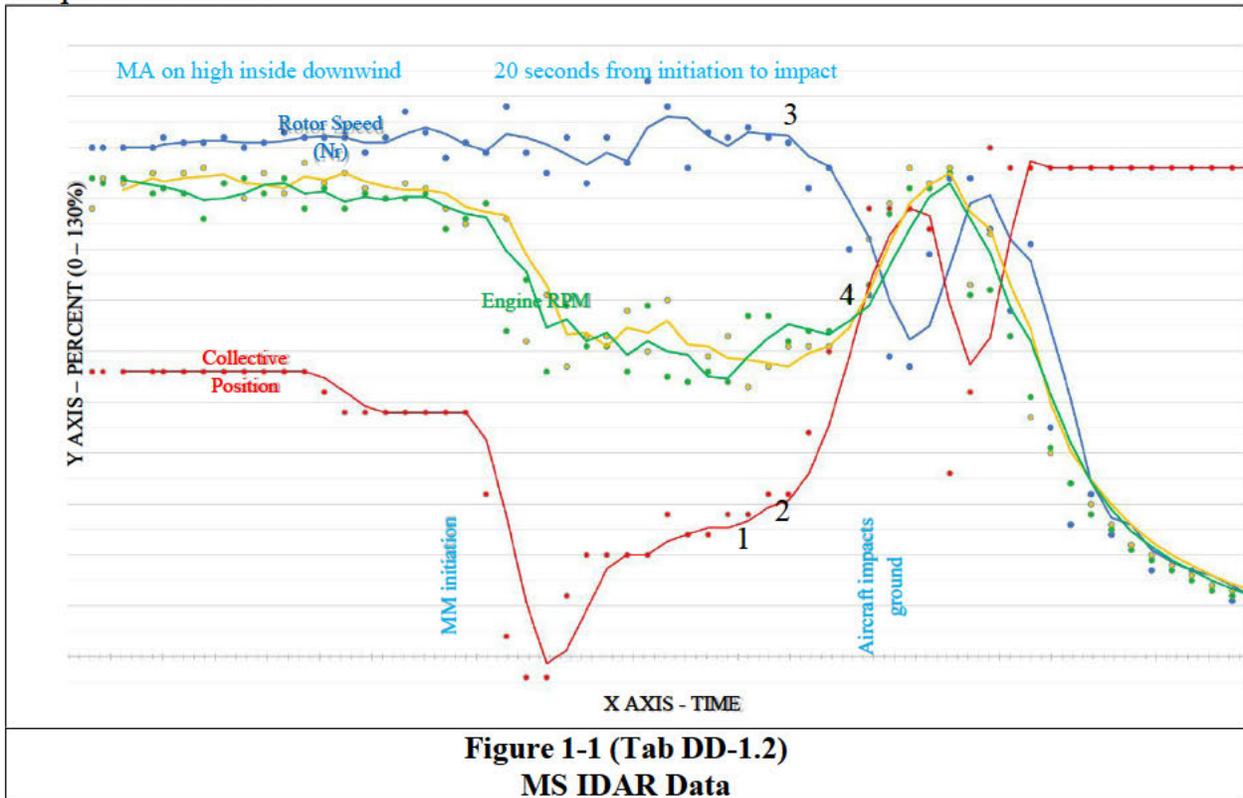
Figure 1-1 (Tab DD-1.2)
MS IDAR Data

1. Aft cyclic needed to be applied to flare the aircraft enough to nullify the sink rate and transfer the kinetic energy of the sink rate into potential energy that increases the rotor speed.
2. The throttles needed to be rolled full open immediately to increase rotor speed.
3. The collective needed to be applied as necessary to manage rotor speed. Too much collective results in an Nr decay, while too little collective results in an Nr overspeed.

Instead, the MC continuously increased collective pitch (denoted by steep slope starting at point 2 on figure 1-1), failed to apply sufficient aft cyclic, and delayed rolling the throttles to full open (denoted by increase in engine RPM at point 4 on figure 1-1). Ultimately, these control inputs resulted in a sharp decrease in Rotor (Nr) (denoted by sharp negative slope starting at point 3 on figure x). The sharp decrease in Nr was due to the continuous collective increase combined with lack of opening the throttle, all without a substantial reduction to the sink rate because there was insufficient aft cyclic to bring the MA's nose up. During simulator recreations of the mishap sequence, arresting the sink rate required a nose-pitch up angle of 15- to 20-degrees. The MC's maximum pitch up attitude during the mishap sequence was 10-degrees. The sim crew was able to recover the maneuver within normal practice 180 autorotation parameters (i.e., greater than 5 feet AGL) the majority of the time when they used a 15- to 20-degree nose pitch up attitude. Had the MC applied sufficient aft cyclic, opened the throttle and applied appropriate collective inputs to keep the rotor above 91% Nr (the -1 limit of rotor speed during a practice autorotation), it is likely the aircraft would have either not touched down, or touched down with a structurally acceptable sink rate.
