**UNITED STATES AIR FORCE**  
**AIRCRAFT ACCIDENT INVESTIGATION**  
**BOARD REPORT**

**KC-46A, T/N 15-046069**

**DATE OF ACCIDENT: 15 OCTOBER 2022**

## SUMMARY OF FACTS AND STATEMENT OF OPINION

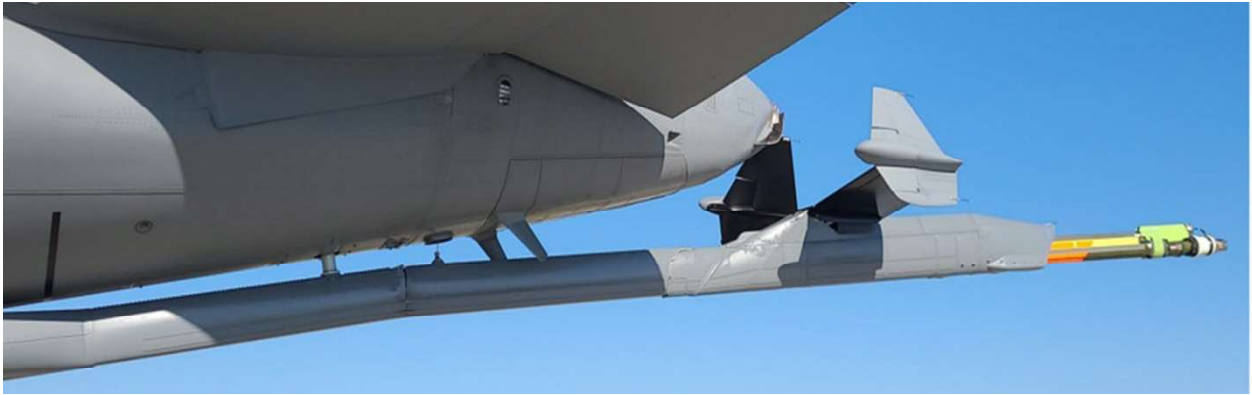
MA1 sustained damage in the following areas: the Aerial Refueling Boom, the left and right APU access doors, the APU exhaust, the APU exhaust deflector, and the aircraft tail section (Tab Z-12). There is potential for additional internal tail section structural damage, which will require further engineering assessment. MA2 sustained a damaged In-Flight Refueling (IFR) receptacle (Tab Z-12).

**Figure 2: ARB After Landing (Tab Z-12)**

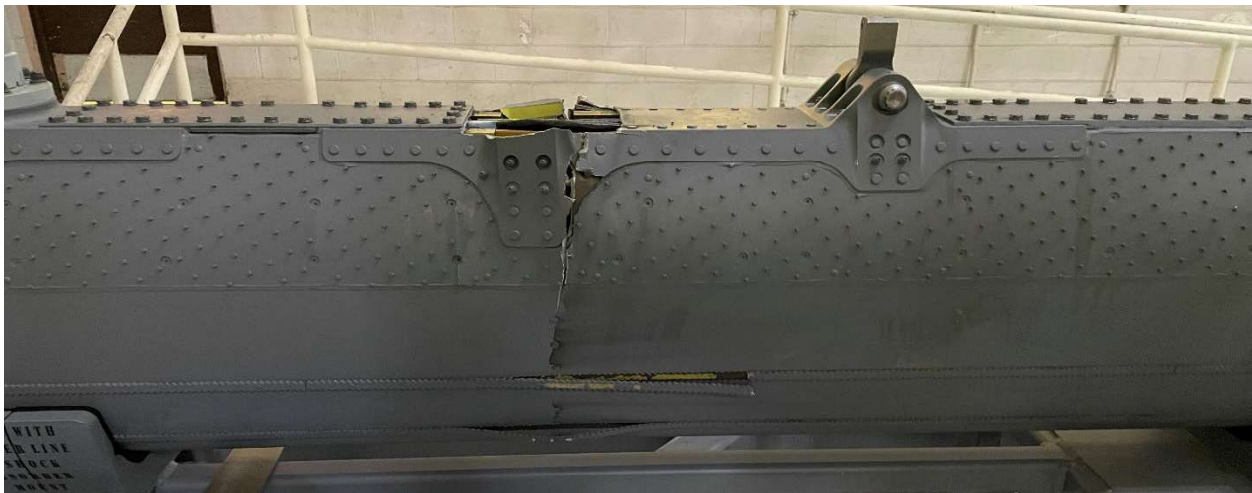
The ARB flexed beyond structural limits and cracked 13.5ft aft of its attachment point to the aircraft, where the ARB Stow/Unstow hook was located (Tab Z-5).

**Figure 3: Close up of ARB Stow/Unstow Damage (Tab Z-5)**

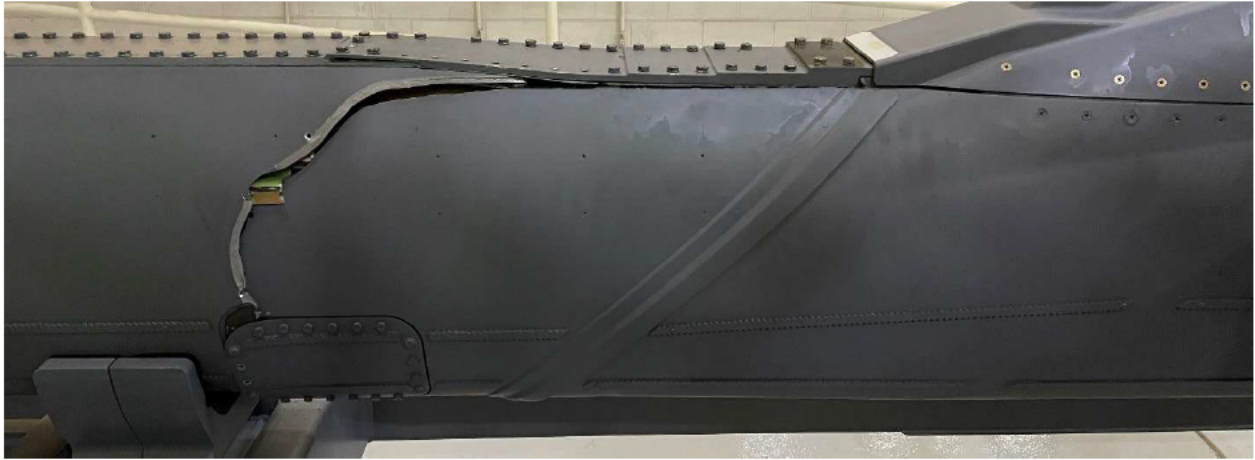
The second structural failure is 21.5ft down the ARB. This failure was caused by the ARB striking the tail section of the aircraft at a rate that exceeded expected capabilities. The fairing cracked along both sides and the bottom (Tab Z-6).

**Figure 4: Close up of ARB Fairing Damage (Tab Z-6)**

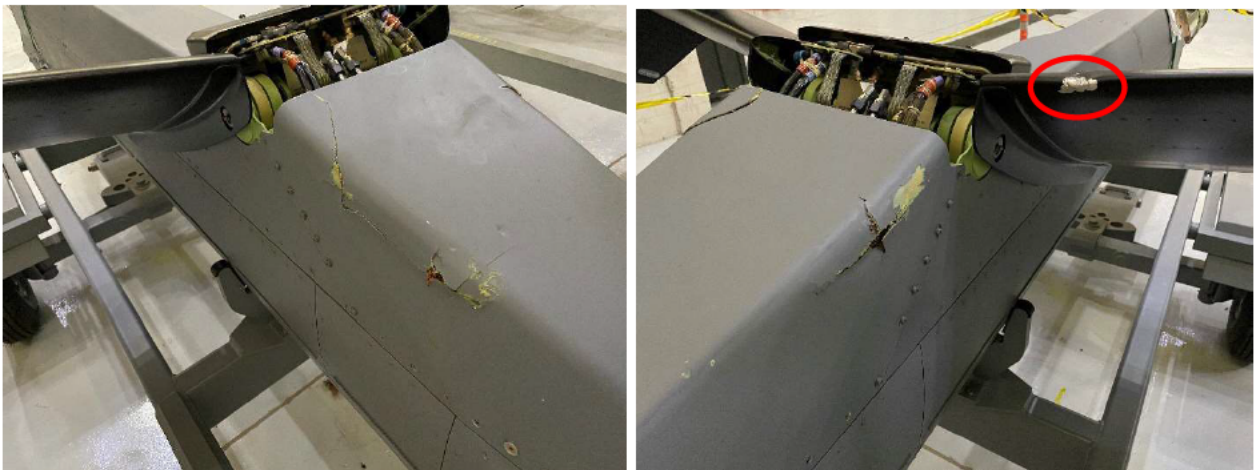
Due to the ARB striking the tail section of MA1, the ARB flight control fairing and the left ARB elevator were gauged beyond structural limits on the leading edge (Tab Z-7 AND Z-8).

**Figure 5: Close up of ARB Fairing and Elevator Damage (Tabs Z-7, Z-8)**

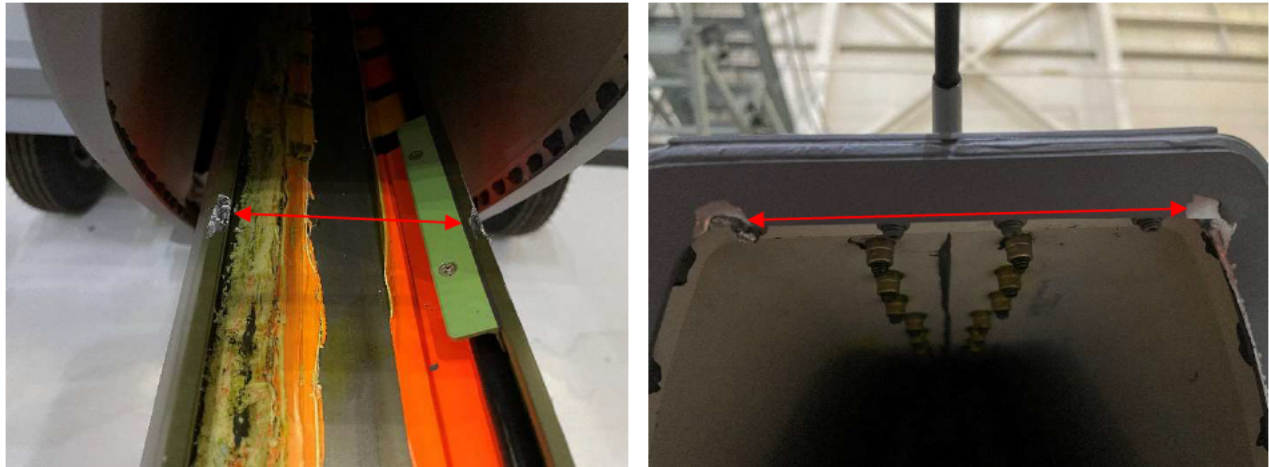
The force of the ARB striking the tail section of MA1 caused the ARB inner tube to contact the top of the ARB ice shield at 8.5ft extended and gouge the inner tube beyond structural limits (Tab Z-9, Z-11, and Z-14).

**Figure 6: Close up of ARB Inner Tube and Ice Shield Damage (Tabs Z-9, Z-11)**

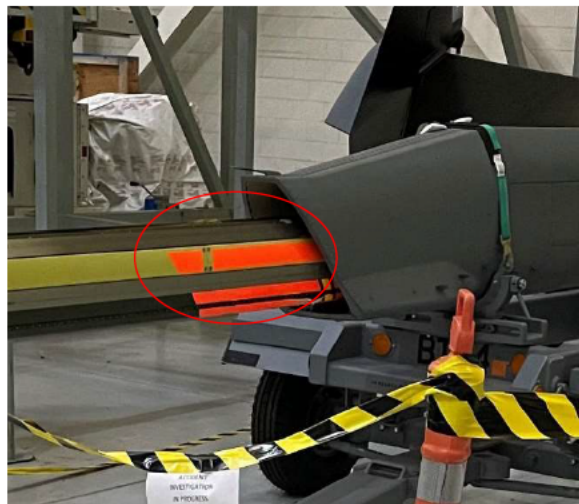
**Figure 7: ARB Inner Tube and Ice Shield (Tab Z-14)**

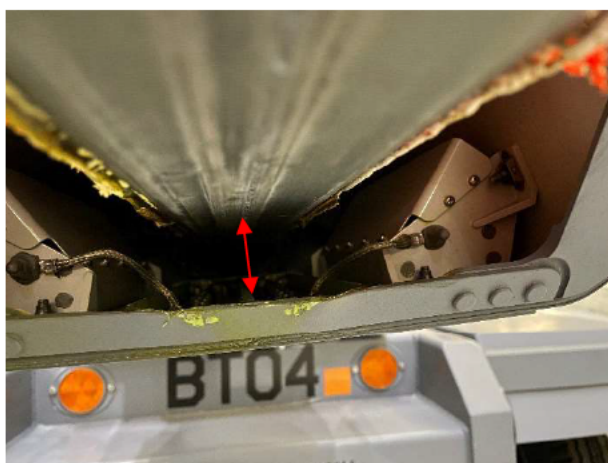
Due to the binding incident, when attempting to disconnect from the receiver aircraft, the inner tube was pulled from the ARB, scraping the bottom edge of the ARB ice shield (Z-10). This caused abrasion damage to the ice shield composite material and to the bottom of the ARB inner tube (Tab Z-10).

**Figure 8: Close up of the Bottom Edge of the ARB Ice Shield Damage (Tab Z-10)**

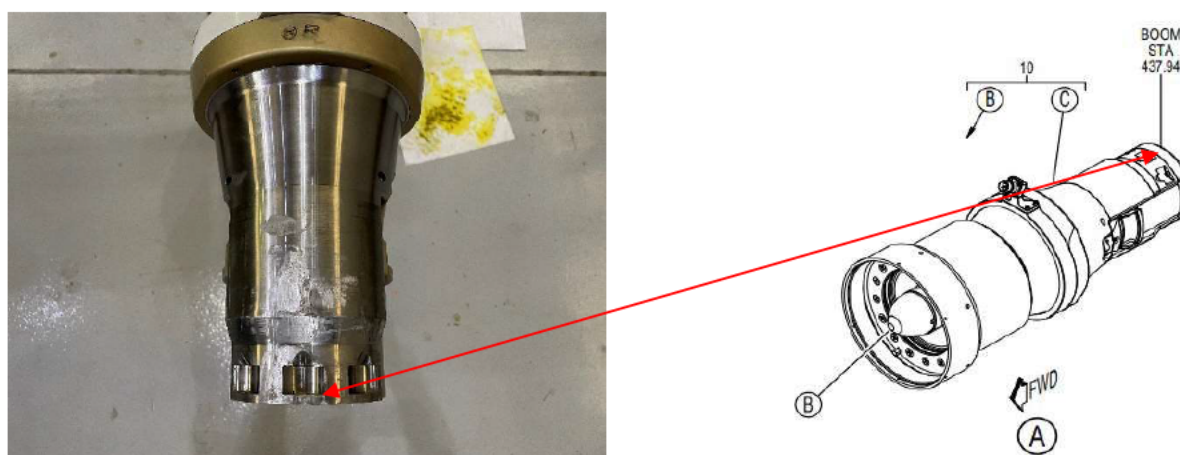
The binding of the ARB nozzle caused it to gouge the top of the nozzle and break off the ARB nozzle poppet valve (Tab Z-13).

**Figure 9: Close up of ARB Nozzle Damage (Tabs Z-13, D-4)**

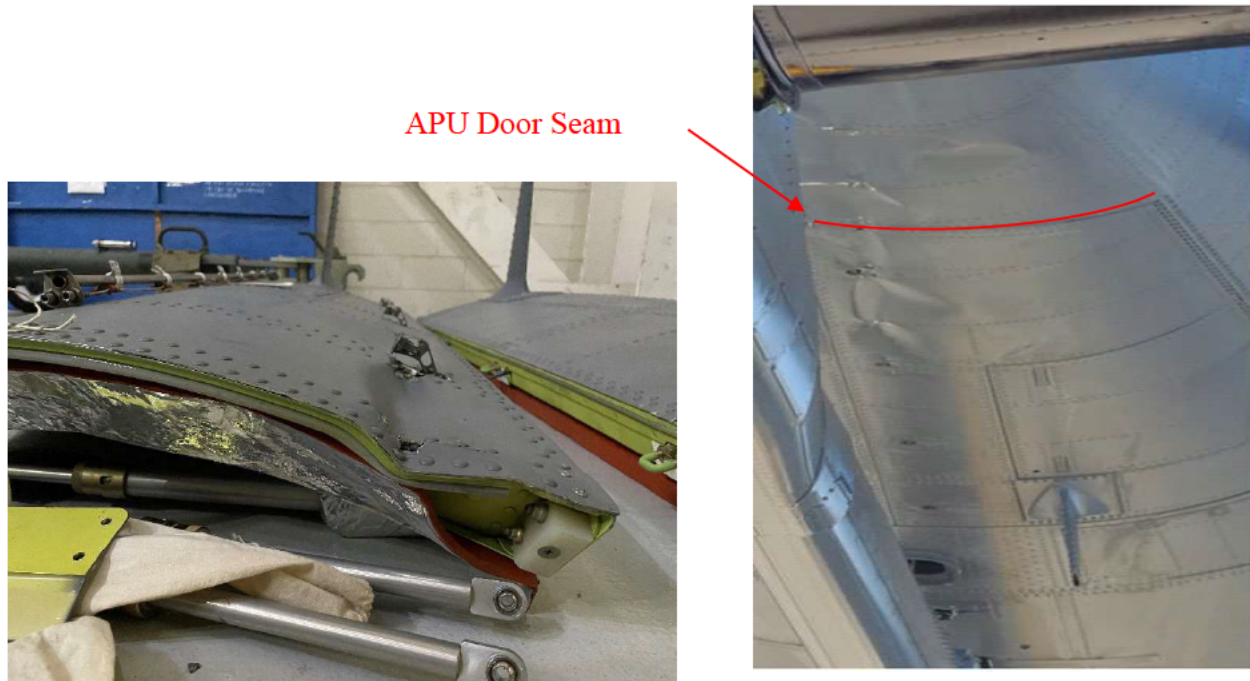
The Left APU access door received minor skin damage from the compression of the ARB impacting the aft section of MA1 and from compression derived from the right APU access door being damaged (Tab S-3).

The Right APU access door received extensive damage from the ARB's impact with the aft section of MA1 (Tab Z-3 and Z-4). Multiple stiffeners were cracked and/or bent. The skin on the access door was bent and torn in multiple locations (Tab Z-3 and Z-4).

**Figure 10: APU Access Door Damage (Tabs Z-3-4)**

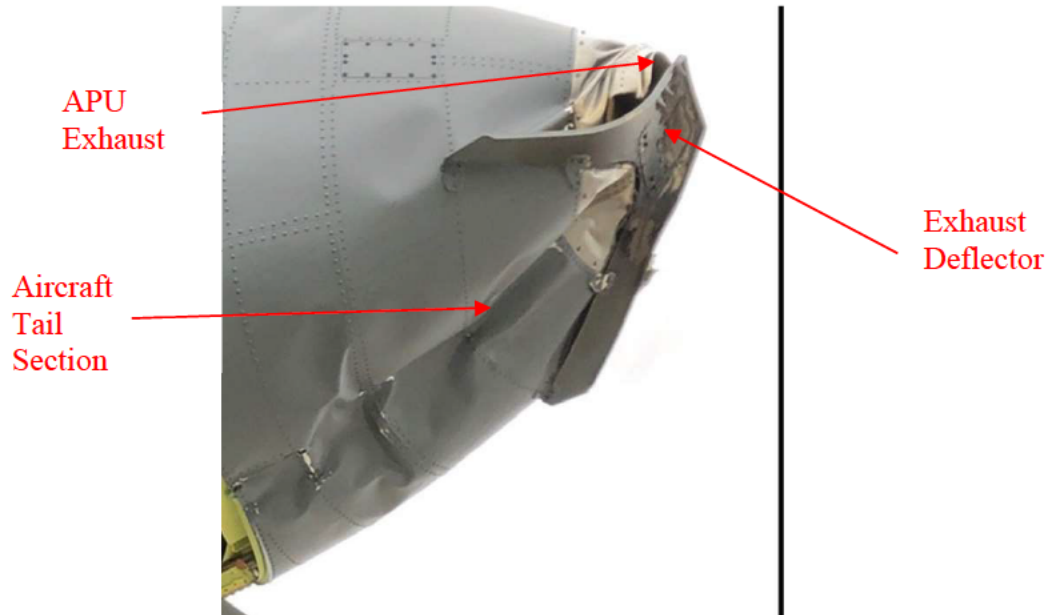
Multiple aircraft structural components in the tail section, aft of the APU enclosure doors, were cracked and/or pushed inwards from the impact of the boom on the lower surface of MA1's tail section (Tab Z-15).

**Figure 11: APU Exhaust, Exhaust Deflector and Tail Section Damage (Tab Z-16)**

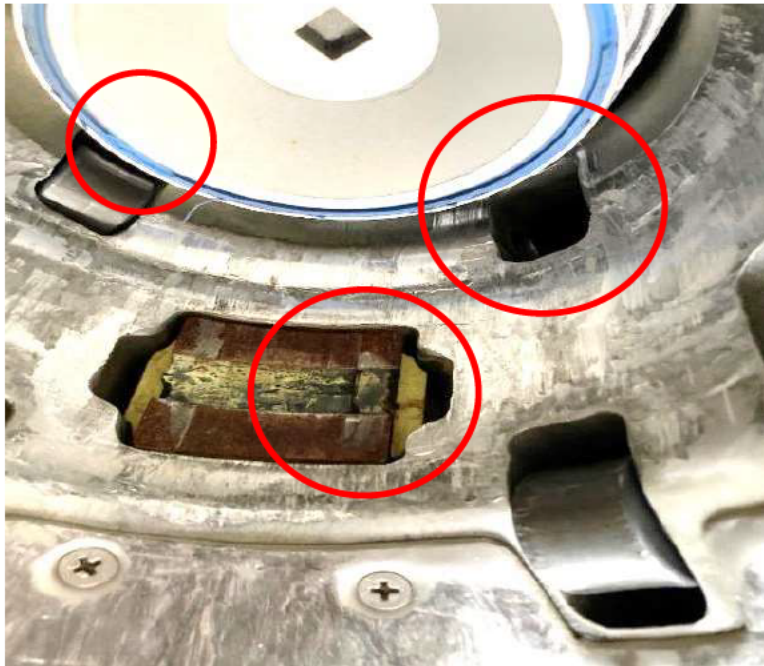
The lower roller within the receptacle was broken off, the induction coil was cracked, and the seal for the IFR fuel line was gouged due to the binding force applied by MA1's ARB nozzle (Tab D-85).

**Figure 12: MA2 IFR Bucket Damage (Tab D-85)**
