The commander of Alaskan Command and his pilot died in a tragic fishing trip mishap.

Survival and Tragedy in Ala

ska

By John Lowery

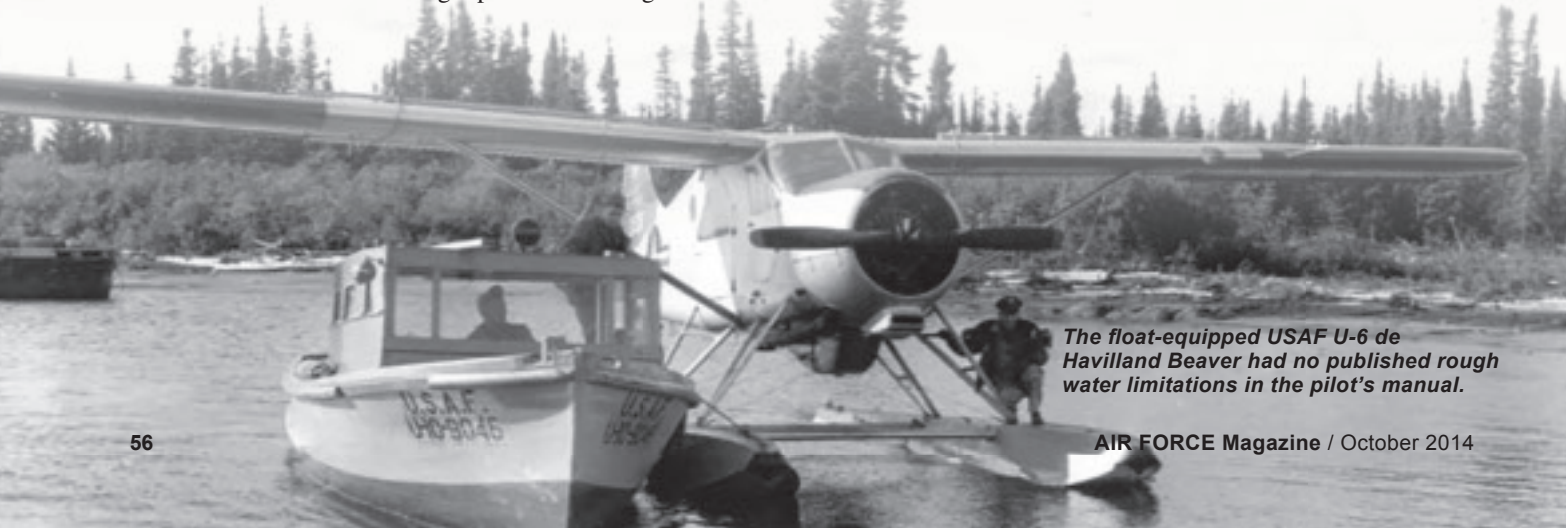
Despite being downwind "the aircraft bounced high into the air several times, but did not have sufficient airspeed to remain airborne," the report stated. The Beaver finally crashed when the floats contacted the water with tremendous force after the final bounce. The float and strut assemblies collapsed, and the aircraft nosed down into the water.

The aircraft's floats and struts collapsed as the aircraft bounced on the turbulent surface of the water, sending it down into the icy lake.

The float-equipped USAF U-6 de Havilland Beaver had no published rough water limitations in the pilot's manual.
