# *The B-47's Deadly Dominance*

By Walter J. Boyne

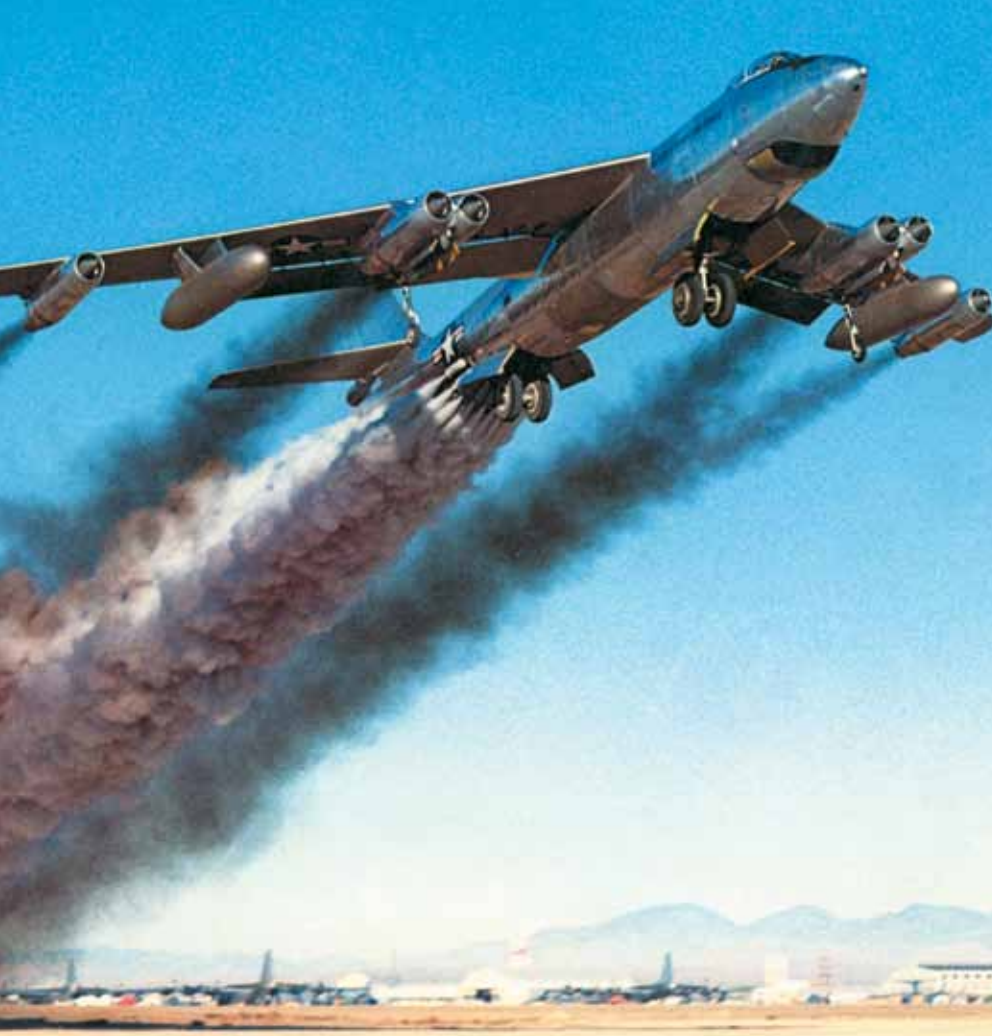
*A B-47 pulls inverted during an Immelmann turn in 1957.*

One of the most important changes was SAC’s establishment of the Hair Clipper training program for low-level flight and the use of the LABS (low altitude bombing system) maneuver. In this, the B-47 entered a half-loop at maximum speed, pulled up at 2.5 to 3.5Gs, automatically released its bomb at a predetermined point, then rolled out at the top in an Immelmann turn at a frighteningly low airspeed. The bomber dived away from the target to regain speed.

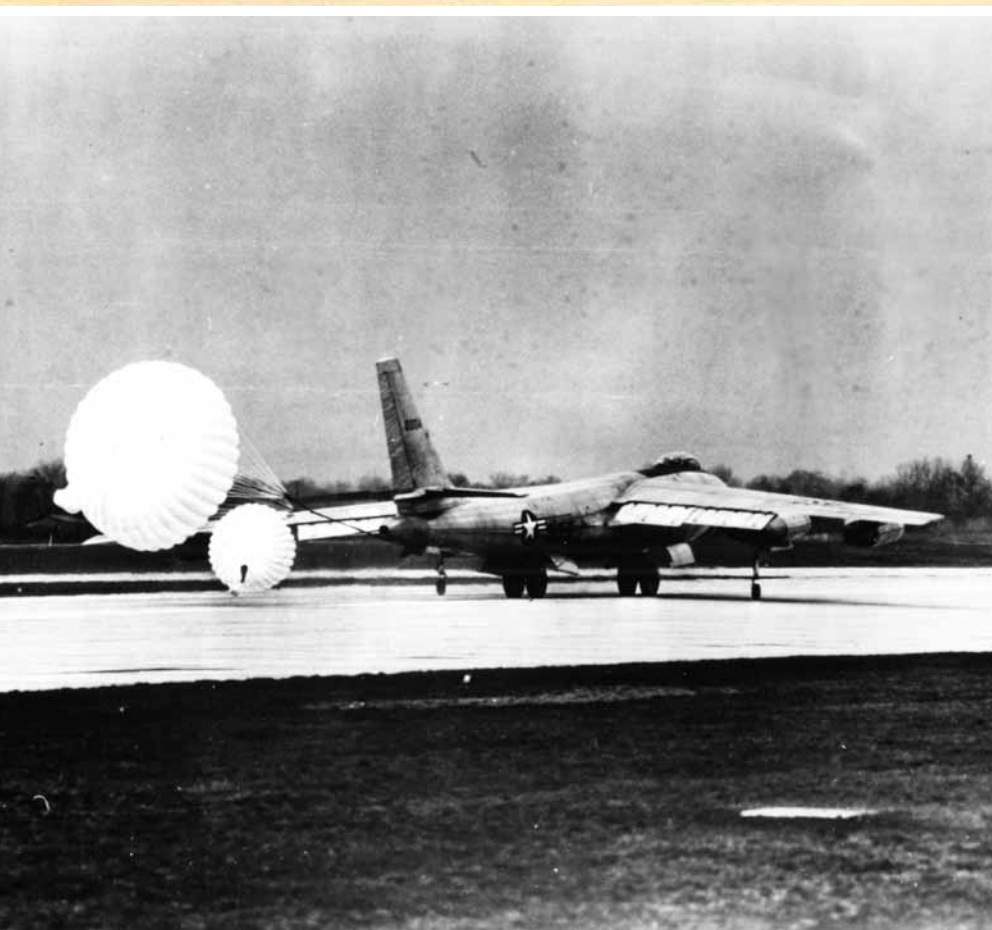
*Above left: A Stratojet makes a rocket-assisted takeoff in 1954. Left: A B-47 lands with both drag chutes deployed.*

Flying the aircraft at approach and landing speeds was demanding because the engines were so slow to accelerate. A drogue parachute was used to allow approach and landings to be made with the engines still carrying enough power to enable rapid throttle movement. After landing, a 32-foot brake parachute and an anti-skid brake stopped the aircraft.

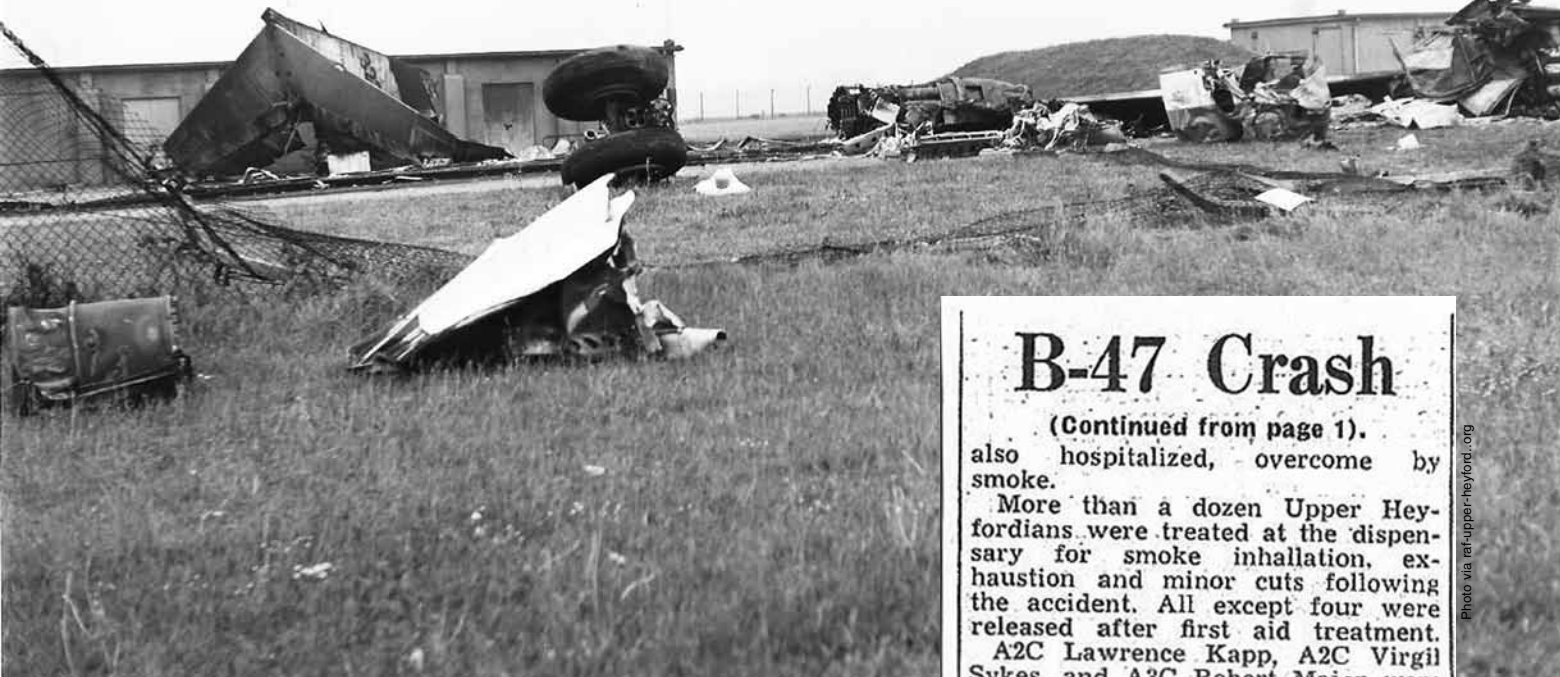
*Debris from a May 1964 B-47 crash litters RAF Station Upper Heyford in England. At right, a clipping from a SAC newspaper describing the deadly crash.*

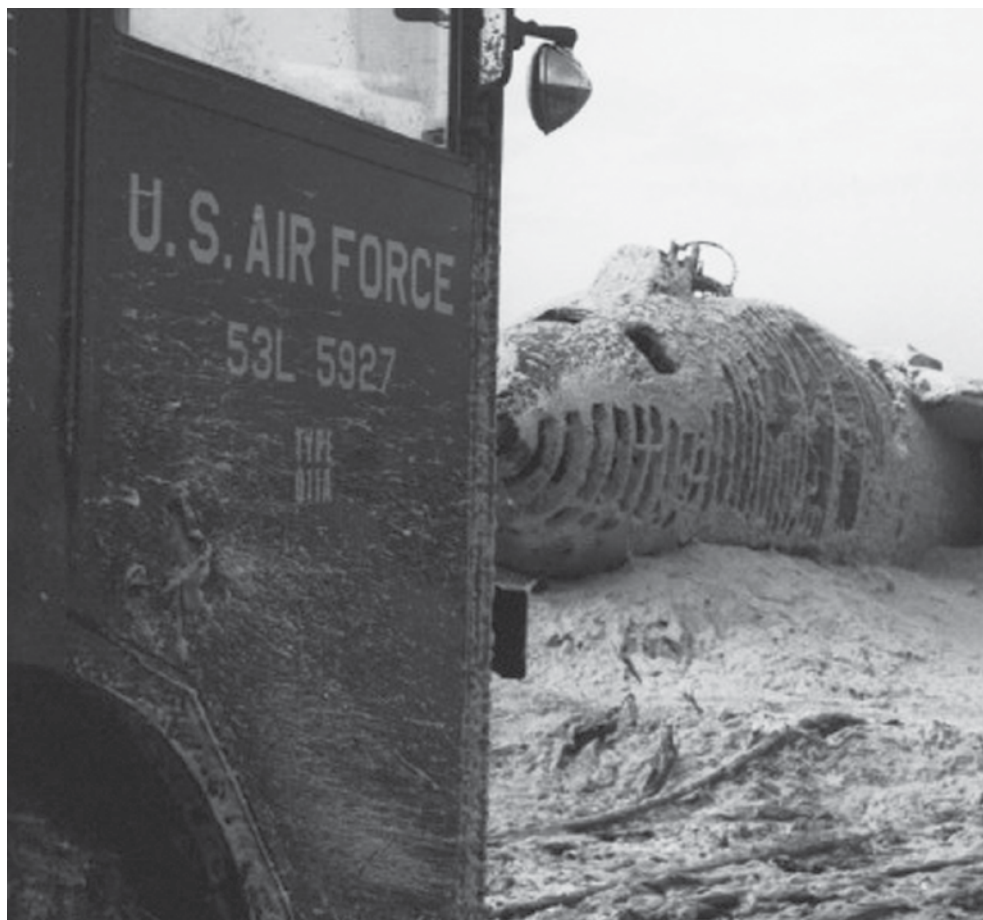
*The Lincoln AFB, Neb., fire crew smothered this B-47 in foam after an accident in the early 1960s.*
