The Carswell B-36 Disaster

By Sam McGowan

Two B-36 bombers at Carswell AFB, Texas, after the Labor Day 1952 microburst that knocked out two-thirds of the bomber type—USAF's main nuclear deterrent against the Soviet Union.

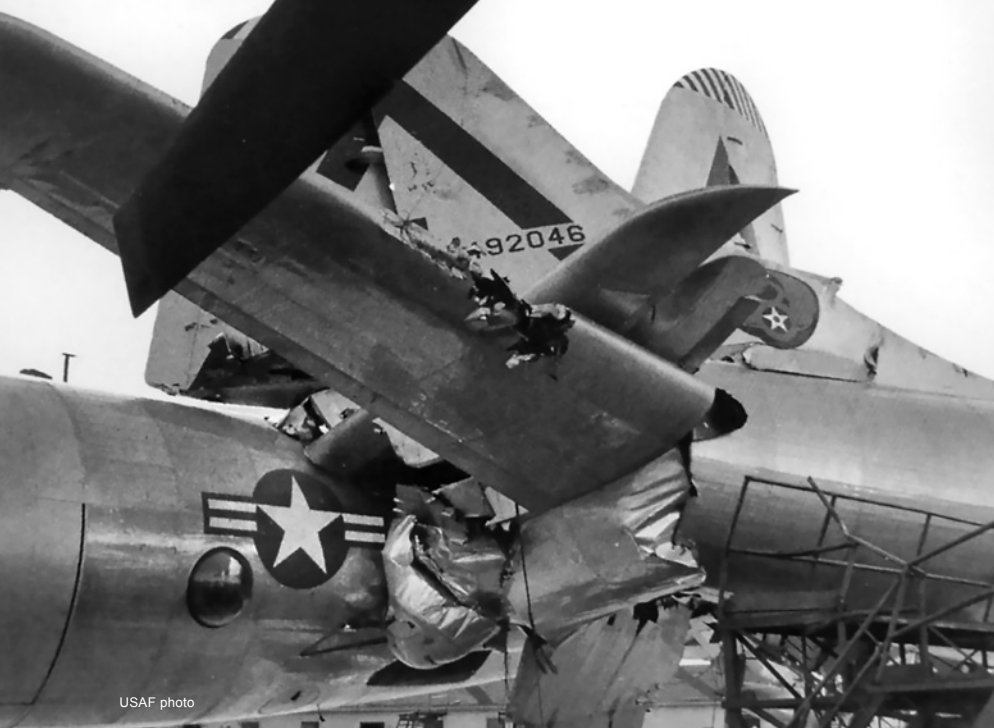
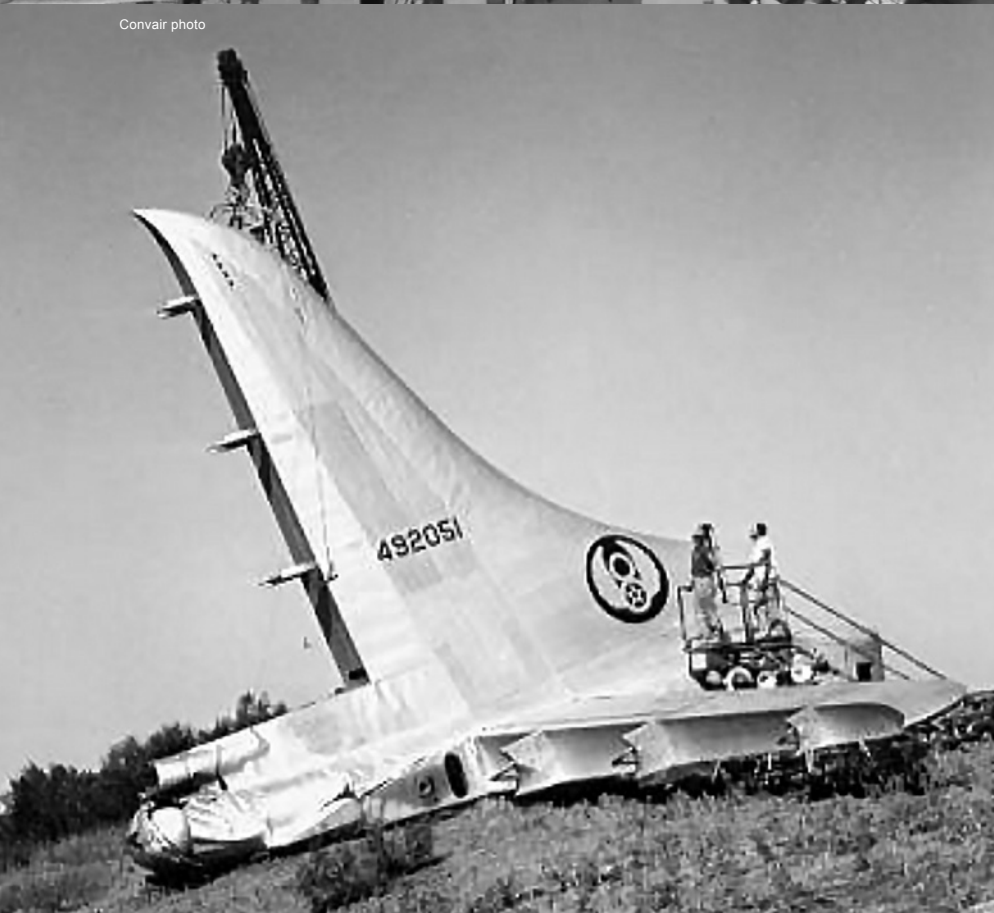
Left top: Tail damage to two B-36s after the microburst. Left: The tail section of a B-36 after the aircraft was blown completely off the runway, its fuselage broken in half, and the left wing and tail severed during the brief but vicious storm.

When it was over, the flight line was a tangle of airplanes, equipment, and pieces of buildings. The power of the storm was evidenced by the sole Peacemaker declared a total loss: Picked up by the winds, it was carried away, coming to rest in a ravine. Its fuselage was broken, only one wing was still attached, and its tail had been sheared off.
