UNITED STATES AIR FORCE
AIRCRAFT ACCIDENT INVESTIGATION
BOARD REPORT

QF-4E, T/N 74-1629

DETACHMENT 1, 82D AERIAL TARGETS SQUADRON
53RD WING
HOLLOMAN AIR FORCE BASE, NEW MEXICO

DATE OF ACCIDENT: 7 FEBRUARY 2014

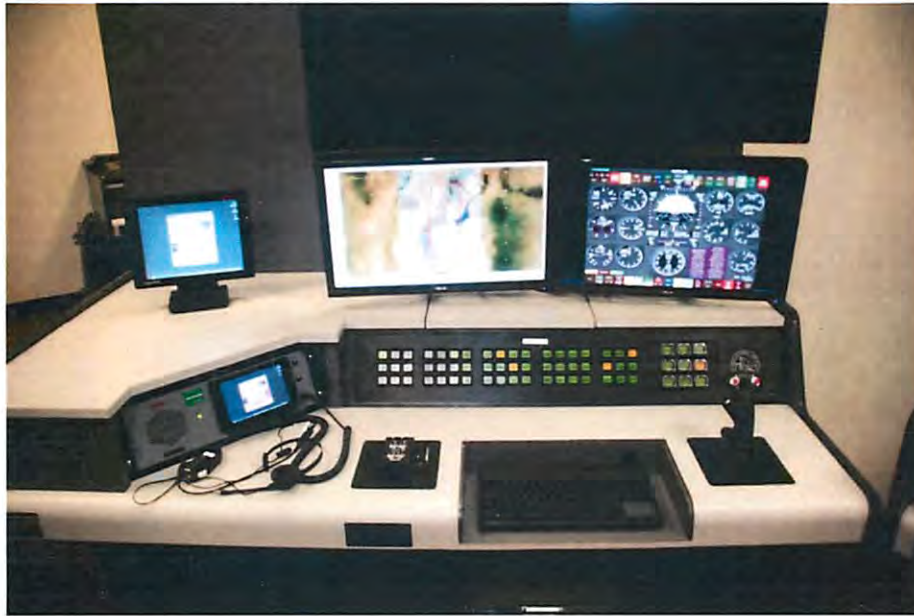
Figure 2: WITS Operating Console (Tab Z-1.1)

Tab V-2.2). However, when the MC crosschecked the flight instruments on the WITS Operating Console right screen the wings appeared level (Figure 2; Tab N-7; Tab V-1.3 through Tab V-1.5; Tab V-2.1 through Tab V-2.2). Additionally, the Mishap Mission Coordinator (MMC) concluded the attitude indicator froze periodically for no more than 2/10 of a second during the mishap sequence (Tab V-2.3).

The MC correctly identified a discrepancy between the information received from the CP's radio calls, the moving map display and the aircraft instruments, and determined a problem existed (Tab N-7; Tab V-1.4; Tab AA-1.8; Tab AA-1.13 through Tab AA-1.14). Therefore, the MC determined that he needed to take manual control of the MA, turn the MA back towards the WSMR, and troubleshoot the missed landing approach (Tab V-1.4; Tab V-1.6). At 16:07:17Z the MC switched the MA into manual control (Figure 3; Tab V-1.4; Tab AA-1.15; Tab AA-3.2). Personnel in the control room watching a live video feed of the MA began verbally reacting to the MA's pitch oscillations (Figure 1; Tab S-9; Tab V-1.4; Tab V-3.2; Tab EE-1.6 through Tab EE-1.11). The MC did not watch the video feed of the MA because it provided a delayed feed of the actual performance of the MA (Tab V-1.4). However, the Mishap Mission Coordinator (MMC) who was responsible for monitoring both the WITS Operating Console and the video feed, identified the MA's pitch oscillations and directed the MC to select Automatic Takeoff (ATO) (Tab S-9; Tab V-1.4; Tab V-2.2).

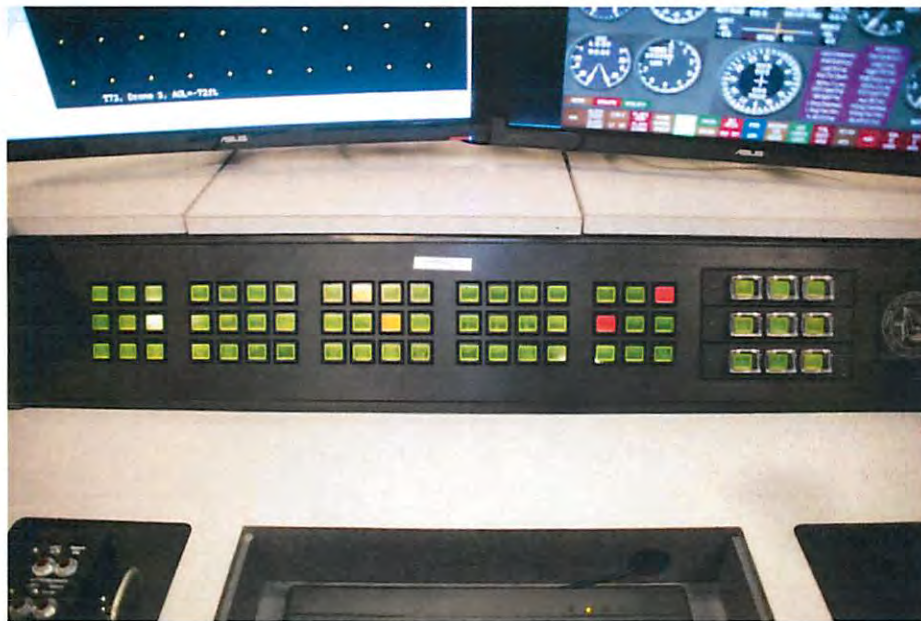
Figure 4: WITS Flight Instrument Display (Tab Z-1.2)

The MA position, control and performance data were displayed on two controller screens (Figure 4; Tab Z-1.2 through Tab Z-1.3; Tab AA-1.6 through Tab AA-1.12). The left display showed an overhead view of the MA's position on a map; the right display showed an attitude director indicator, compass, and various control and performance parameters (Figure 4; Tab Z-1.3; Tab AA-1.12). The right display provided information to the MC that replicated what the MC would see if the MC was in the MA cockpit (Figure 4; Tab V-1.8; Tab Z-1.3).
