Appendix B

CRASH SITE AND DAMAGES

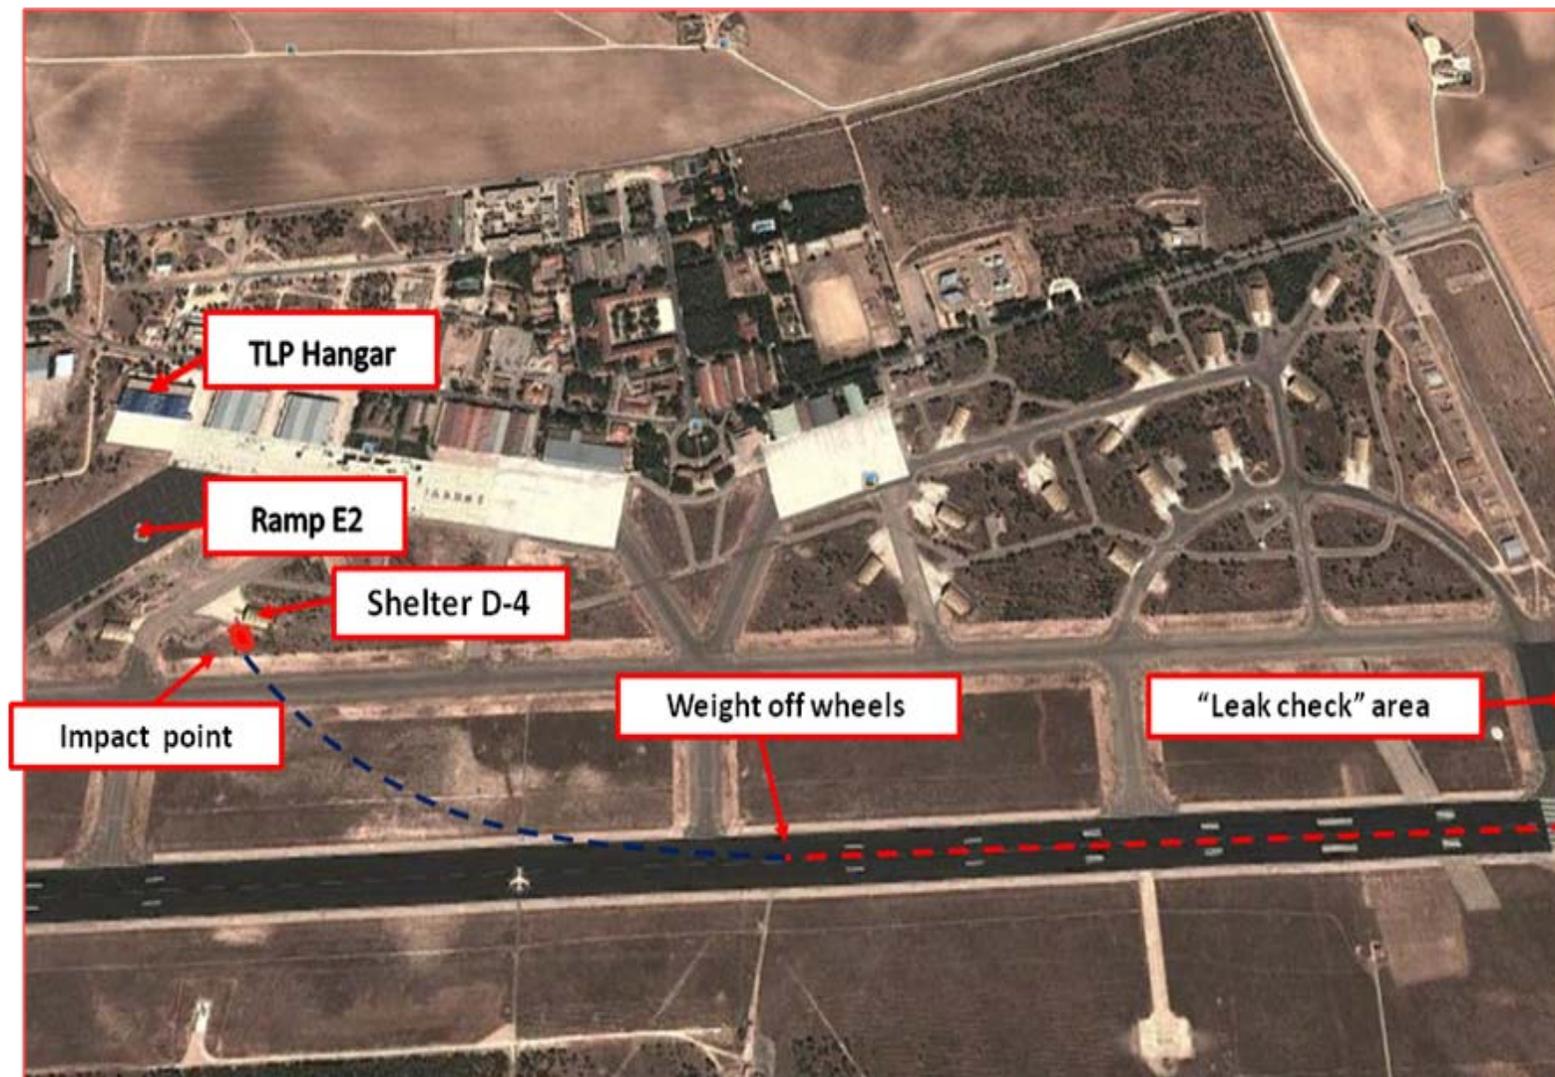
Picture B-1.: View of the Albacete AFB with the main runway, facilities and the MA trajectory (approximate). With red line is the MA trajectory before it becomes airborne and with blue afterwards
