**UNITED STATES AIR FORCE**  
**AIRCRAFT ACCIDENT INVESTIGATION**  
**BOARD REPORT**

**UH-1N, T/N 69-6603**

**512TH RESCUE SQUADRON**  
**58TH SPECIAL OPERATIONS WING**  
**KIRTLAND AIR FORCE BASE, NEW MEXICO**

**DATE OF ACCIDENT: 27 APRIL 2011**

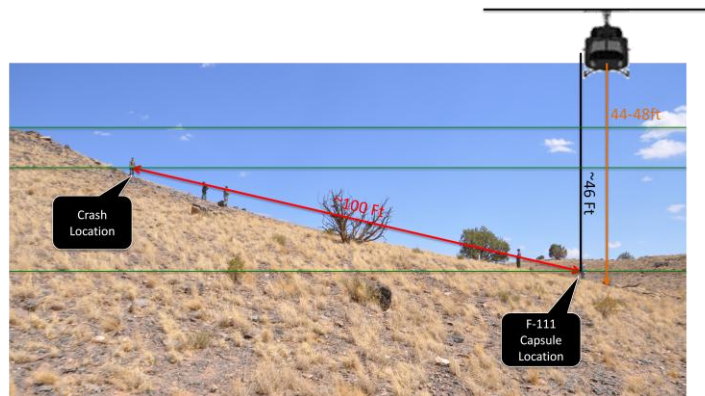
**Figure 8. Approximate Mishap Terrain Vertical Reference**

The MA turned to a northeastern heading, positioning itself into a direct crosswind from the northwest. At that point, the forest penetrator ripped free from the F-111 capsule. The MA departed from its radial path and slid left and forward towards the rising terrain. (Tabs V-10.15 through V-10.17) Just prior to impact, MP1 returned to mirroring the flight controls. (Tab V-10.18) Both MP1 and MP2 realized that they could not recover the MA and applied aft cyclic to level the skids with the rising terrain. (Tabs V-8.2, V-10.19) Approximately 3 to 5 seconds passed between the cable snagging and the MA impacting the terrain. (Tabs V-8.23, V-9.24, V-10.20) The cable was sheared by the hoist cable cut mechanism close to impact. (Tab J-45)

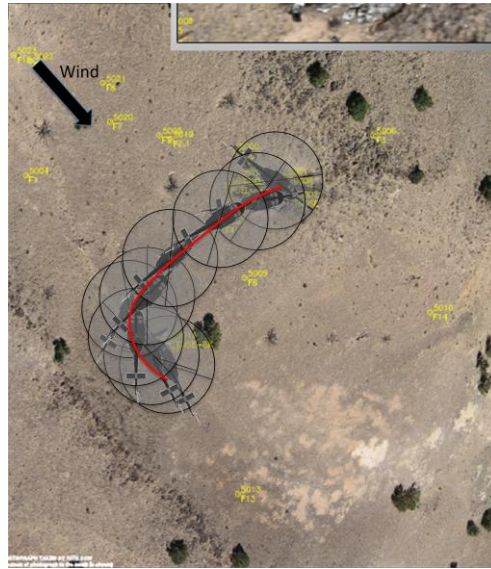
**Figure 9. Approximate MA Flight Path**

The MA impacted at approximately 1115L at 34° 45' 24.8N / 107° 0' 19.9W and an elevation of 5392 feet MSL. (Tabs J-39, S-6) The MA impacted approximately 100 feet northeast and uphill of the F-111 capsule. (Tab J-50) The MA came to rest on a westward facing slope 20 feet below the peak of the hill. (Tab J-39) The forest penetrator lay approximately 35 feet to the west and downhill of the MA and was attached to 39 feet of cable that terminated near the MA. (Tab J-50) The final heading of the aircraft was 120 degrees magnetic. (Tab J-40)
