AIRCRAFT ACCIDENT INVESTIGATION
BOARD REPORT

F-16C+, S/N 87-0242

**176TH FIGHTER SQUADRON
115TH FIGHTER WING
TRUAX FIELD, WISCONSIN**

DATE OF ACCIDENT: 7 JUNE 2011

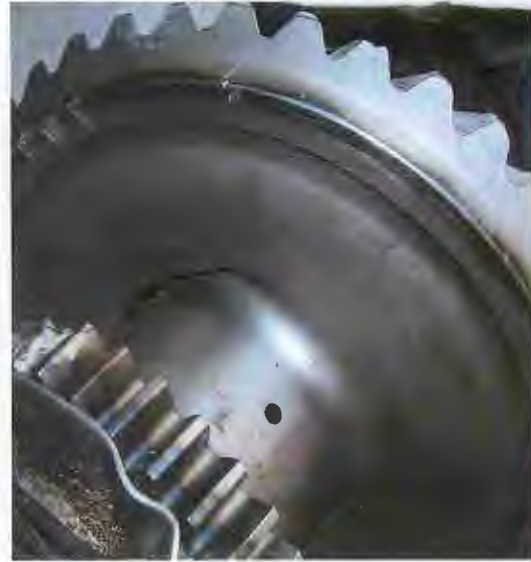
Figure 8: PTO Shaft Bevel Gear

Post-mishap analysis was performed by General Electric Aviation and Tinker OC-ALC Engineers (Tab J-23). The recovered parts were analyzed at the 115th JEIM shop (Tab J-3). Engineering analysis determined that the PTO shaft forward ball bearings were reduced in size allowing PTO shaft movement (Tab J-82). The PTO shaft movement ultimately resulted in disengagement of the mating bevels gears (Figure 7) within the AGB (Tab J-16).

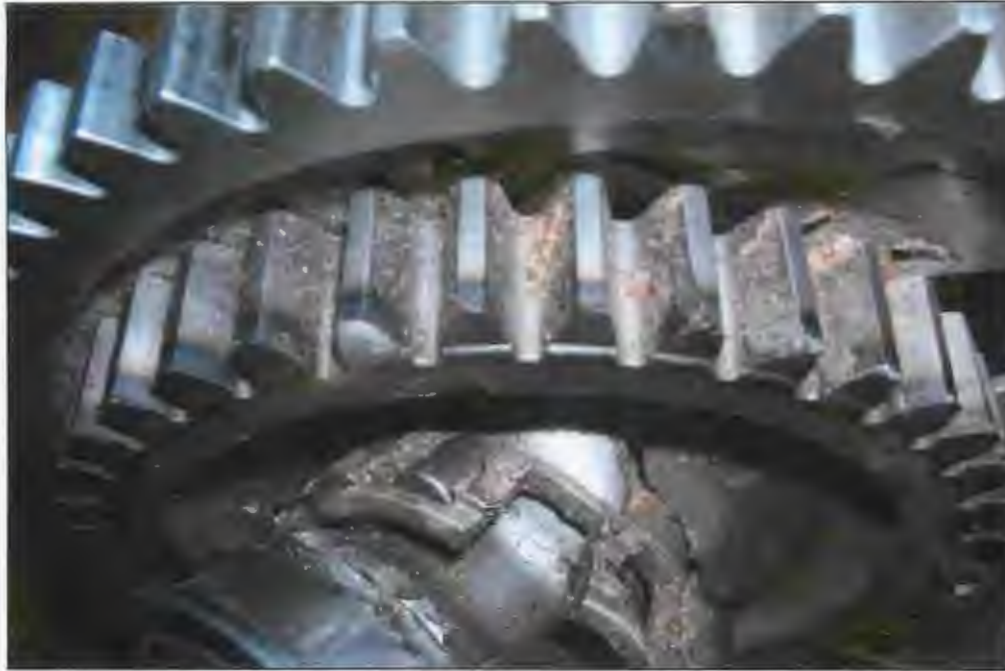
Figure 12: PTO Spur Gear Teeth (Tab J-18)

The PTO shaft bevel gear (Figure 13) had damage to the top lands of the gear teeth, described as a jagged finish and notable material missing that increases at the center of the teeth (Tab J-15). The forward bevel gear had heat discoloration from contact with the 37-tooth spur gear (Tab J-17). The forward half of the spur gear teeth also showed heat damage (Figure 12) (Tab J-17). The PTO Spur Gear teeth also had a groove worn into the forward face (Tab J-17). The PTO

shaft bevel gear damage was consistent with improper alignment of the PTO shaft during engine operation prior to impact (Tab J-18).

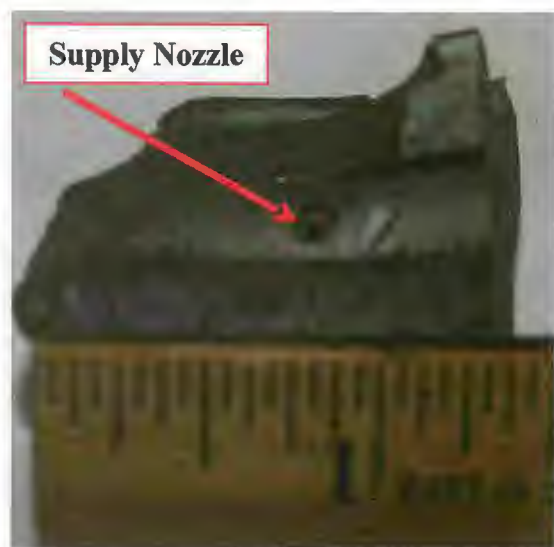
Figure 20: Teflon[®] at Nozzle (Tab Z-6)

As illustrated in Figure 19, the recovered Teflon[®] debris is small enough to travel freely through the 100 millimeter diameter oil supply line. However, the Teflon[®] debris was unable to exit through the 36 millimeter diameter oil supply nozzle as show in figure 20. The Teflon[®] debris is of unknown origin. Engineers testified that the Teflon[®] debris in combination with glass-bead media would be sufficient to clog the oil supply line (Tab V-8.4)
