**UNITED STATES AIR FORCE**  
**AIRCRAFT ACCIDENT INVESTIGATION**  
**BOARD REPORT**

**M-28, T/N 08-0319**

**318th Special Operations Squadron  
27th Special Operations Wing  
Cannon Air Force Base, New Mexico**

**DATE OF ACCIDENT: 18 DECEMBER 2011**

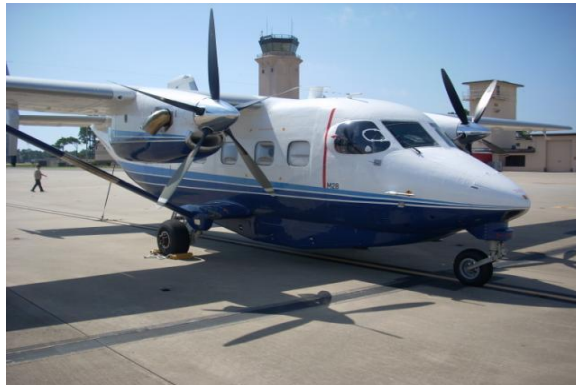
#### (1) Fuselage

The MA fuselage received significant structural damage to the bottom forward section during the mishap. It also sustained damage to the top and sides of the fuselage during the mishap. It received additional damage during the process of being prepped for shipment which included moving the MA to a safer distance from the mishap landing zone, flipping it over to the upright position, and cutting away the wings, nacelles, and empennage.

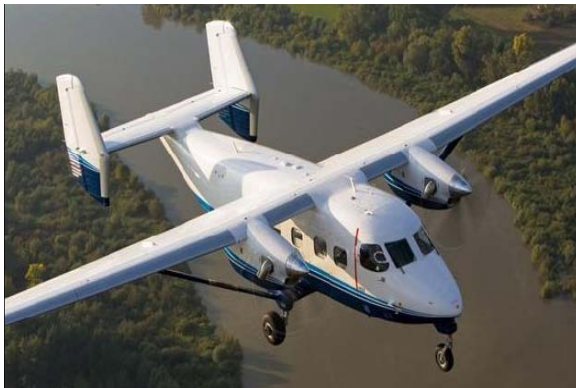
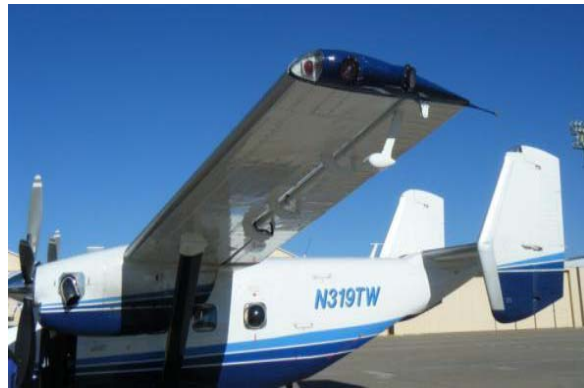
## (2) Wing

The right outboard wing and center wing sustained significant structural damage during the mishap. The left outboard wing sustained damage to its outer surface and flight control surfaces during the mishap. Additional damage was sustained during the process of prepping the aircraft for shipment. This included moving the MA to a safer distance from the mishap landing zone, flipping it over to the upright position, and cutting the wings away from the fuselage. It also included cutting the wings into smaller sections for shipment.

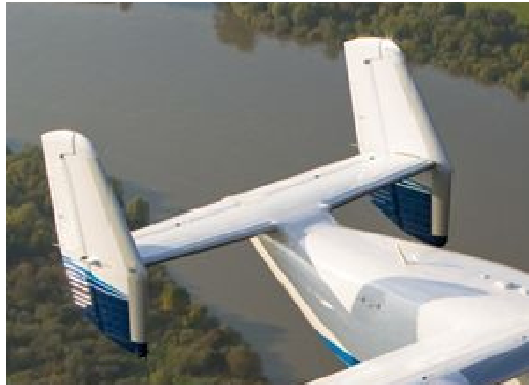
### (3) Empennage

The empennage sustained damage to the vertical fins during the mishap. Additional damage was sustained during the process of prepping the aircraft for shipment. This included moving the MA to a safer distance from the mishap landing zone, flipping it over to the upright position, and cutting the empennage away from the fuselage. It also included cutting the empennage into smaller sections for shipment.

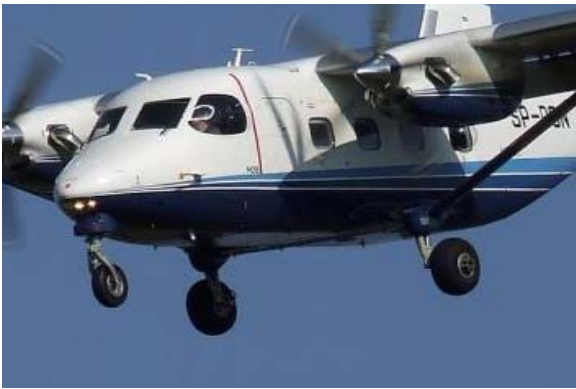
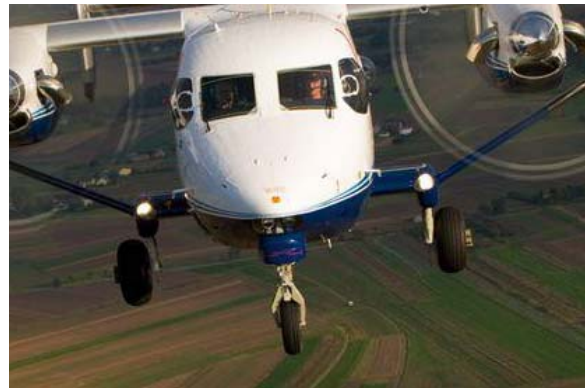
#### (4) Landing Gear

The nose wheel landing gear structural support collapsed during the mishap allowing the nose wheel landing gear to collapse into the bottom forward fuselage. The main landing gear fairings sustained damage when the outboard wing supports were cut away in preparation for shipment.

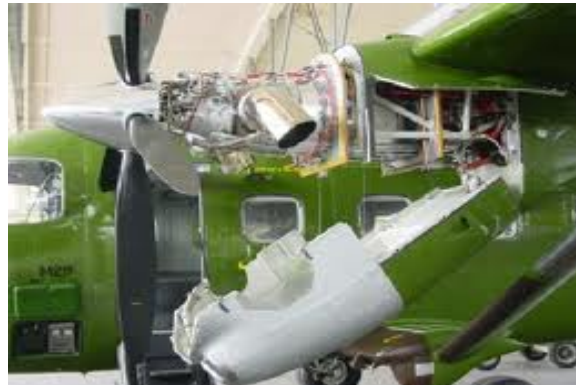
### **(5) Power Plant**

A detailed 90-day review of records and forms revealed a recurring discrepancy with the power plant propeller system which contributed to the mishap (Tabs D-5, D-8-9, U-49, U-241-243, V-1.9-1.10, V1.19, V-1.23, V-2.4, V-2.10, V-3.4, V-3.9-3.13, V-4.3, V-4.6, V-4.9, V-5.3-5.12, V-6.3-6.9, V-7.6-7.8, V-8.3-8.14, V-9.3-9.4, V-12.3-12.8, EE-7-16).

An analysis of the FDR data during landing indicates the presence of asymmetric thrust pushing the aircraft to the right. At touchdown, the aircraft was producing forward thrust from the left-hand engine and within one second of touchdown was producing reverse thrust from the right-hand engine, which caused the aircraft to veer to the right (Tabs BB-39, DD-405-419, FF-32-33, V-1.9).

The Flight Data Recorder (FDR) data for Left Hand Engine Torque (TQLH) and Right Hand Engine Torque (TQRH) indicates that both subject engines, PCE-PP0118 and PCE-PP0138, experienced over torque conditions during the mishap sortie per the PZL M28 AFM, Paragraph 2.7.2. (Tabs BB-33-35, DD-3-58, EE-7-15, V-16.1).

The right engine nacelle and both left and right propeller systems sustained damage during the mishap. Both the left and right engine nacelles and propeller systems sustained additional damage during the process of prepping the aircraft for shipment. This included moving the MA to a safer distance from the mishap landing zone, flipping it over to the upright position, and cutting the nacelles away from the wings. It also included cutting the individual propellers away from the propeller hubs.
