**UNITED STATES AIR FORCE**  
**AIRCRAFT ACCIDENT INVESTIGATION**  
**BOARD REPORT**

**F-16CM, T/N 88-0510**

**31ST FIGHTER WING  
AVIANO AIR BASE, ITALY**

**DATE OF ACCIDENT: 28 JANUARY 2013**

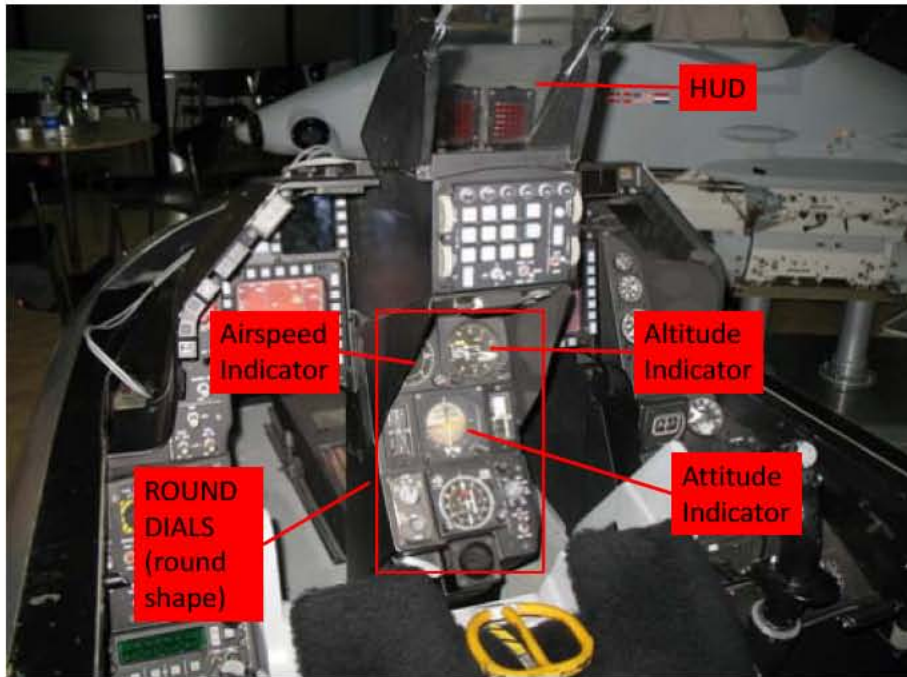
**Figure 2**  
**"Round Dials" (Tab Z-3)**

“Knock it off” procedures are used to direct aircraft or aircrew to stop engagements, scenarios and tactical maneuvering. “I’m spatial D” meant that the MP recognized that he was spatially disoriented. Spatial disorientation is a failure to correctly sense a position, motion, or attitude of the aircraft or of oneself within the fixed coordinate system provided by the surface of the earth and the gravitational vertical (Tab BB-32). Three seconds later at 19:49:16L, the MW directed the MP to transition to primary recovery instruments by communicating “Look at the round dials, disregard the HUD” (Tab N-17). The round dials are the primary attitude, altitude, and airspeed indicators used in unusual attitude recovery, and the HUD is the head-up display (Figure 2 and Tab BB-55).

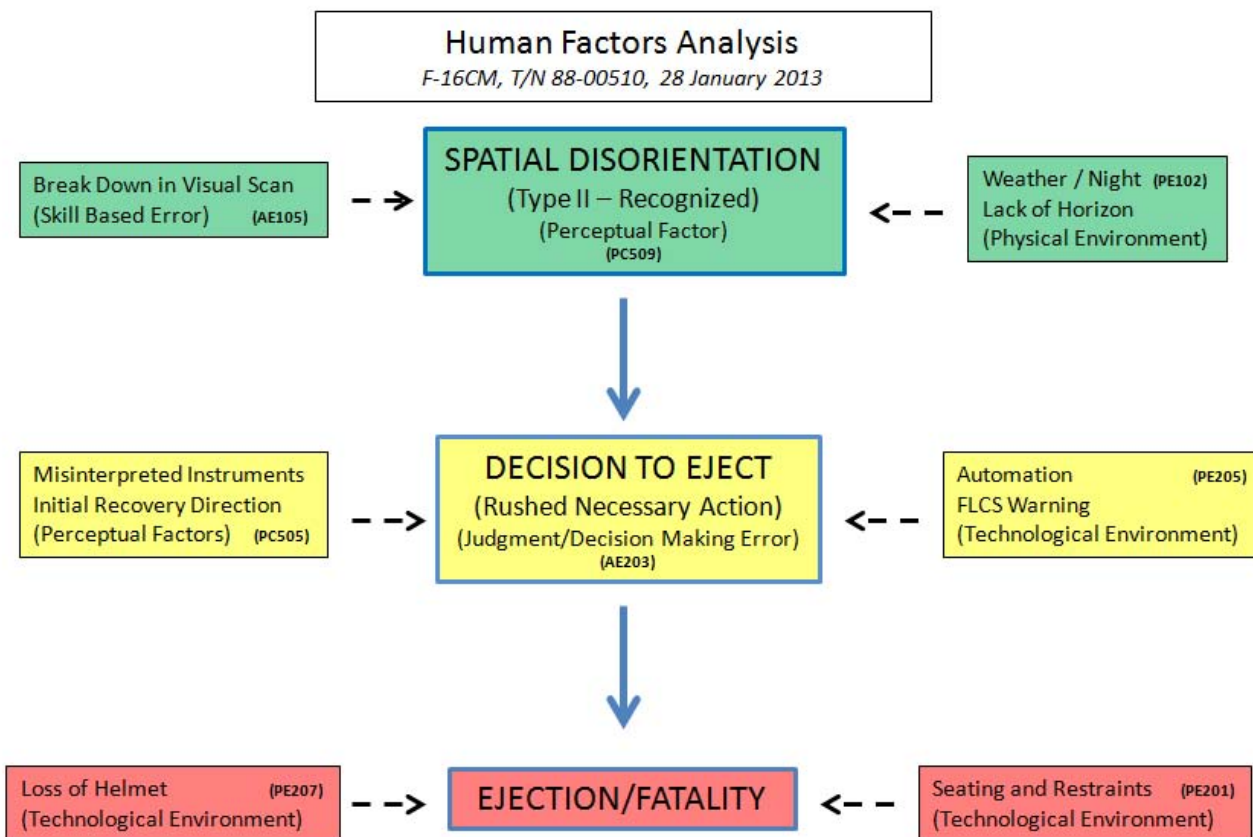
The human factors analysis is broken down into three phases in order to assist understanding of the mishap sequence. (See Chart, below.) Phase I consists of analysis of why the MP may have become spatially disoriented. Phase II examines why the MP may have chosen to eject from the MA. Phase III examines what factors around the ejection sequence may have contributed to the MP's cause of death. In particular, Phase III examines the interaction between the MP and the safety equipment designed to prevent injury during the ejection sequence.

\* Chart prepared by AIB members, derived from factors described in AFI 91-204, *Safety Investigations and Reports*.

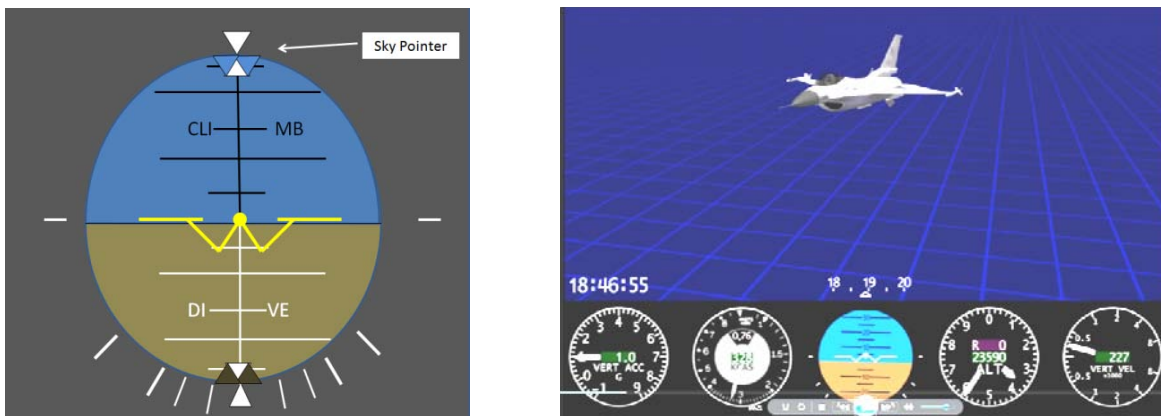
**Figure 11. Straight and level flight. Tab Z-8**

The F-16 Attitude Direction Indicator (ADI) is the primary flight instrument giving the pilot artificial awareness of the horizon and was the primary instrument to which the MW was referring when he instructed the MP “to get on the round dials” (Tab N-17). Note that in the aircraft, the ground is indicated by the color brown and the sky is indicated by the color blue. The horizon line between the brown and blue fields is a strong cue to the horizon and gives an excellent indication of how far the horizon is from the nose of the aircraft (indicated by the dot in the middle of the yellow W symbol) (Tab DD-146). The ADI is depicted below for level flight (Figure 11).

If the aircraft is more than 25 degrees nose low, there is no evidence of blue and the primary horizon line is not viewable in the ADI (see figures 12 and 14). This situation leaves the sky pointer as the primary cue to the nearest horizon. The sky pointer is always visible and is indicated by the white triangle pointing at the blue field behind it (see, AFMAN 11-217, Volume 1, *Instrument Flight Procedures*, 22 Oct 2010, para. 2.5.3.3).
