UNITED STATES AIR FORCE
AIRCRAFT ACCIDENT INVESTIGATION
BOARD REPORT

B-1B, Tail Number 85-0091
34TH BOMB SQUADRON
28TH BOMB WING
ELLSWORTH AIR FORCE BASE

LOCATION: BROADUS, MONTANA
DATE OF ACCIDENT: 19 AUGUST 2013
BOARD PRESIDENT: COLONEL BRIAN A. HUMPHREY
CONDUCTED IN ACCORDANCE WITH AIR FORCE INSTRUCTION 51-503

SUMMARY OF FACTS AND STATEMENT OF OPINION
B-1B, Tail Number 85-0091
19 AUGUST 2013

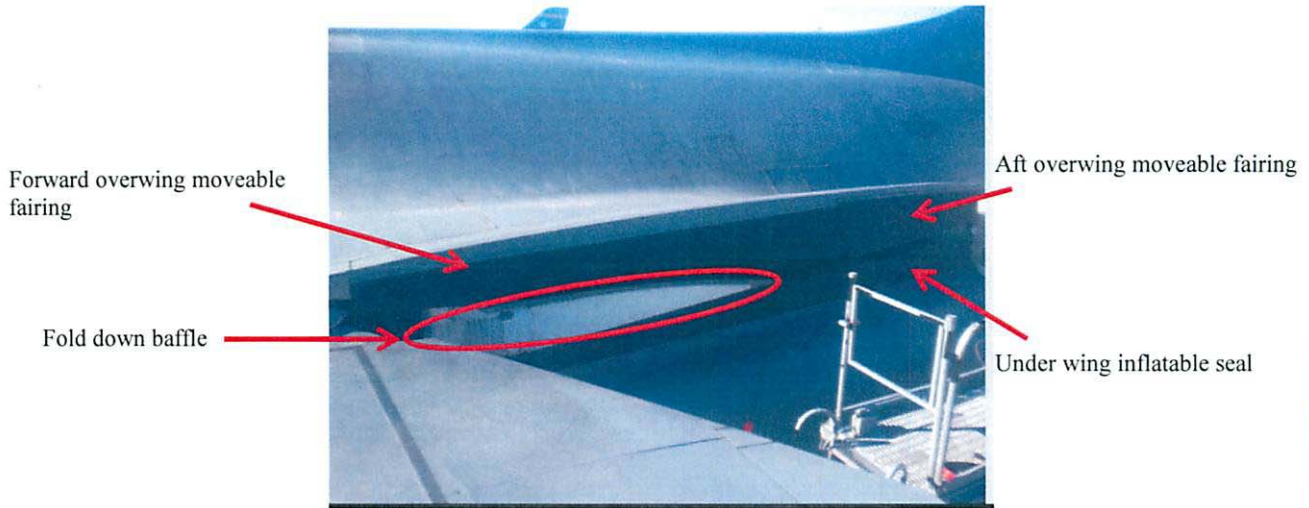
Figure 2. Side View of Left Overwing Fairing (Wing Forward).

The lower seal is attached to left and right nacelle, which contain the engines, auxiliary power units, hydraulic pumps, accessory drive gearboxes, and other aircraft systems (T.O. 1B-1B-2-53GS-00-1). It seals the bottom surface of the wing when the wings are swept back (T.O. 1B-1B-2-53GS-00-1). When the wings are swept forward, the seal and the underwing fold down baffle form the underwing fairing, working together to seal the cavity above the nacelle (T.O. 1B-1B-2-53GS-00-1 and T.O. 1B-1B-2-54GS-00-1). The fold down baffle, which is manufactured by the Boeing Company, is broad at the front and tapers to an acute, v-shaped angle at the aft end (see Figure 2) (Tab U-24 to U-25). Two mandrel spring assemblies, also manufactured by the Boeing Company, provide positive pressure against the fold down baffle to keep the seal in place (Tab U-23 and U-25; T.O. 1B-1B-2-54GS-00-1).

During aft wing sweep, only the wing and the fold down baffle move inward into the overwing cavity (see Diagram 1). The overwing fairings house the 4.5-inch main fuel line, the 2-inch fuel cooling loop line, the fuel cooling blower, the overwing fairing fire detection loops, multiple aircraft wire harnesses, and hydraulic lines (Tabs J-38 to J-39 and J-47 to J-49; T.O. 1B-1B-2-27GS-00-1).

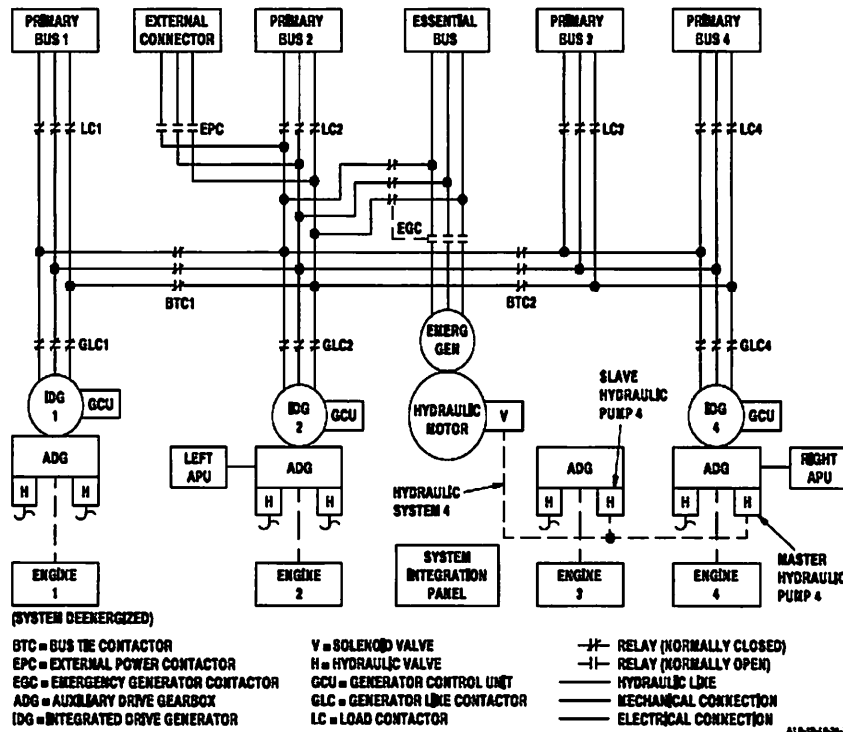
Diagram 2. AC Power Generation (T.O. 1B-1B-1).

After MP1 initiated procedures to address the fires in the left overwing fairing, Engine 1, and Engine 2, the number one and number two AC generators were rendered inoperative, leaving the MA to rely on the number four and emergency AC generators (Tabs J-67, V-3.8, V-3.12, and V-3.18; T.O. 1B-1B-1 and T.O. 1B-1B-2-24GS-00-1). The rupturing of the MA’s fuel tanks resulted in the severing of the electrical cables running through the tops of the fuel tanks, causing a complete and permanent loss of electrical power in the crew compartment (Tabs V-1.8 to V-1.9, V-2.7, V-3.9, V-3.13, V-4.11, and FF-7; T.O. 1B-1B-2-24GS-00-1). The loss of electrical power degraded MP2’s ability to control the MA (Tabs V-2.9, V-3.8 to V-3.9, and FF-3; T.O. 1B-1B-1 and T.O. 1B-1B-2-24GS-00-1).
