UNITED STATES AIR FORCE
AIRCRAFT ACCIDENT INVESTIGATION
BOARD REPORT

RC-135V, T/N 64-14848

LOCATION: OFFUTT AIR FORCE BASE, NEBRASKA

DATE OF ACCIDENT: 30 APRIL 2015

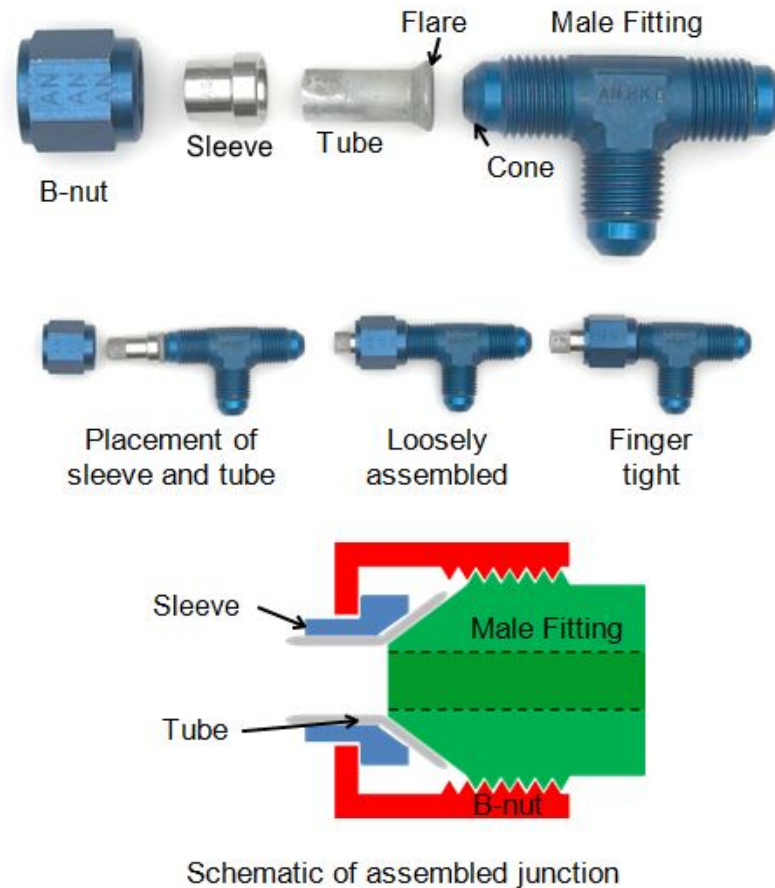
Figure 5. Oxygen System Fittings (Tab J-28).

Fittings used in the oxygen system are shown in Figure 5. The T-shaped fittings may be replaced by elbow-shaped fittings as needed (Tab J-29). These fittings are commonly referred to as “AN” fittings because each fitting has a specification that begins with “AN” (Tabs J-8, J-28). These fittings consist of four components; a male threaded end, a female nut (referred to as a B-nut), a sleeve, and a flared tube. A schematic of the system shown in Figure 5 indicates that contact between the inside of the flared tube and the male fitting cone constitutes the sealing surface of the fitting (Tab J-28). The B-nut itself does not provide sealing force to the fitting (Tab J-28). When properly tightened, the B-nut and sleeve provide clamping force to the sealing surface between the flared tube and the male fitting cone (Tab J-28).

Tightening (or torquing) “AN” fittings to the proper specification requires initial torquing, leak checking and final torquing (Tab U-2.15). Initial torquing is a two-step process which involves hand tightening the B-nut (in accordance with the schematic in Figure 5) to ensure proper alignment and a firm seal between the male cone fitting and the flared tube, and then torquing the B-nut using a torque wrench to an initial minimum torque value (Tabs U-2.15, V-11.1). The initial minimum torque value for 5/16 inch aluminum tubing used in the MA is 100 inch-pounds (in-lbs) (Tabs U-2.16, J-9, J-30). Leak checking involves pressurizing the oxygen system to operational specifications while examining all fittings and connections using a leak test compound (Tab U-2.17). Final torquing is required if any leaks occur and involves increasing the torque value as necessary to stop the leak, up to a maximum specified torque value (Tab U-2.15). The maximum torque value for 5/16 inch aluminum tubing used in the MA is 125 in-lbs (Tabs U-2.16, J-9, J-30). Replacement or repair is necessary if leakage cannot be stopped at the maximum torque value (Tab U-2.15).
