UNITED STATES AIR FORCE
AIRCRAFT ACCIDENT INVESTIGATION
BOARD REPORT

F-16C T/N 87-0306
121ST FIGHTER SQUADRON
113TH WING
JOINT BASE ANDREWS, MARYLAND

LOCATION: CLINTON, MD
DATE OF ACCIDENT: 5 APRIL 2017
BOARD PRESIDENT: COLONEL DAVID V. COCHRAN
Conducted IAW Air Force Instruction 51-503

SUMMARY OF FACTS AND STATEMENT OF OPINION
F-16C, T/N 87-0306
5 APRIL 2017

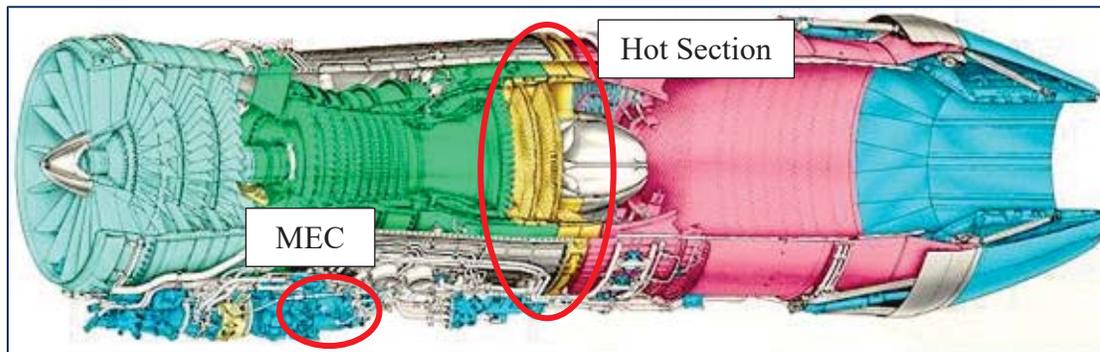
Figure 5: F110-GE-100C Engine Cross Section Overview (Tab J-6)

The MA was destroyed on impact (Tab J-34). Due to the steep impact angle, the radome, cockpit, and forward fuselage sections of the aircraft folded beneath the engine and aft fuselage (Tab J-35). The right wing was in two pieces and the left wing was mostly intact (Tab J-5). The aft fuselage, vertical tail, left horizontal stabilizer and the engine (Figure 5) were in one piece (Tab J-5).

The engine remained relatively intact with exception of the front frame, which sheared off along with most of the struts (Tab J-7). The controls and accessories were still attached to the gearbox, with the exception of the hydraulic pump (Tab J-8). The fuel boost pump and augments fuel pump were badly damaged and sheared from the gearbox, but remained attached to the engine via tubing (Tab J-8). The MDEC also remained attached to the lower fan duct with one mount bolt and tubing holding it in place (Tab J-8). The MEC and main fuel pump remained mounted to the gearbox housing with the v-band clamp still secured (Tab J-8). The MDEC, MEC, and main fuel pump had relatively minor structural damage, as seen in Figure 6 and Figure 7 (Tab J-8).
