UNITED STATES AIR FORCE
AIRCRAFT ACCIDENT INVESTIGATION
BOARD REPORT

F-35A, T/N 12-5052

LOCATION: MOUNTAIN HOME AIR FORCE BASE,
IDAHO

DATE OF ACCIDENT: 23 SEPTEMBER 2016

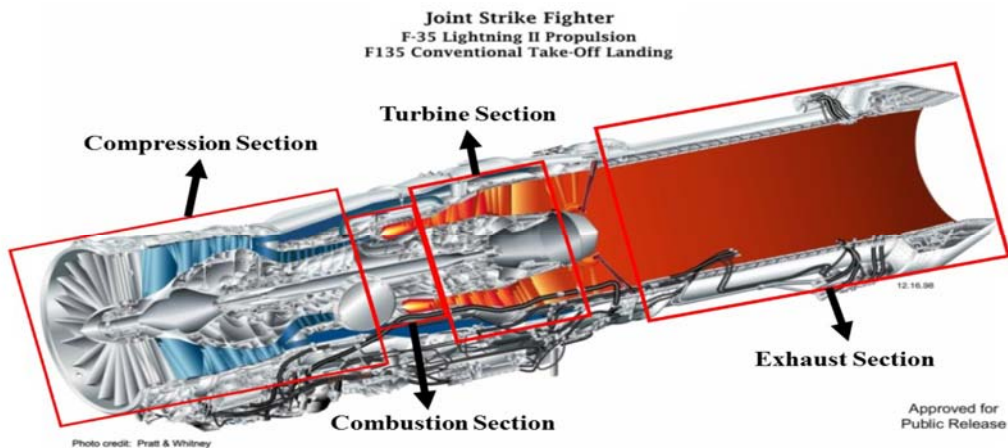
Fig 12. Engine Cutout Diagram (Tab Z-7)

The F135 engine, developed by Pratt & Whitney, is a two spool, axial flow engine which provides up to 43,000 pounds of thrust. It contains compressor, combustion, turbine, and exhaust sections, similar to other jet engines (See Fig-12). The F135 engine initially is rotated by the ES/G during a normal start sequence. Once the ES/G accelerates the engine to a certain speed, fuel and ignition are provided to begin combustion. The ES/G and combustion then combine to accelerate the engine to increased speeds. When the engine reaches a speed at which it can sustain rotation by combustion alone, the ES/G stops providing rotation assistance. (Tab EE-5).
