**UNITED STATES AIR FORCE  
AIRCRAFT ACCIDENT INVESTIGATION  
BOARD REPORT**

**KC-10A, T/N 83-0080  
9TH AIR REFUELING SQUADRON  
60TH AIR MOBILITY WING  
TRAVIS AIR FORCE BASE, CALIFORNIA**

**LOCATION: NEAR MOUNTAIN HOME AFB, IDAHO  
DATE OF ACCIDENT: 1 NOVEMBER 2016  
BOARD PRESIDENT: COL PERRY M. LONG III  
Conducted IAW Air Force Instruction 51-503**

## Class A Mishap, Near Mountain Home AFB, ID

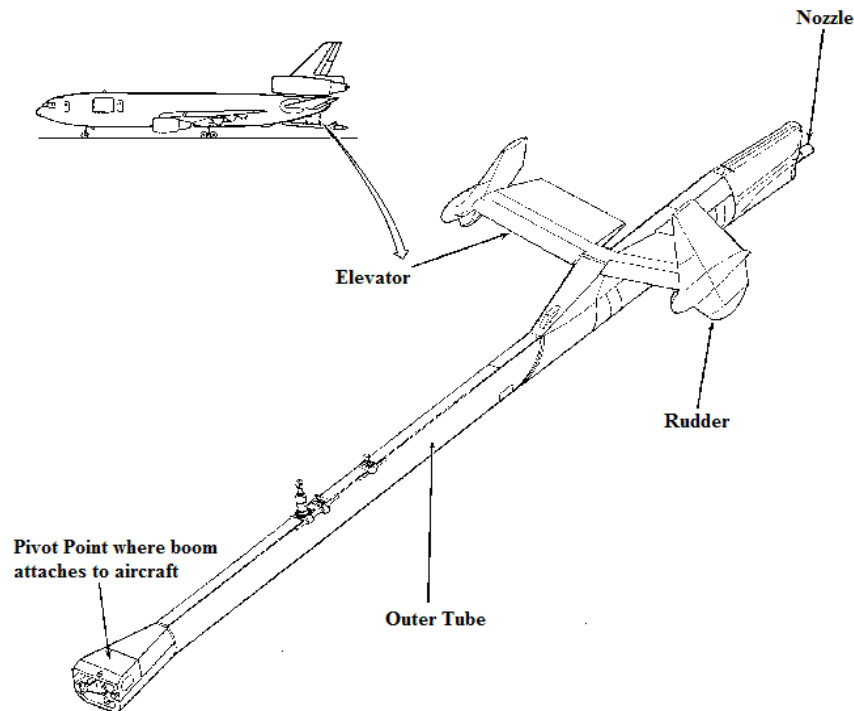
**Figure 6.1 (Tab BB-20)**

The KC-10 boom assembly (Figure 6.1) consists of a telescopic refueling boom equipped with bilateral rudders and a trailing elevator (flight control surfaces) to assist with elevation and roll control while in flight (Tab BB-17). The Boom Flight Control System is an integrated closed-loop, fly-by-wire system that utilizes a repurposed McDonnell Douglas MD-80 autopilot box called the BCU (Tabs BB-17 and EE-5). The flight control actuation system consists of the following (Figures 6.1 and 6.2):

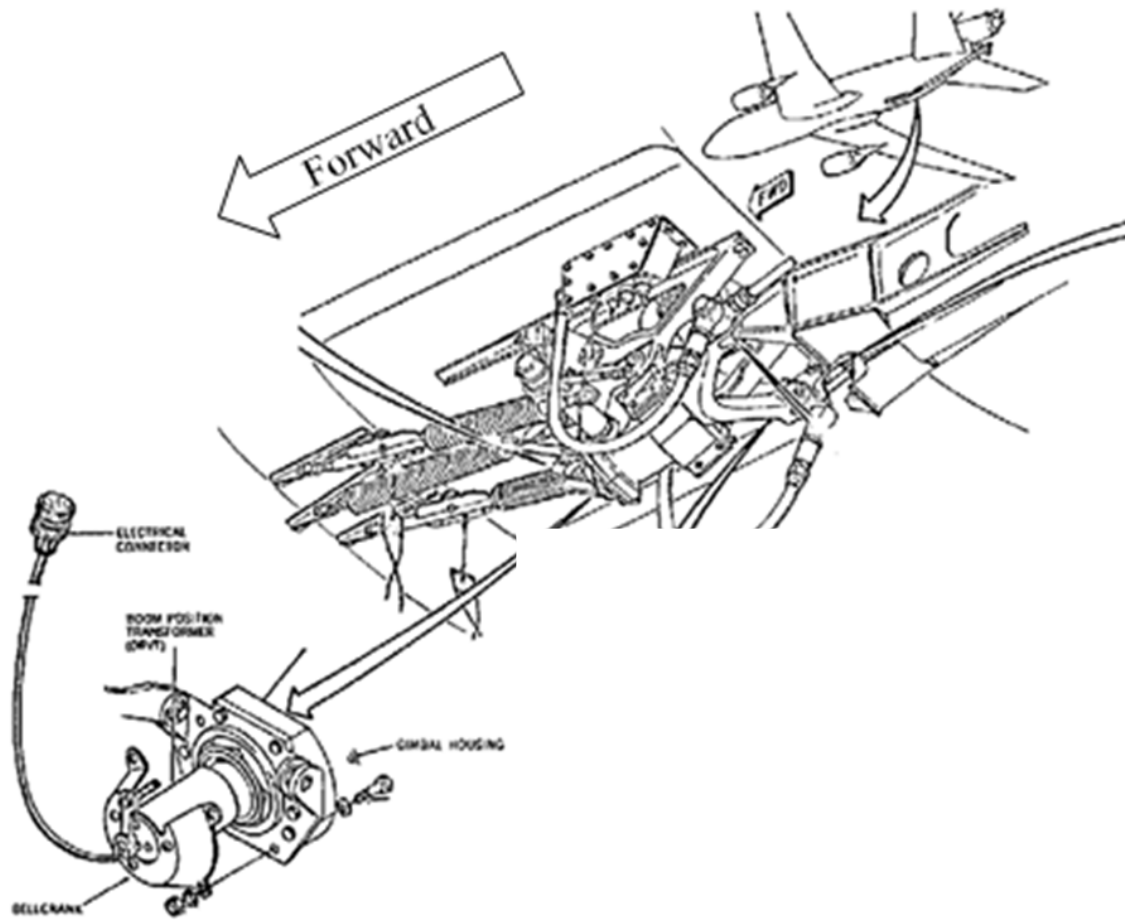
**Figure 6.2. (Tab BB-23)**

In addition to the BCA elevation and roll LVDTs, there are more sensors located on the boom gimbal and yoke assembly that continually monitor the boom's position (Figure 6.2) (Tab BB-17). A single DRVT, located in the gimbal yoke housing, senses boom roll by translating rotational movement into voltage, and sending that voltage signal to the BCU, similar to the LVDTs (Tab BB-17). The boom accelerometer, located near the end of the outer fuel tube, detects boom angular roll rates (Tab BB-17).

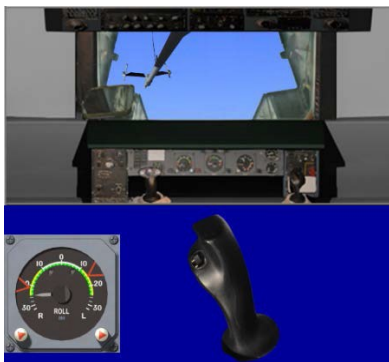
Figure 6.3 (Tab Z-6)

- Step 20 directs the boom operator to perform a flight control check, which consists of flying the boom first left and right to 25° roll, then up to 18° and down to 40° elevation (Tab BB-14). Figures 6.3 and 6.5 below depict 25° Right and Left (with respect to the aircraft) with corresponding gauge and flight control stick position (Tabs Z-6, Z-7).

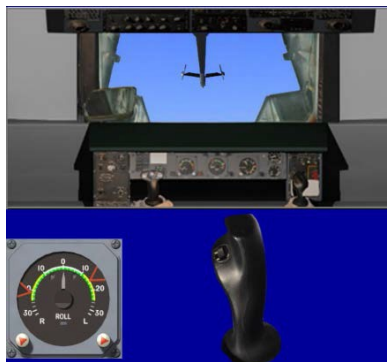
Figure 6.4 (Tab Z-5)

- A lever is moved to *Lower*, and a hydraulically controlled cable (hoist cable) lowers the boom to approximately 0° elevation (Tabs BB-3, BB-14).
  - An electronic switch (*Boom Elevation Position Switch*) is moved to the *Refuel* position, and the BCU lowers the boom to its centered position (Tab BB-14). The normal, centered position of the boom, in reference to the aircraft's fuselage, is 0° left and right and 30° down from level, depicted in Figure 6.4 (Tabs Z-5, BB-14).

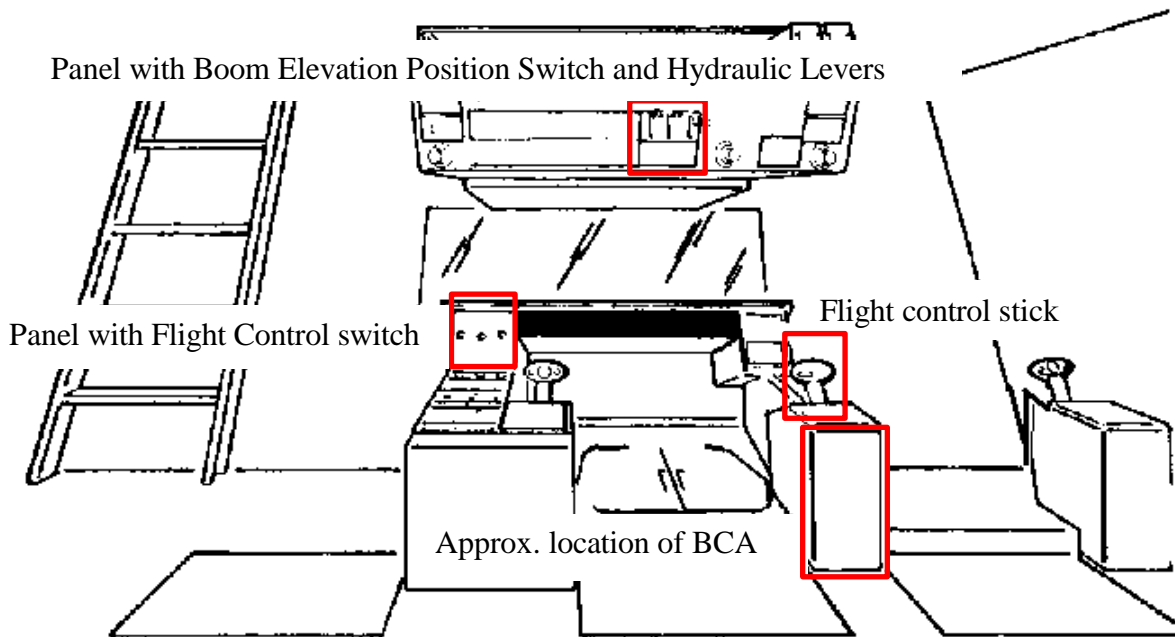
**Figure 6.6 (Tab BB-22)**

- Steps 1-11 direct the boom operator to open the sighting window and power up hydraulics to the flight controls (Tab BB-12 to BB-13). The boom operator keeps the boom in view using the boom sighting window and angled mirrors (Figure 6.6) (Tab BB-22).
