UNITED STATES AIR FORCE
AIRCRAFT ACCIDENT INVESTIGATION
BOARD REPORT

A-10C, T/N 79-0204, AND A-10C, T/N 78-0657

LOCATION: NEVADA TEST AND TRAINING RANGE 65C

DATE OF ACCIDENT: 6 SEPTEMBER 2017

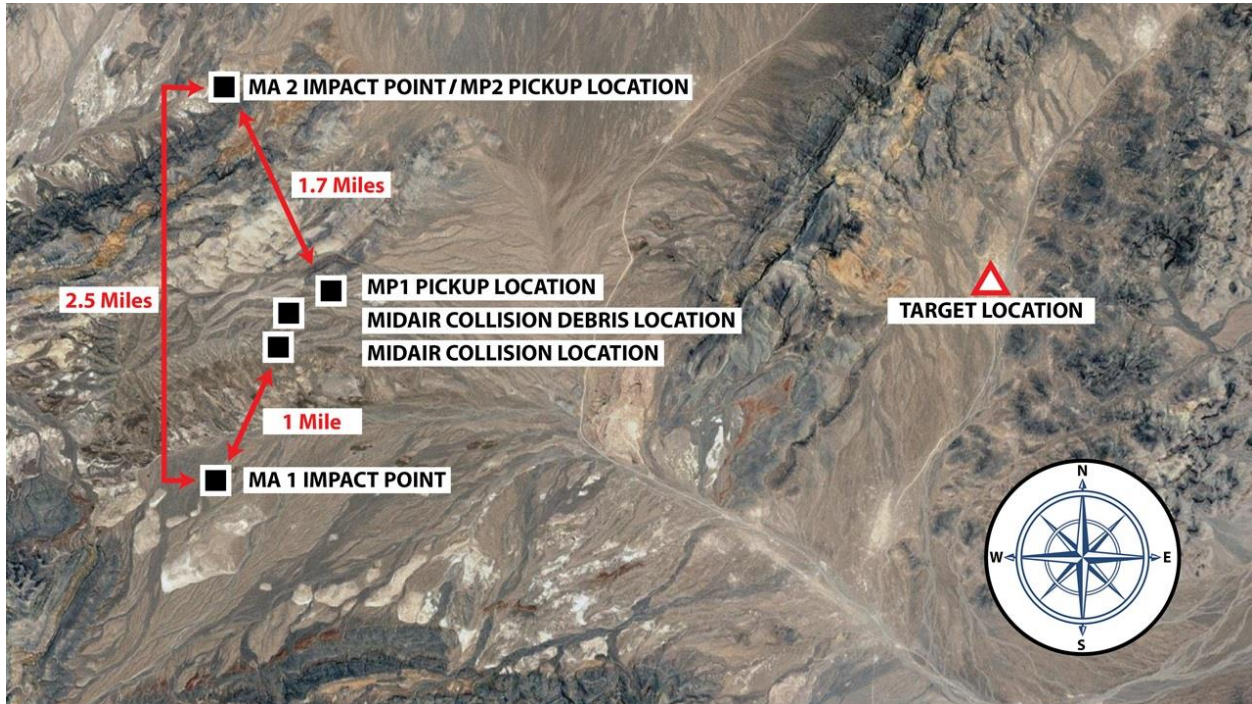
Figure 6. Map of crash and recovery sites (Tab Z-3)

Wreckage from the collision of MA1 and MA2 landed in a mixed debris field near the midair collision location (between the two crash sites) as depicted in Figure 6 (Tabs S-14, S-16, S-18, U-3 and Z-3).

MA1 crashed into the ground 1 mile southwest of the midair collision location depicted in Figures 6 and 7 (Tabs S-8, S-23, Z-3, and FF-5). Based upon an inspection of the crash site, MA1 crashed in a left-wing-low orientation (Tab S-8 to S-12). At the time of the crash, MA1 was carrying training munitions (Tab P-4 to P-5).

MA2 crashed shortly after MA1, 1.7 miles northwest of the midair collision location and 2.5 miles from the MA1 crash site as depicted in Figures 6, 8, and 9 (Tabs S-3 to S-7, S-23, V-2.20, Z-3, and FF-4). Based upon an inspection of the crash site and witness testimony, MA2 crashed while northbound in an 80 - 90 degree, nose-low orientation (Tabs S-3 to S-7, S-23, and V-2.20). At the time of the crash, MA2 was carrying training munitions (Tab P-6 to P-7).
