UNITED STATES AIR FORCE
AIRCRAFT ACCIDENT INVESTIGATION
BOARD REPORT

CV-22B OSPREY, T/N 06-0031

DATE OF ACCIDENT: 9 APRIL 2010 (L)

SUMMARY OF FACTS AND STATEMENT OF OPINION
CV-22B, T/N 06-0031 ACCIDENT
9 April 2010 (L)

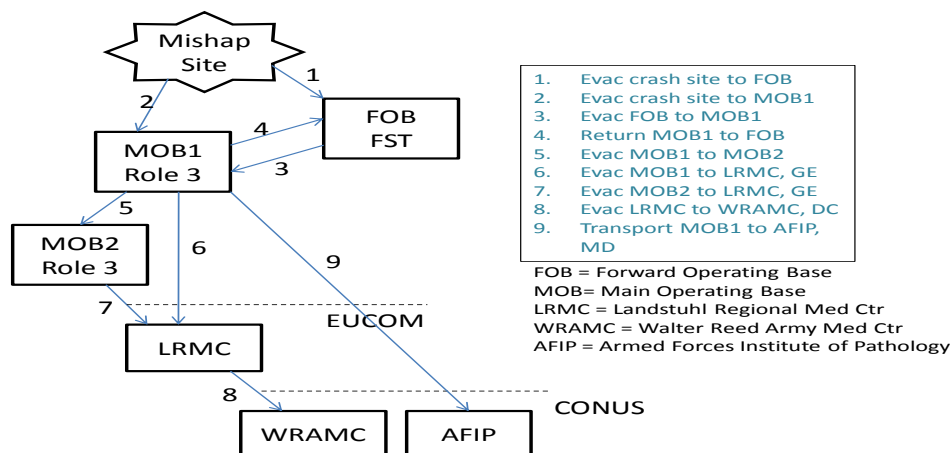
The below diagram represents the overall evacuation routings used for all of the mishap crew and passengers. (Tab X-3 thru X-4)

Individual mishap crew members and passengers were evacuated via the following routings (routing numbers correspond to the diagram above), with final dispositions noted:

Individual	WIA/KIA	ROUTING
MP	KIA	1, 3, 9 for Autopsy
MCP	WIA	2, 5, 7, 8 – CONUS
MFE	KIA	1, 3, 9 for Autopsy
MTS	WIA	1, 3, 5, 7, 8 – CONUS
CHK1A	WIA	1, 3, 4 – Returned to Duty (RTD)
CHK1B	WIA	2, 4 – RTD
CHK1C	WIA	1 – RTD
CHK1D	WIA	1 – RTD
CHK1E	WIA	2, 4 – Then returned to CONUS by unit
CHK1F	WIA	2, 6, 8 – CONUS
CHK1G	WIA	2, 5, 7, 8 – CONUS
CHK1H	WIA	1 – RTD
CHK1I	WIA	2, 4 – RTD
CHK1J	KIA	1, 3, 9 for Autopsy
CHK1K	WIA	2, 5, 7, 8 – CONUS
CHK1L	KIA	1, 3, 9 for Autopsy
CHK1M	WIA	2, 6, 8 – CONUS
CHK1N	WIA	1, 3, 6, 8 – CONUS
CHK1O	WIA	1, 3, 6, 8 – CONUS
CHK1P	WIA	2, 5, 7, 8 – CONUS
