AIRCRAFT ACCIDENT INVESTIGATION
BOARD REPORT

F-16C+, S/N 87-0242

**176TH FIGHTER SQUADRON
115TH FIGHTER WING
TRUAX FIELD, WISCONSIN**

DATE OF ACCIDENT: 7 JUNE 2011

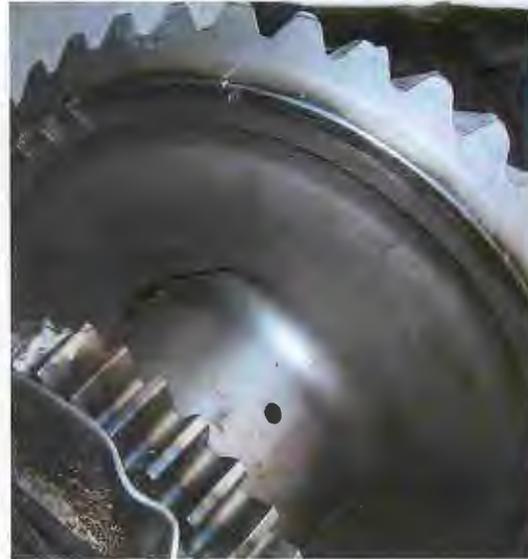
Figure 8: PTO Shaft Bevel Gear

Post-mishap analysis was performed by General Electric Aviation and Tinker OC-ALC Engineers (Tab J-23). The recovered parts were analyzed at the 115th JEIM shop (Tab J-3). Engineering analysis determined that the PTO shaft forward ball bearings were reduced in size allowing PTO shaft movement (Tab J-82). The PTO shaft movement ultimately resulted in disengagement of the mating bevels gears (Figure 7) within the AGB (Tab J-16).

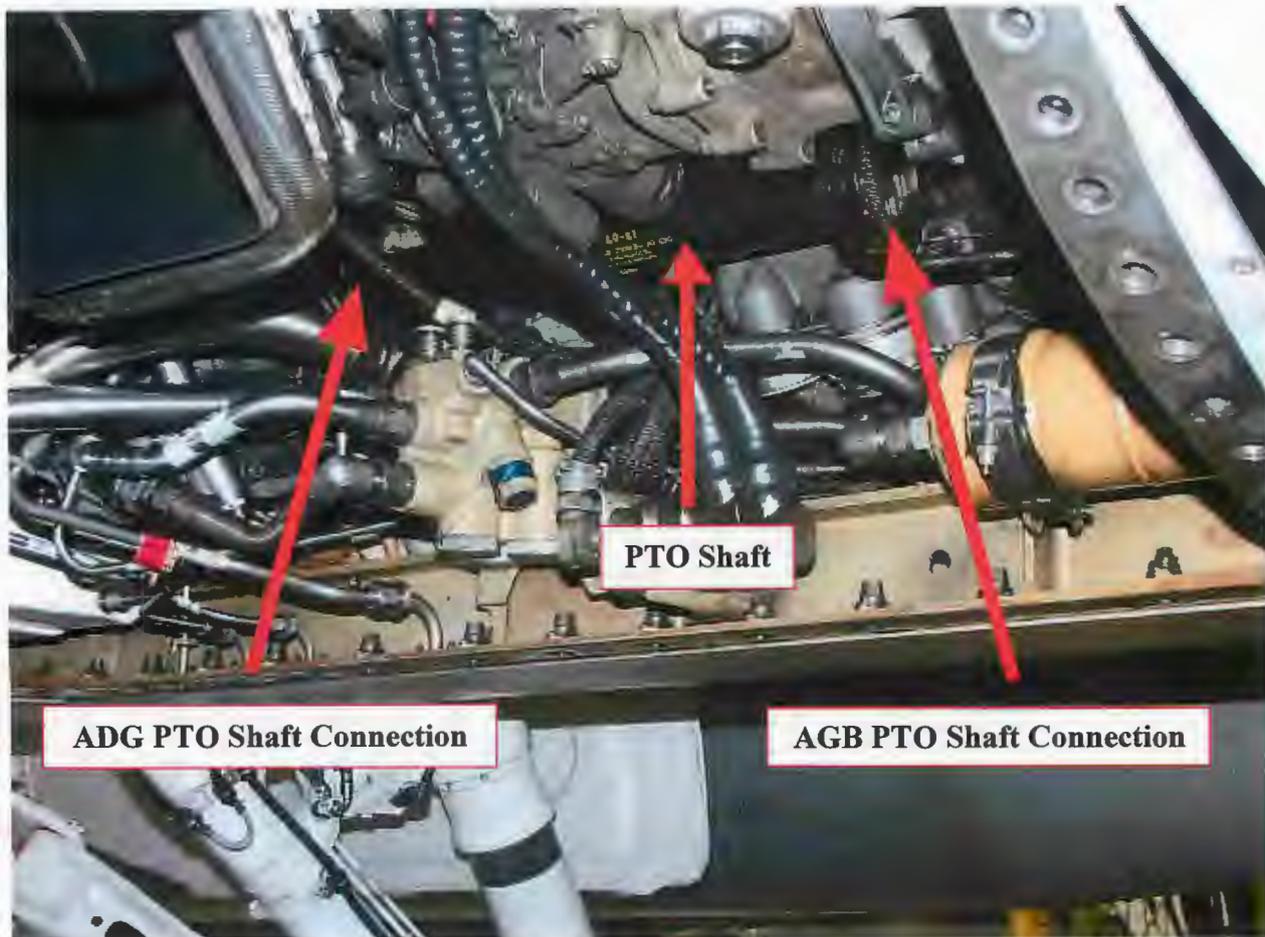
Figure 9: ADG to AGB connection (Tab Z-4)

The MP executed emergency procedures and engaged the JFS which is connected to the AGB by a PTO shaft (Figure 9) (Tab J-26, V-1.8). With the AGB decoupled from the engine, the JFS had

a significant reduction in dynamic load and rotated the AGB and all AGB driven accessories to a false indicated 50% engine RPM % in 3 - 4 seconds (Tab L-12 @ time 3690, V-8.14). All AGB driven accessories began functioning and were then being powered solely by the JFS (Tab L-12 @ time 3690, V-8.15).

The MEC was energized and was provided the same false 50% engine RPM (V-8.14). The MEC had engine control authority which scheduled fuel flow and repositioned IGVs and VSVs to the 50% engine RPM position (Tab J-22, V-8.15). IGVs and VSVs “shape” the airflow through the engine. IGVs control the angle at which airflow enters the face of the engine while VSVs control the angle at which airflow enters the internal compressor blades of the engine. The ME began to restart, but was unable to achieve a full recovery due to the MEC not sensing an appropriate engine RPM acceleration during the engine start phase (Tab V-8.17). The MEC was still provided with a constant false 50% engine RPM from the JFS powered AGB (V-8.14). This resulted in an apparent “hung start” (Tab V-8.17). IGVs and VSVs remained at a 50% engine RPM position which provided a reduced airflow through the engine, however, the MEC continued to increase fuel flow to meet pilot throttle position which was at military power (Tab V-8.16, 8.17). This resulted in the engine exceeding temperature operating limits just prior to
