UNITED STATES AIR FORCE
AIRCRAFT ACCIDENT INVESTIGATION
BOARD REPORT

F-16C, T/N 88-0433

**421st FIGHTER SQUADRON
388th FIGHTER WING
HILL AIR FORCE BASE, UTAH**

DATE OF ACCIDENT: 4 MAY 2012

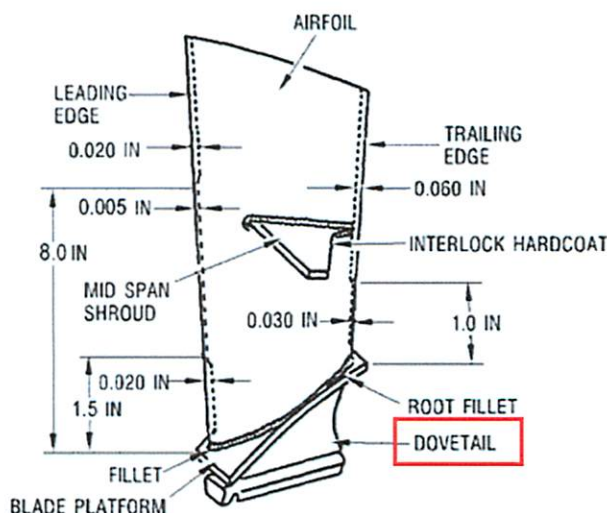
Figure 4. Stage 1 Fan Blade (Tab V-2.34)

The Board President found, by clear and convincing evidence, the cause of the mishap was failure of the number 17 blade in the first stage fan section of the engine. The fan blade liberated from its supporting structure, causing catastrophic damage to the rest of the fan, compressor, and high and low pressure turbines. Because of this extensive damage, the engine could not produce thrust or be restarted.

Additionally, the Board President found, by a preponderance of the evidence, a blade anomaly coupled with eight years of normal operating fatigue substantially contributed to the mishap. The anomaly at the base of blade 17 was formed during a manufacturing process. Blade 17 separated due to fatigue cracking propagating from the edge of the anomaly.

The fan blades underwent cleaning, visual inspection, repair, and replacement. Due to their unique function in an ever-changing environment, these blades are precisely measured, marked, balanced, and installed on the fan assembly. (Tabs U-11 through U-17, V-7.2, V-7.5, V-9.2 through V-9.4) Figure 4 depicts a detailed view of the fan blade.
