UNITED STATES AIR FORCE
AIRCRAFT ACCIDENT INVESTIGATION
BOARD REPORT

F-16CM, T/N 90-0714
80TH FIGHTER SQUADRON
8TH FIGHTER WING
KUNSAN AIR BASE, SOUTH KOREA

LOCATION: KUNSAN AIR BASE, SOUTH KOREA
DATE OF ACCIDENT: 2 DECEMBER 2019
BOARD PRESIDENT: COLONEL JARED J. HUTCHINSON
Conducted IAW Air Force Instruction 51-307

**SUMMARY OF FACTS AND STATEMENT OF OPINION
F-16CM, T/N 90-0714
2 DECEMBER 2019**

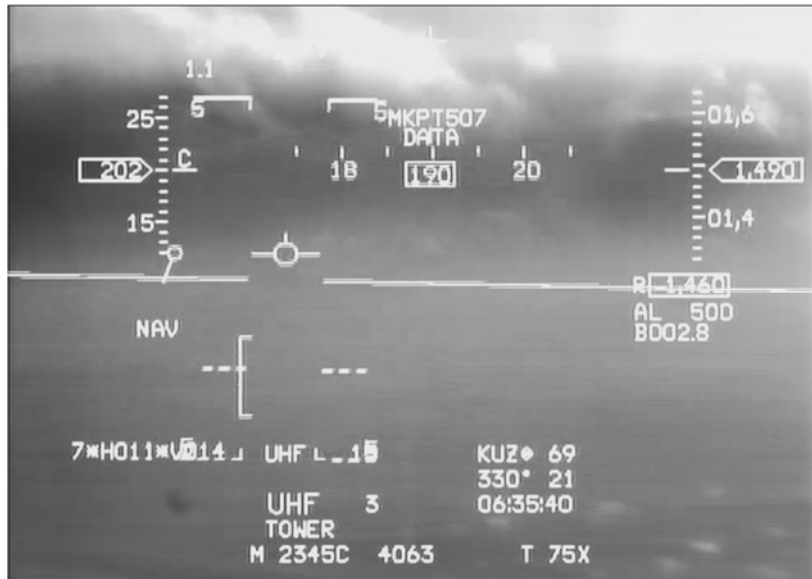
At approximately 15:35:40 hours local time (L), the MP called "SALT 3 Gear" on Tower frequency and began the base turn (Image 1) (Tab L-2). The MP saw positive indications that the MA's landing gear were down and locked (Tab R-639). In the F-16CM, a positive gear indication includes having three green wheels-down lights, no light in the landing gear handle, and the appearance of the angle of attack (AOA) staple in the head-up display (HUD) (Tab BB-54). The MP had checked the landing gear lights both before the turn to base and after the MP had rolled out on final approach (Tab R-634).

Image 1. MP's "SALT 3, Gear" Radio Call Prior to Base Turn (Tabs L-2, Z-2)

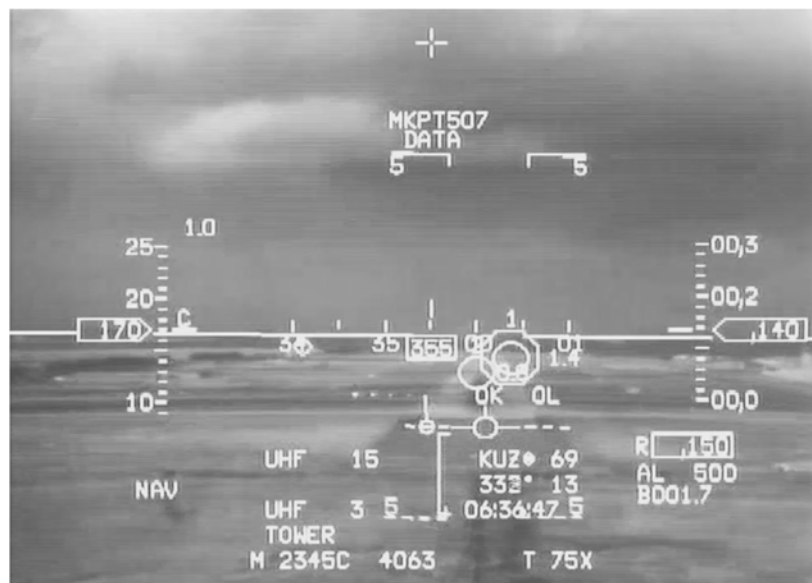
At 15:36:32L the MP rolled out on final runway heading and continued flying the approach at approximately 170 knots calibrated airspeed (KCAS) and an appropriate AOA (Image 2), in accordance with (IAW) approved techniques and procedures (Tab R-638).

Image 2. MA Final Approach (Tabs L-2, Z-2)

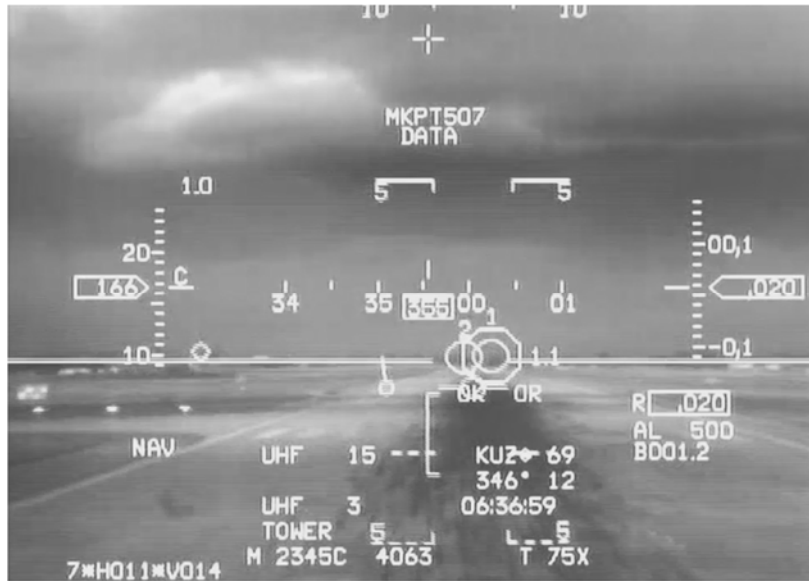
At 15:36:59.12L, 5.31 seconds prior to touchdown, the MA vertical velocity was recorded at -4 feet per second (Image 3) (Tab J-23). For the F-16 heavyweight landing gear, the limit sink rate is established at -10 feet per second for aircraft gross weights up to 31,000 pounds (Tab J-23). The gross weight of the MA at the time of initial touchdown was approximately 25,000 lbs (Tab J-23).

Image 3. MA's Flight Parameters Prior to Touchdown (Tabs L-2, Z-3)

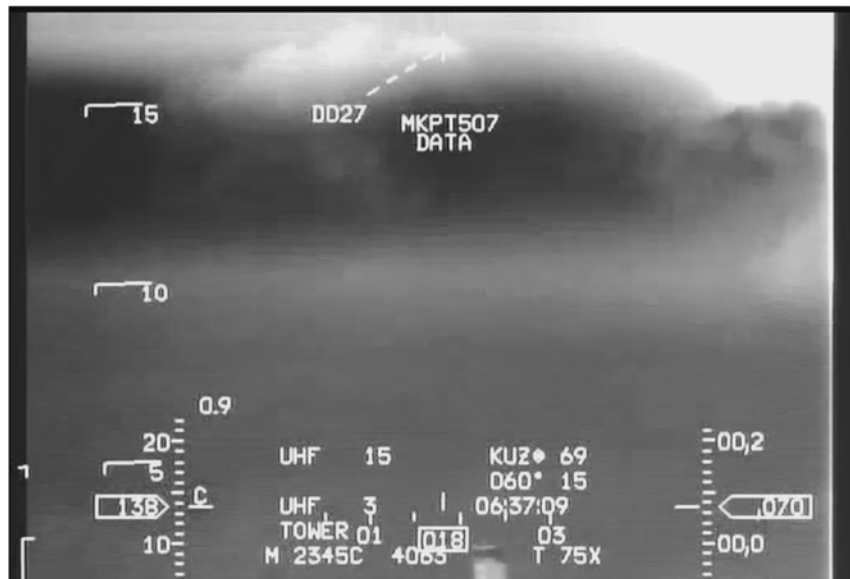
Prior to departing the runway's prepared surface, the MP made an aft stick input and the MA reached a sufficient AOA to cause the low speed warning tone to sound (Tab L-2). The MP's aft stick inputs and resultant AOA reduced the weight on the RMLG enough for the RMLG to fully extend and lock as the MA departed the runway's prepared surface (Tab J-18). At 15:37:09.99L, the crash survivable flight data recorder (CSFDR) measured a maximum AOA of 17.05 degrees prior to ejection (Image 8) (Table 1) (Tab L-2).

Image 8. MA's AOA Prior to Ejection (Tabs L-2, Z-5)

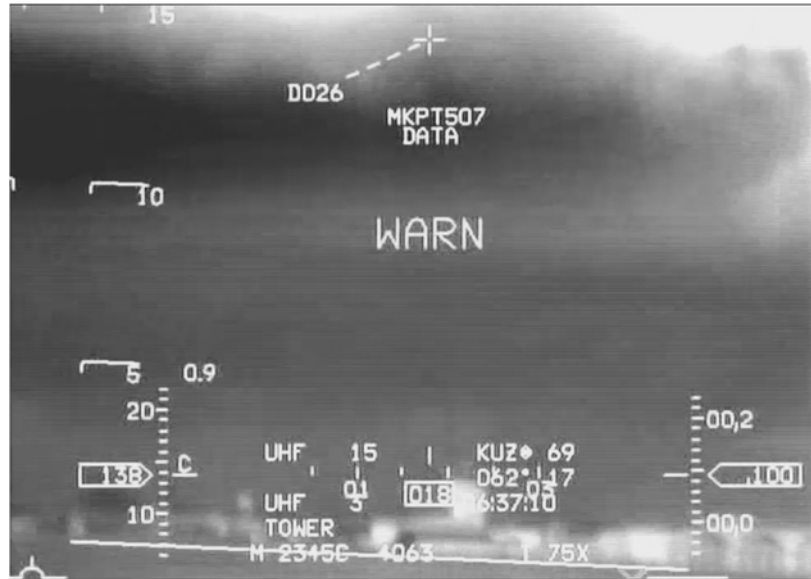
Just prior to departing the runway's prepared surface, the MP followed emergency action procedures and initiated the ejection sequence before departing a prepared surface above a normal taxi speed (Tabs R-629 to R-630, BB-1). At 15:37:10.30L the canopy opened, and at 15:37:10.49L the ejection seat departed the aircraft approximately 1,320 feet from the initial touchdown point

(Image 9) (Table 1) (Tabs J-23, L-2). The ejection sequence was successful, and the MP sustained only minor injuries (Tab X-2 to X-3). The MP was transported to Wonkwang Medical Center and was released later that day (Tabs N-5, R-556).

Image 9. MA's Canopy Opens from Ejection (Tabs L-2, Z-5)
