UNITED STATES AIR FORCE
AIRCRAFT ACCIDENT INVESTIGATION
BOARD REPORT

F-16C, T/N 88-0496

311th FIGHTER SQUADRON
54th FIGHTER GROUP
HOLLOMAN AIR FORCE BASE, NEW MEXICO

DATE OF ACCIDENT: 31 JANUARY 2017

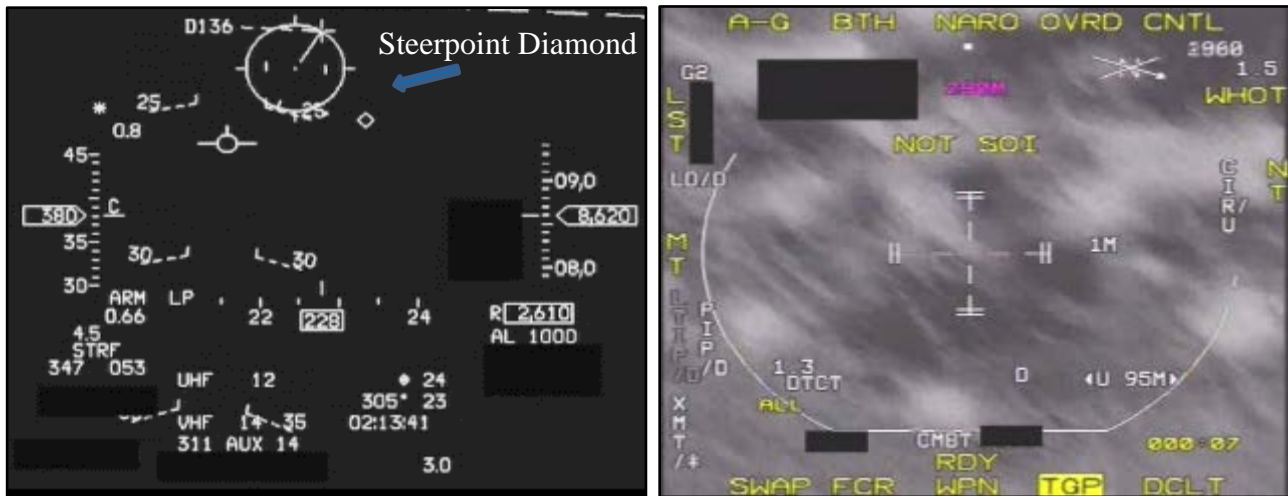
At 19:13:25 hours L, the MP made his second high-angle strafe attack attempt and called "in, heading 220" (Tabs BB-54). MJ1 cleared the MP "hot" at 19:13:27 hours L while the MIP again "sparkled" the target with his TGP's IR pointer (Tabs BB-54). The MP rolled out on an aircraft heading of 228 degrees magnetic, 26 degrees nose down, 2,610 feet above ground level with 380 knots indicated airspeed (Figure 9) (Tabs Z-15 and BB-54). The MP's heads-up-display video (Figure 10) showed a steer point "diamond" (Inertial Navigation System data) which correlated to the SA-8 training target (Tabs Z-17 and BB-54).

Figure 10: MP's HUD and TGP sensor /second strafe attempt at 19:13:41 hours L (Tab Z-17 and Z-31)

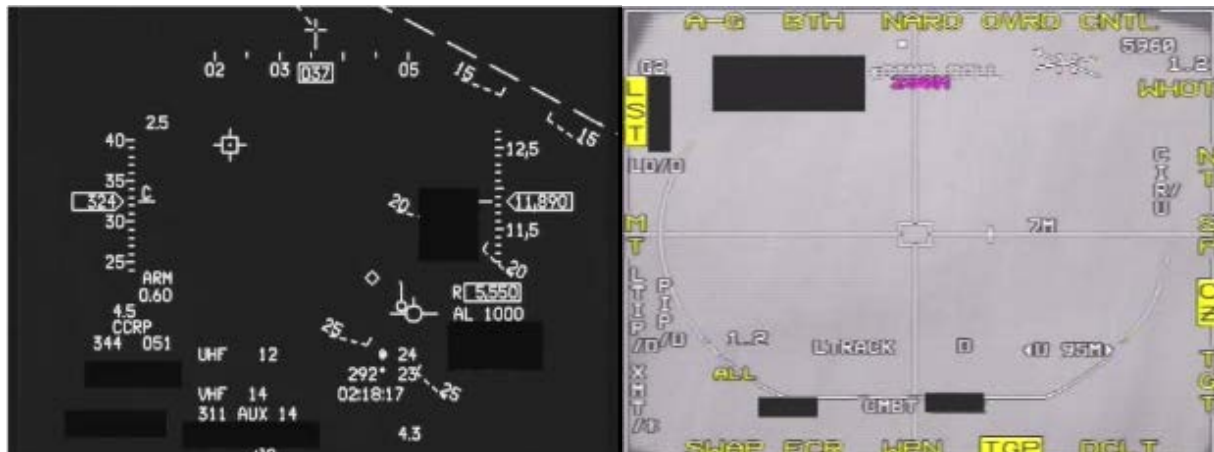
Figure 12: MP's heads-up-display and TGP sensor/third strafe pass 19:18:17 hours L (Tab Z-19 and Z-33)

At 19:18:15 hours L, the MP initiated the high-angle strafe attempt on the SA-8 training target and called that he was “in [heading] 045;” the MIP responded with “Biggie 2 cleared hot” (Tabs N-7 and BB-55). As the MP rolled-in for the attack, his TGP “gimbal rolled” (Figure 12) (Tabs Z-19 to Z-33 and BB-55). A “gimbal roll” is a normal and common occurrence where the TGP can no longer maintain focus or “stare” at a target because the TGP can only turn in one direction so far

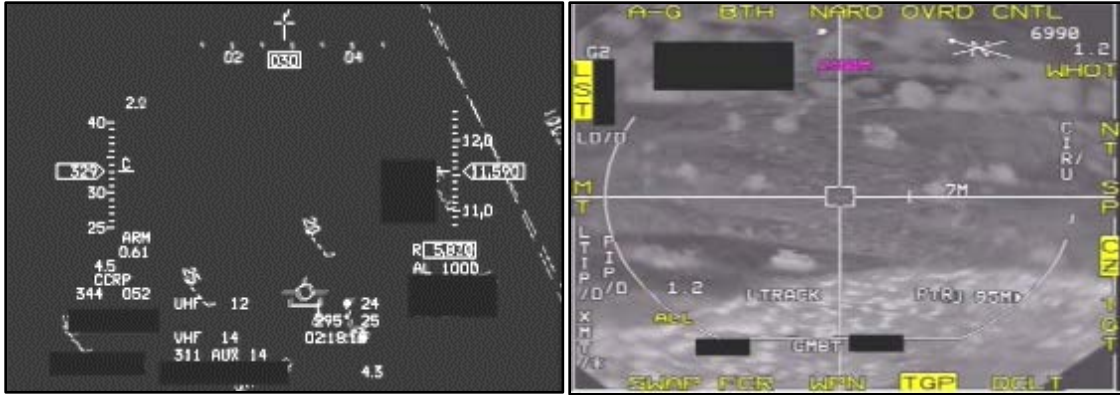
At 19:18:17 hours L, the TISL symbology in the MP's HUD moved up, then down to the left (Figure 13) (Tabs Z-5 and BB-55). At 19:18:18 hours L, the TISL symbology was no longer visible in the MP's HUD (Figure 14) (Tabs Z-20 and BB-55). Data from the MIP's targeting sensor showed that the MIP's laser target designator and IR pointer drifted away from the SA-8 training target (Tab BB-55). Data from the MP's TGP sensor showed the MIP's laser spot track moved approximately 15 meters east and 4 meters north of the SA-8 training target (Figure 14); at which time, the MP then maneuvered his aircraft further to the left to then point at the OP (Tabs Z-20 and BB-55). At 19:18:19 hours L, when the MP's heads up display no longer had the TISL container or the SA-8 training target steerpoint visible, the MP's TGP then reacquired the MIP's laser, at 19:18:25 hours L (Figure 15) (Tabs Z-21, Z-32 and BB-55).

Figure 14: MP's head up display and targeting pod sensor at 19:18:18 hours L (Tab Z-20 and Z-25)

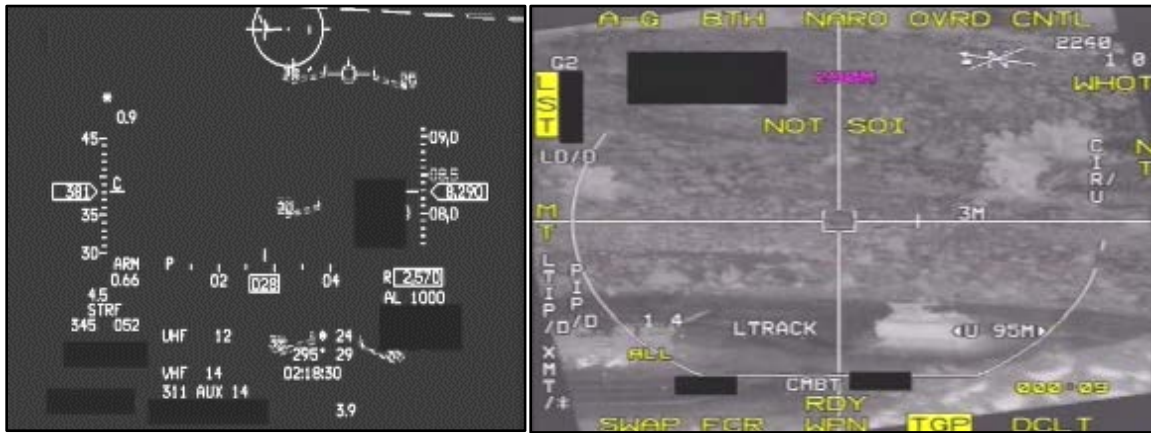
At 19:18:25 hours L, the MP put his aircraft into air-to-ground strafe mode, causing strafe symbology to appear in his HUD (Figure 15) (Tabs Z-21 and BB-55). The AIB was unable to determine what the MP was looking at to aim his F-16 toward his intended target as the SA-8 training target was no longer in the MP's HUD; however, the SA-8 training target is in the field of view of the MP's TGP sensor (Figure 16) (Tabs Z-21, Z-32 and BB-55). At 19:18:30 hours L, the MP squeezed the trigger, firing 155 rounds of 20mm TP (Figure 16) (Tabs Z-22, Z-24, AA-46 and BB-55). The MP released the trigger at 19:18:32 hours L (Tab BB-55).

Figure 16: MP's heads-up-display and TGP sensor at 19:18:30 hours L (Tabs L-3, Z-22, and Z-24)

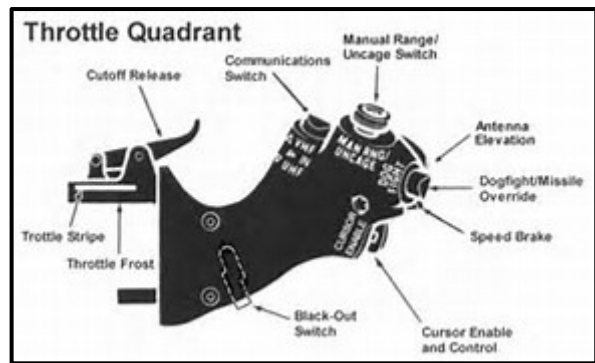
Tab J-36.

After the mishap sortie the MP documented on AFTO form 781A, “Hog knob broken, spins continuously in both directions” (Tab D-8). The “hog knob” is the manual range/uncage pushbutton switch located on the throttle quadrant housing (Tab J-30). The MP described the hog knob’s impact as causing limited zoom-in/zoom-out functionality for the TGP (Tabs V-29.1). The MP also noted that his first press on the hog knob during the fatal strafing attack failed to put his aircraft in strafe mode as it should; it took a subsequent long press on the hog knob to put the jet successfully into strafe mode (Tab V-29.1). The MP did not indicate that the hog knob caused or contributed to the mishap (Tab V-29.1). The AIB concluded that the hog knob did not contribute to the mishap.
