UNITED STATES AIR FORCE
AIRCRAFT ACCIDENT INVESTIGATION
BOARD REPORT

C-130J-30, T/N 11-5736

**37TH AIRLIFT SQUADRON
86TH AIRLIFT WING
RAMSTEIN AIR BASE, GERMANY**

DATE OF ACCIDENT: 23 APRIL 2020

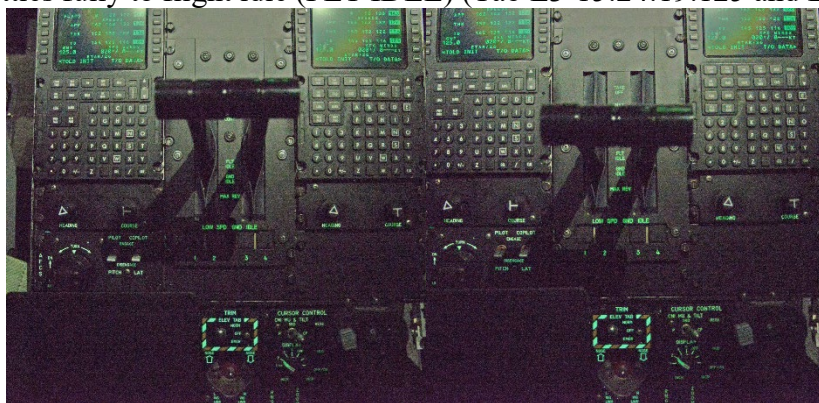
Figure 4: Throttle quadrant, Left is the required power to maintain 116 knots, and right is Flight Idle (Tab DD-19).

The MC was targeting a speed of 116 KCAS (Tab V-2.5). Seven seconds prior to impact, the MA was at 115 KCAS, which led to MP2 calling, "minus one on your speed" (Tabs DD-19, L-33, and L3-15:24:16.375). MP2 began that statement at 117 KCAS (Tabs DD-19 and L3-15:24:16.375). By the time, MP2 finished speaking the MA was at 120 KCAS (Tabs DD-19 and L3-15:24:17.375). The increase in airspeed correlates to a downwards pitch movement by MP1 (Tab L3-15:24:14.75 to L3-15:24:18.50). The DFDR and removable memory module (RMM) data show a pitch attitude change from 0 degrees to -2.3 degrees (Tab EE-2020-04-23T15:24:14:000Z and EE-2020-04-23T15:24:18:000Z). MP1 then began reducing power (Figure 8 and Tabs DD-19 to DD-20 and L3-15:24:18.000). The power pull was initiated at approximately 70 feet AGL (Figure 8 and Tabs DD-19 to DD-20 and L3-15:24:18.000). According to testimonies from MP2 and MP3, MP2 "shadowed" the aircraft controls with the left hand at the base of the throttles and right hand shadowing the yoke—a common technique for the PM in the C-130J community (Tabs R-8, V-2.3, V-3.3, and V6.5). The difference in the throttle angles between what is required to hold 116 KCAS and flight idle is approximately 5 degrees (Figure 4 and Tab DD-19). Prior to the power pull, the MA was at a descent rate of roughly 660 FPM, which is a normal descent rate for this stage of flight (Tab EE-2020-04-23T15:24:17:300Z). At 58 feet AGL and 3.5 seconds prior to touchdown, the engine torque had decreased approximately 76% from 70 feet AGL (Tab L3-15:24:18.125 to L3-15:24:19.125). At 45 feet AGL and 2.5 seconds prior to touchdown MP1 had reduced the throttles fully to flight idle (FLT IDLE) (Tab L3-15:24:19.125 and L3-15:24:21.125).

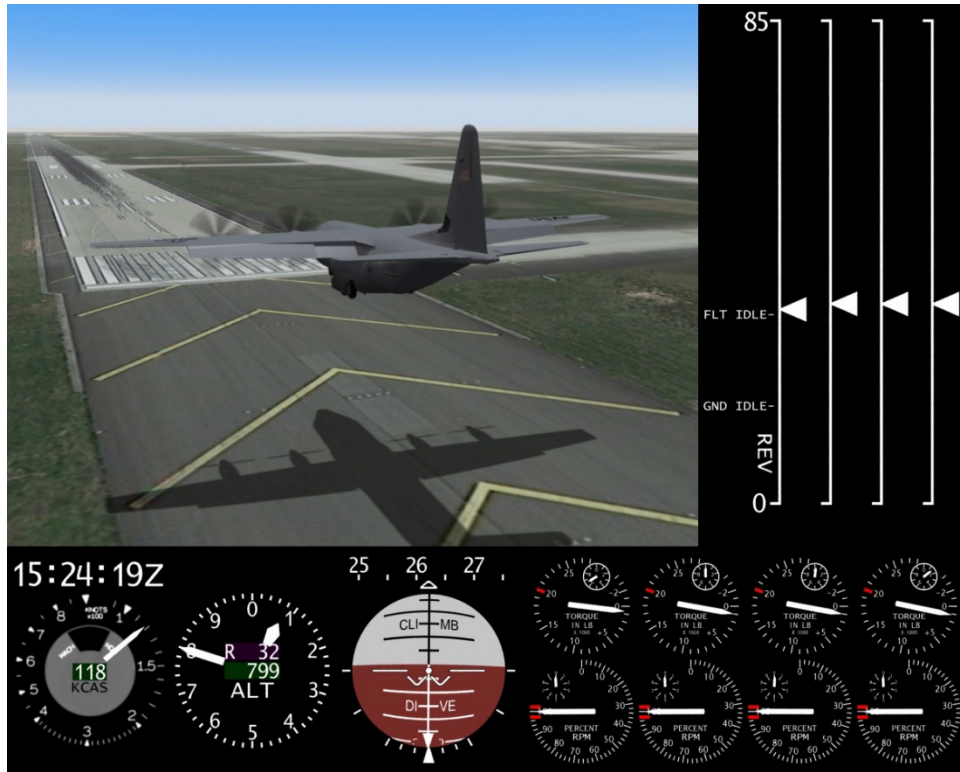
Figure 9: 50 Foot Call (Tab DD-21)

MP2 made the 50 and 40 feet AGL calls on time (Figure 9 on page 13, Figure 10 on page 13, and Tab DD-19). At approximately 30 feet AGL, MP2 recognized the high sink rate and called, “add power” (Tab V-2.5 to V-2.6). Simultaneously as MP2 began saying “add power”, MP1 was already beginning to move the throttles up (Figure 11 on page 14 and Tab DD-19). At this time, roughly 25 feet AGL, the aircraft was at a sink rate of approximately 1005 FPM or 16.75 feet per second (FPS) (Tab EE- 2020-04-23T15:24:20:800Z). Based on DFDR elevator input evidence, at approximately 30 feet AGL the MP1 began to rotate up from pitch attitude of approximately 2.3 degrees nose down (Tab L3 – 15:24:20.625). The MA began flaring (adjusting the pitch of the aircraft into a landing attitude) at 15 feet AGL as indicated by the pitch attitude change (Tab L3-15:24:20.250 to L3-15:24:22.250).

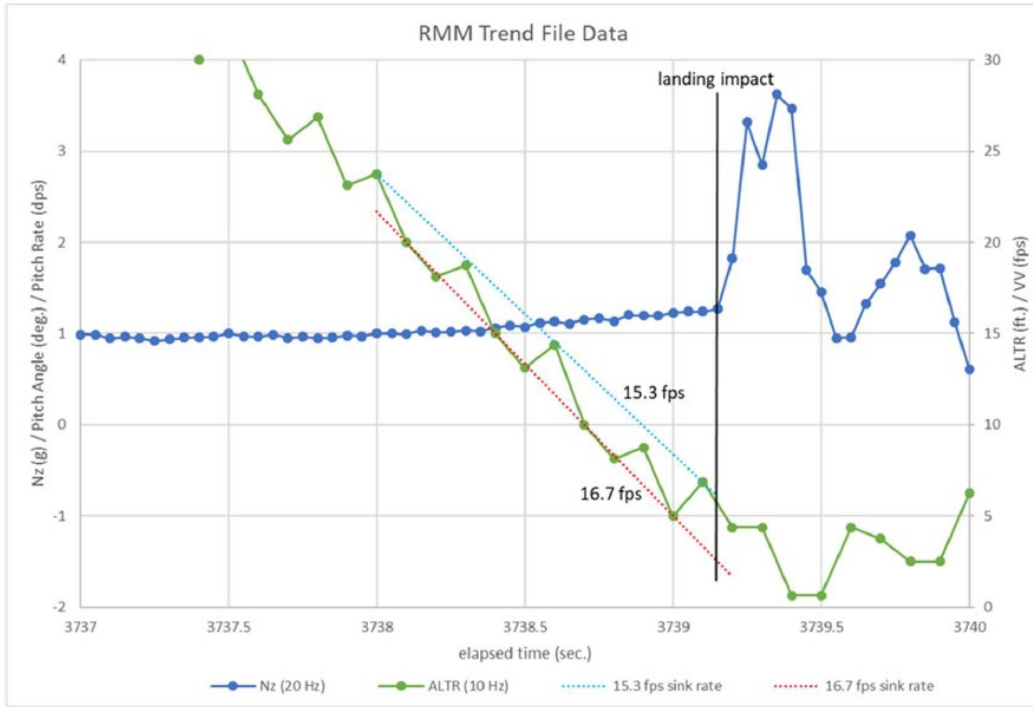
Figure 14: LM Engineering RMM trend file plot (Tab J-109)

On 15 May 2020, the debrief ground maintenance computer was updated and supplemental DTADS processing was completed (Tabs J-62 to J-81 and U-120). The updated DTADS data was analyzed by LM and concluded the MA center wing may have exceeded limit load and the outer wings may have reached ultimate load (Tab J-98 to J-136). This information was forwarded via email on 15 May 2020 to 86 MXG leadership and due to the LM estimate of damage in excess of \$23 million the mishap was reclassified from a Class C to a Class A mishap (Tab J-3 and J-134 to J-136). At that time all maintenance actions ceased and an Interim Safety Board (ISB) was formally appointed on 21 May 2020 (Tab A-2) followed by the Safety Investigation Board (SIB) on 27 May 2020 (Tab A-3 to A-7).

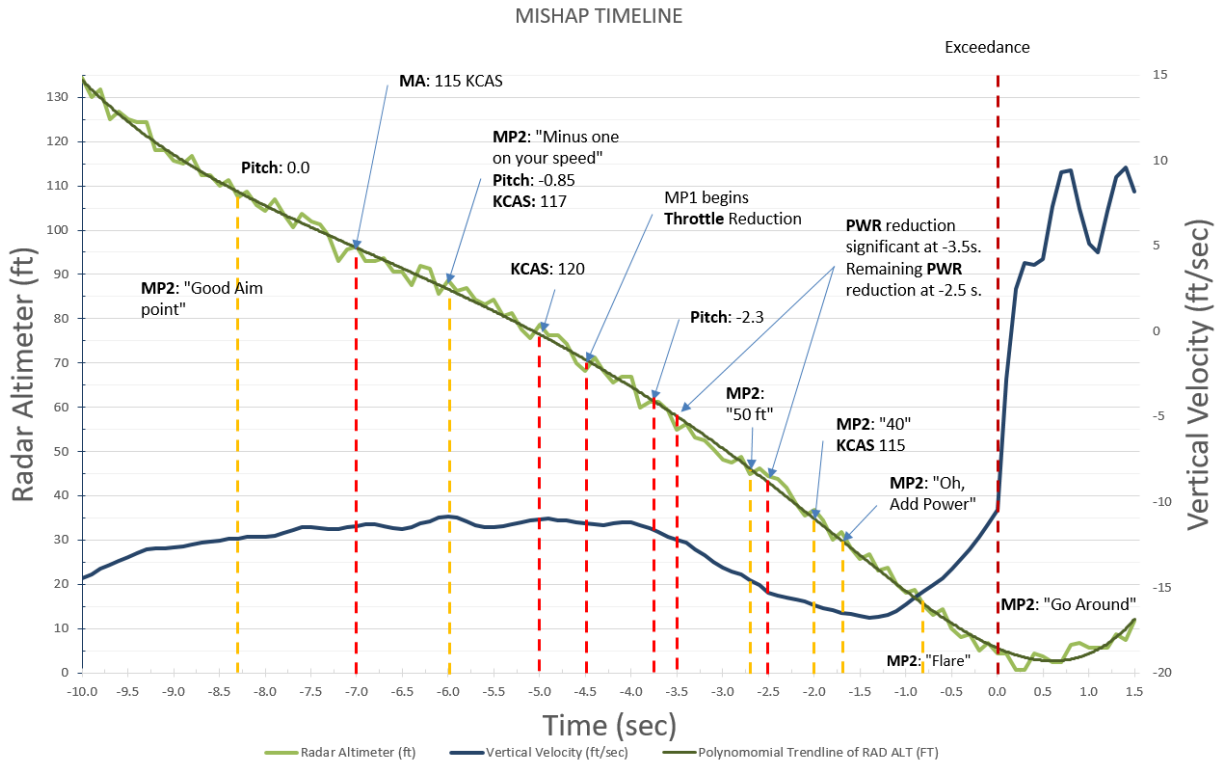
Figure 15: Mishap timeline 10 sec prior to touchdown (Tab DD-24)

Analysis of the mishap timeline plots show MP2’s verbal calls in reference to radar altimeter, vertical velocity, and other pertinent information such as the MA’s pitch attitude (Figure 15 and Figure 16 and Tab DD-25). There was a noticeable change in vertical velocity around 50 feet AGL (Figure 15, -3.5 to -2.5 and Tab DD-24). Eight seconds to the hard landing, the pitch of attitude of the aircraft began reducing from 0 degrees to -2.3 degrees (Figure 15, -8.0 and Tab DD-24). At 62 feet AGL and 4.0 seconds prior to touchdown, the MA reached -2.3 pitch attitude (Figure 15, -4.0 and Tab DD-24).

The MA began increasing airspeed from pitching down and reached 120 KCAS (Figure 15, -5.0 and Tab DD-24). MP1 then began to reduce the engine power at 70 feet AGL and 4.5 seconds prior to touchdown (Figure 15, -4.5 and Tab DD-24). At 58 feet AGL and 3.5 seconds prior to touchdown, the engine torque had decreased approximately 76% from 70 feet AGL (Tab L3-15:24:18.125 to L3-15:24:19.125). This power reduction corresponds with the increased sink rate (Figure 15, -3.5 and Tab DD-XX).

excessive sink rate (Tab DD-13 to DD-14). The GCAS can be set to normal or tactical mode (Tabs DD-13 to DD-14 and BB-83). Because the crew was flying a tactical approach, the correct procedure would be to set the GCAS to “tactical” which would increase the warning alert envelope from 1750 FPM to 1785 FPM (Tabs DD-13 to DD-14 and BB-83). Below 30 feet AGL, the GCAS does not provide sink rate alerts (Tab DD-13 to DD-14). At 50 feet AGL, the GCAS will alert the crew of an excessive sink rate at approximately 1785 FPM in tactical mode (Tab DD-14). The MA sink rate at 50 feet AGL was 809 FPM and continued to increase and peaked at 25 feet AGL to 1005 FPM (Figure 16 on page 17 and Tab DD-25). The MA never reached a sink rate greater than 1750 FPM, therefore, the GCAS would not have alerted the MC (Figure 15 and Tabs DD-25, L3, and L-33).

MP1 pitched the MA nose down and subsequently reduced power from what is required to maintain airspeed to the FLT IDLE throttle position (Figure 15 and Figure 16 and Tab DD-24 to DD-25). This occurred over the span in which the MA was between 110 feet AGL and 45 feet AGL (Figure 15 and Figure 16 and Tab DD-24 to DD-25). At 58 feet AGL and 3.5 seconds prior to touchdown, the engine torque had decreased approximately 76% from 70 feet AGL (Figure 15 and Figure 16 and Tab DD-24 to DD-25). At 45 feet, AGL MP1 had the throttles fully in FLT IDLE (Figure 15 and Figure 16 and Tab DD-24 to DD-25).

MP2 called out, “Good aim point” at roughly 110 feet AGL and it was after the callout that MP1 began pitching downward (Figure 15, -8.3). Over 4 seconds passed between that callout and the

MA pitching down to 2.3 degrees nose down (Figure 15, -8.3 to -4.0 and Tab DD-24). Within these 4 seconds, MP1 began reducing power to FLT IDLE (Figure 15, -3.75 and Tab DD-24). Reducing power or thrust in an aircraft flying level will normally decrease airspeed; however, an aircraft pitching down would increase airspeed (Tab DD-7). Re-creation of the mishap to include power reduction and pitch in the WST revealed that in the HUD, CDM/aim point of the MA shifts down and closer to the beginning of the runway approach (short of the painted LZ) (Tab DD-7). Attempts to recreate the mishap in the WST highlighted the need for a nose up attitude to maintain a constant aim point while reducing power (Figure 28, Tab DD-7, and DD-26).

Due to the C-130J lacking automated aural RAD ALT callouts, a common technique in the C-130J community is for the PM to callout the radar altimeter in 10-foot increments starting at 50 feet AGL (Tab V-2.7, V-4.5, V-5.3, and V-6.5). Multiple experienced C-130J pilots testify to the importance of this technique (Tab V-2.7, V-4.5, V-5.3, and V-6.5). The countdown by the PM gives the PF a verbal cue on the descent rate based on how quickly or slowly the radar altimeter is counting down—the countdown cadence (Tab V-5.3). MP2 testified using a visual scan is “aim point, airspeed, and RAD ALT” (Tab V-2.8). Figure 15 and Figure 16, based off RMM and CVR data, show that the significant power reduction led to an increased sink rate. As the sink rate was increasing, MP2 began the RAD ALT calls (Figure 16, -2.7). The data also shows that 5.6 seconds passed between MP2’s aim point call and 50 feet RADALT call (Figure 16, -8.3 to -2.7). Additionally, 3.3 seconds elapsed between the airspeed call and the 50 feet RAD ALT call (Figure 16, -6.0 to -2.7). The “sinking feeling” testified by the MC correlates with the increase in vertical velocity as shown in Figure 15 (Tab V-2.5). MP2 directed MP1 to add power at 30 feet AGL roughly 1.7 seconds prior to touchdown (Figure 15 and Tab DD-24).

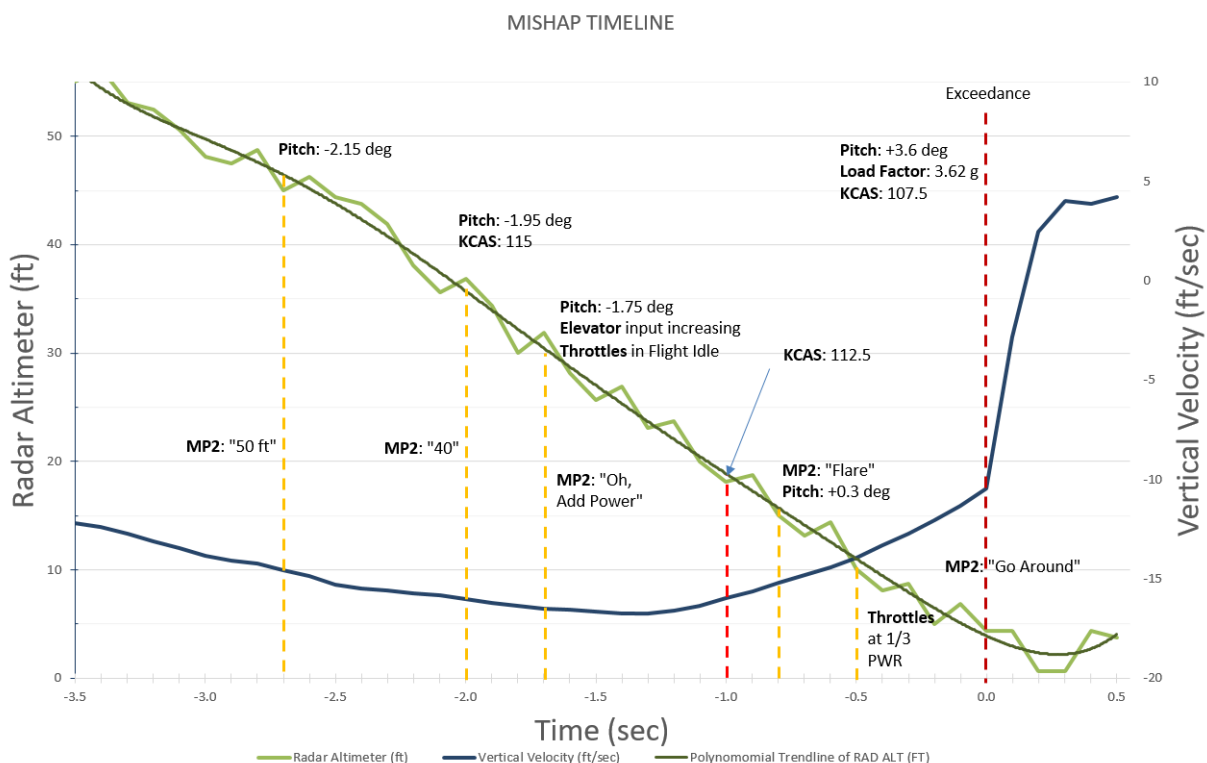
Figure 16: Mishap timeline 3.5 sec prior to touchdown (Tab DD-25)

On a typical approach, making verbal RAD ALT callouts is a common technique and multiple experienced C-130J pilots testified to its value (Tab V-2.3, V-4.5, V-5.3, and V-6.5). The speed at which the cadence is called gives the PF an auditory indication of aircraft sink rate (Tab V-4.5). MP2's 50 and 40-foot callouts were relatively on time given the increased sink rate and factoring human error (Figure 16, -3.3 to -2.0 and Tab DD-25). The sink rate at 50 feet AGL was 13.48 feet per second (809 FPM) and increasing (Figure 15, -2.75 to -2.5 and Tab DD-24). This increasing sink rate corresponds to testimonies of a "sinking feeling" that the MC testified to (Tabs R-8 and V-2.5). The sink rate continued to increase until 25 feet AGL and peaked at 16.75 feet per second (1005 FPM) (Figure 15, -2.5 to -1.25 and Tab DD-24). At 30 feet AGL and 1.7 seconds prior to touchdown, MP1 attempted to correct the high sink rate as indicated by the increasing elevator input (Figure 16, -1.7 and Tab DD-25). Simultaneously, MP2 recognized the high sink rate and directed MP1 to add power (Tab V-2.6). MP2, who was the aircraft commander, testified that he did not take control of the MA because MP1 initiated proper go-around procedures (Tab V-2.7). Power input remained at FLT IDLE 1.5 seconds prior to touchdown, but one second later (the next recorded data point for throttles) at 0.5 seconds to touchdown, the throttles were at roughly 1/3 of full power (Tab L3-15:24:20.875 to L3-15:24:24.875). The MA was 10 feet AGL at 0.5 seconds (Figure 16, -0.5 and Tab DD-25).

Within 0.8 seconds of touchdown MP2 called "flare" at approximately 15 feet AGL (Figure 16, -0.8 and Tab DD-25). As the MA impacted the runway, MP2 announced, "Go-Around" (Figure 16, 0.0 and Tab DD-26).
