UNITED STATES AIR FORCE
AIRCRAFT ACCIDENT INVESTIGATION
BOARD REPORT

F-16C, T/N 86-0317

DATE OF ACCIDENT: 8 DECEMBER 2020

SUMMARY OF FACTS AND STATEMENT OF OPINION
F-16C, T/N 86-0317
HIAWATHA NATIONAL FOREST, MICHIGAN
8 DECEMBER 2020

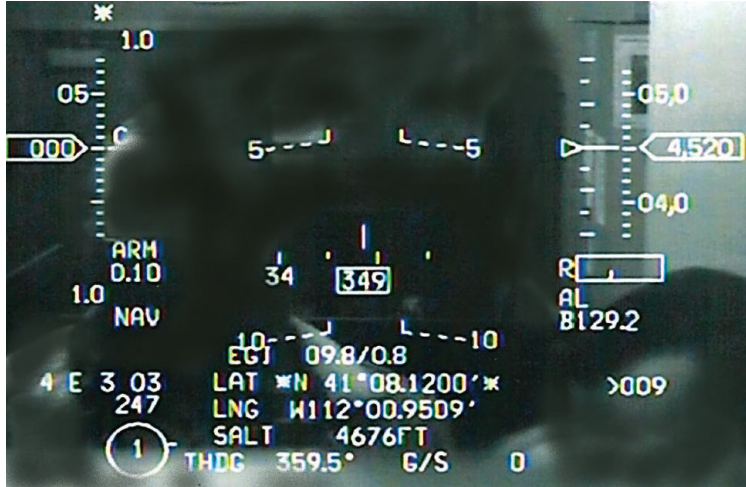
Figure 5: Simulated Fully Capable HUD (Tab T-16)

On the ground, while performing preflight checks, the MP reported having a sufficiently aligned EGI system (Tab T-40). Without the MP's HUD/DVR data, it cannot be determined whether the MA was tracking satellites during ground operations (Tab T-41). However, if an aircraft is stationary and at a level attitude, GPS is not required for the INS to achieve a full and accurate alignment (Tab T-15). Figures 5 and 6 (below) illustrate a fully aligned system with satellites tracking (Tab T-16). A fully aligned system without satellites tracking would appear the same, with the exception of the '4 E 3 03' symbology in the lower left corner of the HUD (Tabs T-15 to T-16).

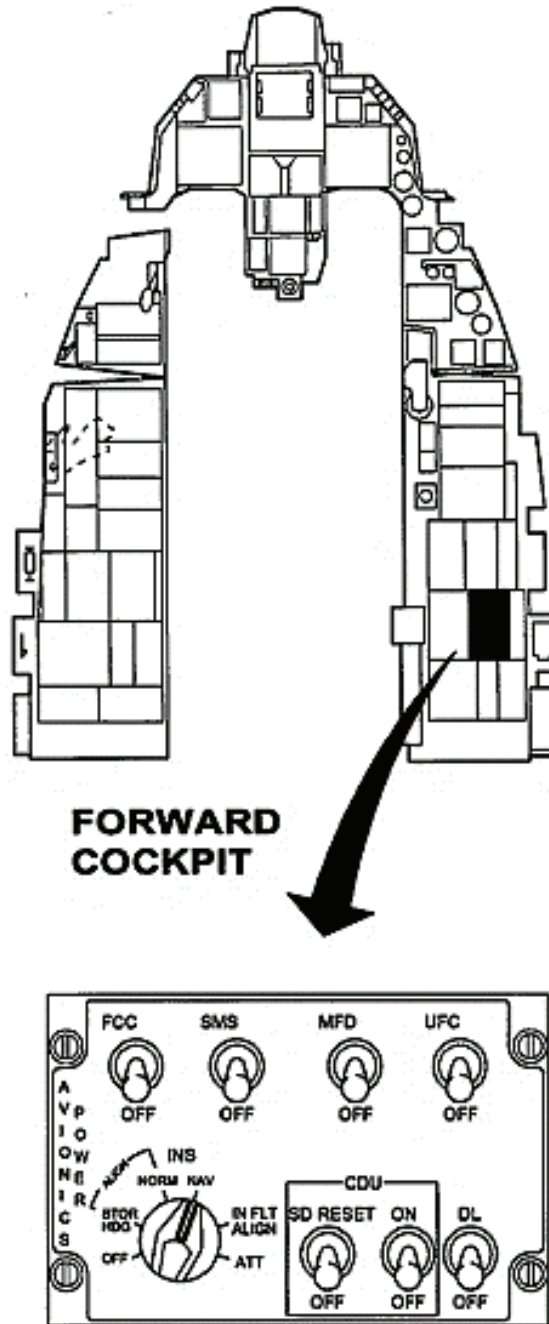
Figure 7: Visual Depiction of INS Switch (Tab X-13)

The first step to perform an IFA is to place the INS knob in the "OFF" position for 10 seconds (Tab BB-2). Next, while established in straight, level, and unaccelerated flight, the INS knob is placed in "INFLT ALIGN" (Tab BB-2). Figure 7 (below) shows the OFF and INFLT ALIGN positions on the INS knob (Tab X-13).

Due to the destruction of the MA, it cannot be determined how long the MP left the INS knob in OFF and how that would affect the IFA (Tabs T-16 to T-17). Communications confirm, after placing the INS knob to INFLT ALIGN, the MP observed attitude, airspeed, and altitude indications in the PFD (Tab T-41). The MP also confirmed the HUD had no FPM or attitude

While attempting the IFA, in radio communications, the MP discussed trying to change the GPS reception mode from "YMODE" to "MIXED" (Tab T-41 and Figure 7). When in YMODE, the EGI navigation solution uses only encrypted, precision satellite signals (Tab BB-14). While in MIXED, the EGI navigation solution uses course and/or precision satellite signals (Tab BB-14). MIXED may be less precise, but the GPS will utilize more GPS satellites in an attempt to provide a navigation solution (Tab BB-14). The switch from YMODE to MIXED resets the GPS and reinitiates satellite acquisition (Tab BB-15). Switching from YMODE to MIXED requires the Mode-Select button on the integrated control panel to be depressed (Tab BB-14). After, the GPS RESET field and the selected reception mode are highlighted (Tab BB-14). Available evidence could not determine if the MP applied the correct steps to switch modes or what mode the GPS was in prior to the mishap (Tab T-41).

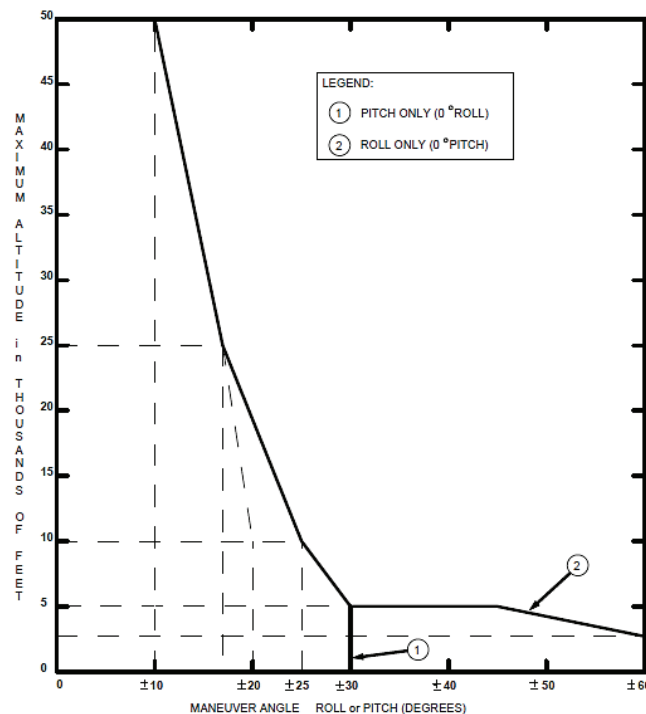
Figure 13: CARA Tracking Capabilities (Tab BB-13)

To prevent controlled flight into terrain, the F-16C is equipped with a ground avoidance advisory function (GAAF) (Tab BB-19). The system provides advisory cues both visually and aurally when the aircraft AGL altitude is less than or equal to the predicted altitude lost during a 4G pull-up plus a clearance buffer (Tab BB-19). Moreover, the ground advisory utilizes combined altitude radar altimeter (CARA) data as long as the aircraft is within the CARA ground track envelope (Tab BB-21). The radar altimeter is located on the bottom of the F-16C, and in extreme attitudes the radar altimeter readings are outside of the ground track envelope (Tab BB-21). Based on the recreation, the MA was outside of the CARA envelope throughout the mishap event up until impact (Tabs T-42 and BB-13). As such, the MP would not receive a GAAF advisory cue (Tab BB-21). Figure 13 (below) provides CARA ground tracking capabilities (Tab BB-13).

In addition to the GAAF, some F-16C Block 30s are equipped with a ground collision avoidance system (GCAS) to prevent controlled flight into terrain (Tab BB-19). The MA was not equipped with the GCAS function (Tab T-43).

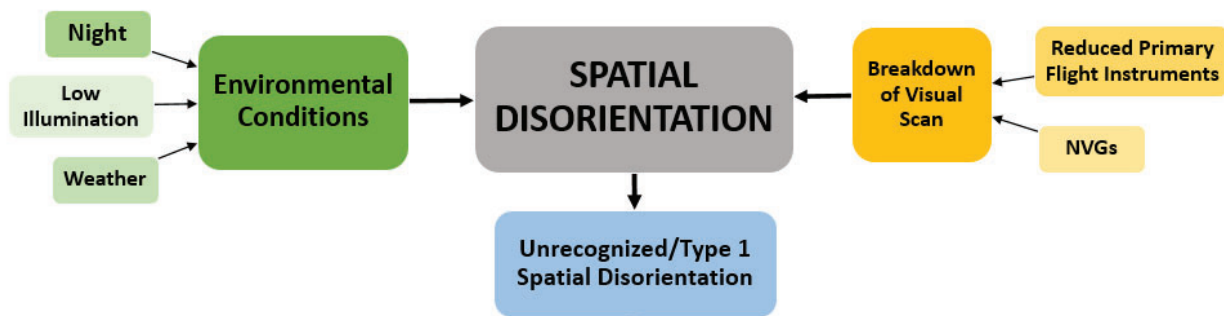
Figure 15: Human Factors Breakdown (Tab Y-57)

DoD HFACS 7.0 are divided into four parts: acts, preconditions, supervision, and organizational influences (Tab Y-6). Four human factors were identified as relevant to the mishap: (1) Environmental Conditions Affecting Vision; (2) Instrumentation & Warning System Issues; (3) Breakdown in Visual Scan; and (4) Spatial Disorientation (Tabs Y-4 to Y-26).

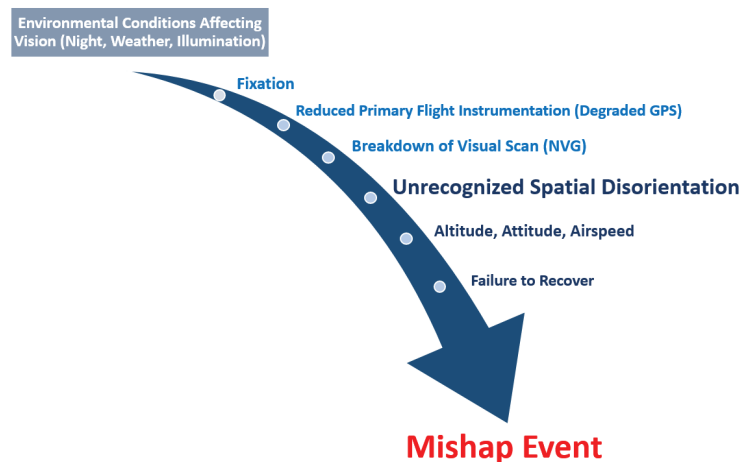
Figure 16: Human Factor Chain (Tab Y-58)

Spatial disorientation is a failure to correctly sense a position, motion, or attitude of the aircraft or of oneself within the fixed coordinate system provided by the surface of the earth and the gravitational vertical (Tab Y-28). It is a factor when perceptual confusion or an illusion is induced through one or more of the following senses: visual, vestibular, auditory, tactile, proprioception, or kinesthetic (Tab Y-16). Spatial disorientation may be recognized or unrecognized and result in partial or total incapacitation (Tab Y-31).
