UNITED STATES AIR FORCE
AIRCRAFT ACCIDENT INVESTIGATION
BOARD REPORT

F-22A, T/N 06-4109

LOCATION: NELLIS AIR FORCE BASE, NEVADA

DATE OF ACCIDENT: 30 OCTOBER 2020

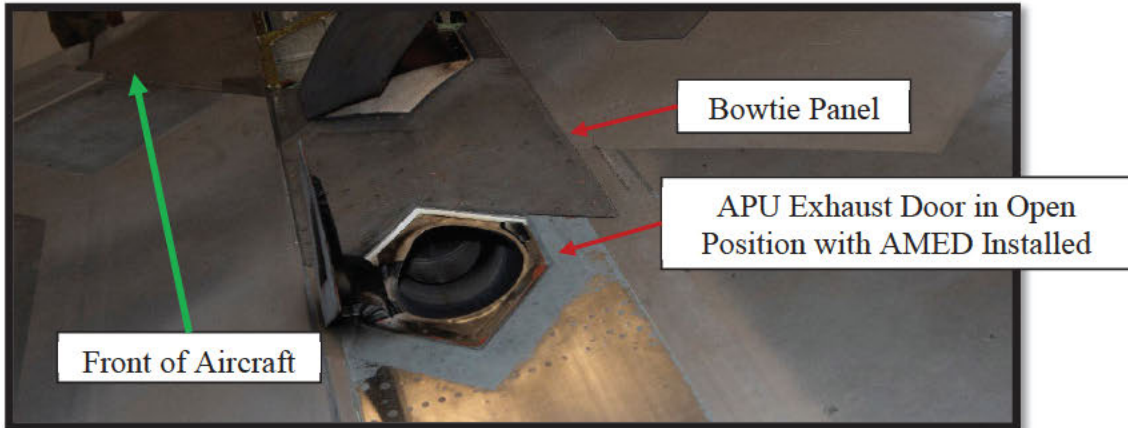
Figure 8: APU Exhaust Bay, Bowtie Panel, and AMED (Tabs Z-8 and EE-6)

The AMED provides the final stage of exhausting the combusted by-product of the APU (Tab BB-57). The duct is made of Inconel, a material capable of withstanding temperatures of up to 1800 degrees Fahrenheit (Tab BB-57 and BB-75). One end of the duct is coupled to the APU secondary exhaust duct (Tab BB-57). The other end of the duct mounts to aircraft structure under the APU exhaust outlet door (Tab BB-57).

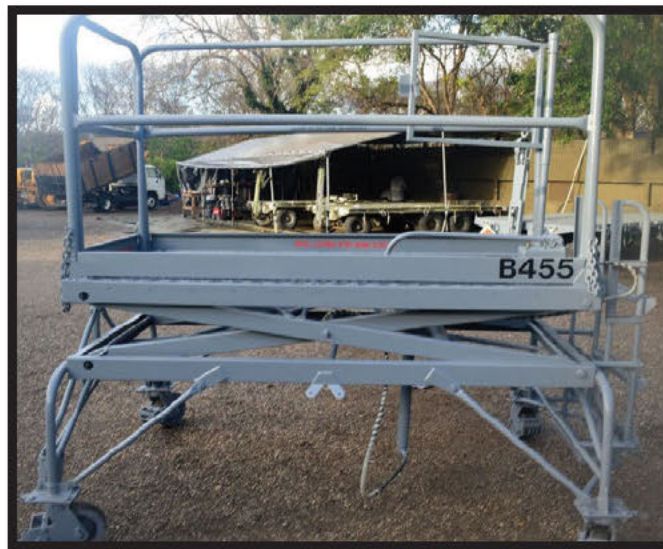
Figure 13: B-4 Maintenance Stand (Tab Z-13)

When asked whether he looked at the APU inlet/exhaust prior to starting the APU, MXM3 responded, "I believe it was MXM7... I had him look at it" (Tabs V-3.16, V-3.21, BB-63, and EE-7). TO guidance requires maintainers to visually inspect APU inlet and exhaust bay for foreign objects and remove debris if present, a task that requires a B-4 stand (Tab BB-63). On the day of the mishap, MXM7 provided written testimony stating that he inspected the APU exhaust and inlet and that it was clear (Tab R-151). MXM7, a 3-Level, was not qualified to perform this procedural task (Tabs BB-63, DD-158, EE-3, and EE-8). On 16 March 2021, MXM7 provided verbal testimony to the AIB, stating, "[He] was visually looking at the... vent where the fog gases come out... those were clear" (Tabs V-7.1, V-7.24 and EE-8). What MXM7 described in this statement was an area different than the APU exhaust areas (Tab EE-8). MXM7 did not recall if there was a B-4 stand available to inspect the bay as seen in Figure 13 (Tabs V-7.18 and Z-13). MXM3 then started the APU (Tab V-3.10). Upon starting the APU without the AMED installed, the hot exhaust gases from the APU entered the APU exhaust bay instead of being diverted out of the aircraft (Tab EE-3)

The B-4 maintenance stand is required by TO guidance to inspect the APU inlet and exhaust bays (Tab BB-63).

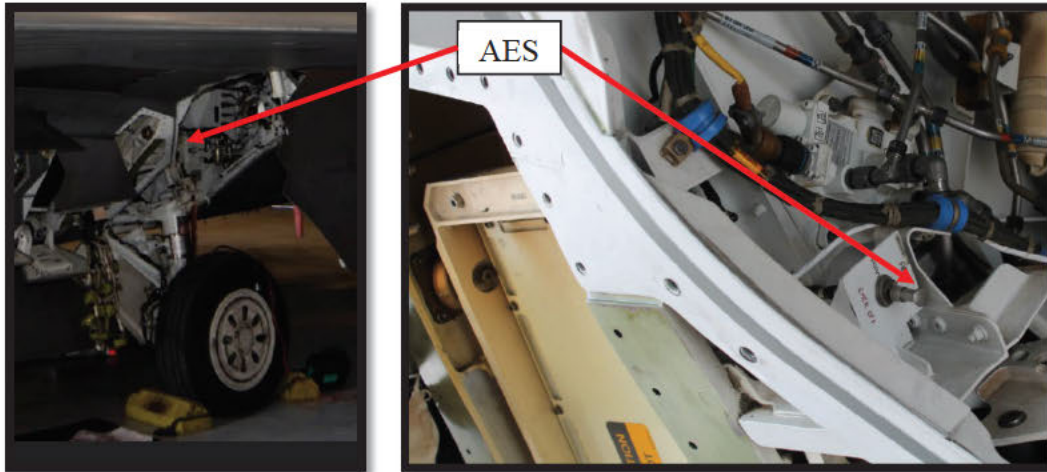
Figure 19-20: Left Main Gear Well and APU Emergency Switch (Tabs Z-19 to Z-20 and EE-5)

After MXM3 started the APU, smoke began to fill the wheel well (Tab V-8.14). MXM3 then began reviewing Fault Reporting Codes (FRC) in IMIS to assess what was wrong (Tab V-8.14). MXM4, a 5-Level in the vicinity, approached the MA and set the AES to EMER OFF to manually shut down the APU (Tabs R-66, V-4.3 and V-8.6). The APU shut down, and the MA was subsequently impounded (Tab EE-5).

The left Main Landing Gear (MLG) wheel well houses the AES as seen in Figures 21 and 22 (Tabs Z-20 and EE-5). The AES provides maintainers the means of shutting off the APU in emergencies, as seen in Figures 21 and 22 (Tabs Z-20 and EE-5).
