**UNITED STATES AIR FORCE**  
**AIRCRAFT ACCIDENT INVESTIGATION**  
**BOARD REPORT**

**KC-46A, T/N 15-046069**

**DATE OF ACCIDENT: 15 OCTOBER 2022**

## SUMMARY OF FACTS AND STATEMENT OF OPINION

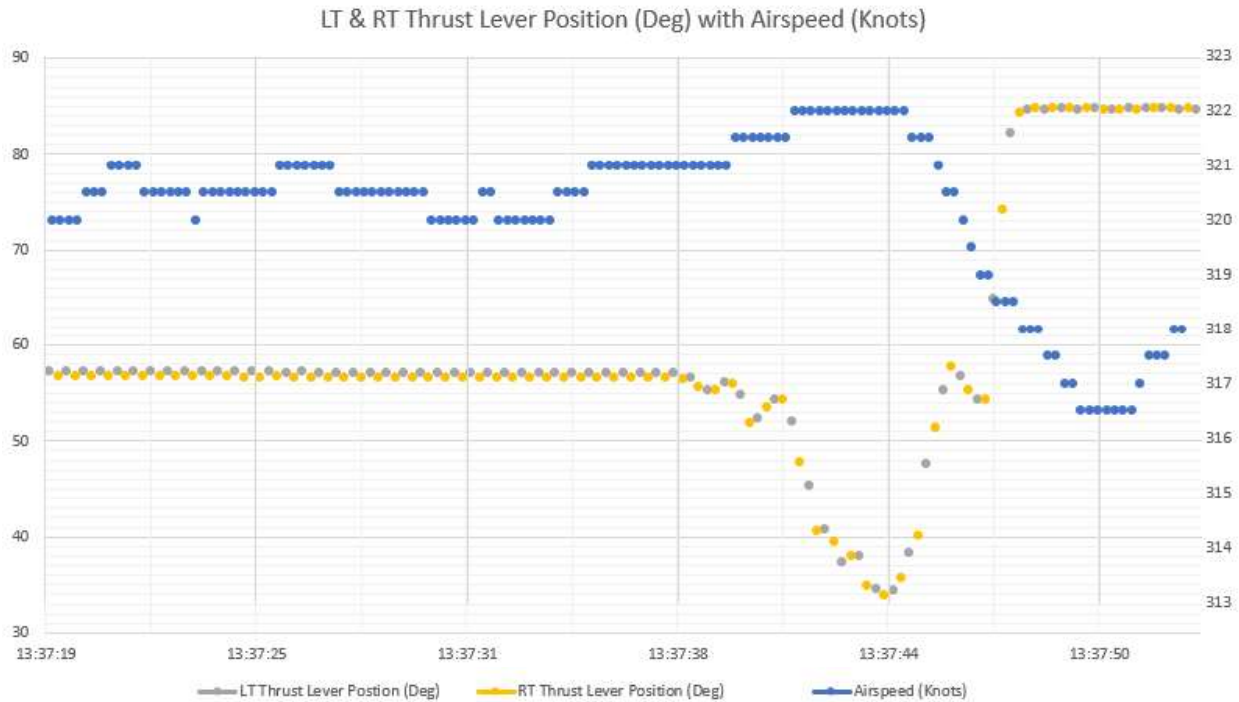
**Figure 13: LT & RT Thrust Lever Position with Airspeed (Tab FF-5)**

Analysis of the MA1's FDR Data was conducted by the AIB's Pilot Member (Tab FF-1-4). This analysis yielded a detailed sequence of events focused on the actions of MP1 between the initiation of air refueling contact with MA2 until after the termination of the emergency breakaway procedures (Tab FF-3). Additionally, the AIB was able to plot the position of the Engine Thrust Levers and MA1's airspeed to illustrate the magnitude of MP1's engine thrust change and effect this had on MA1's airspeed while in physical contact with MA2 (Tab FF-3).
