UNITED STATES AIR FORCE
ABBREVIATED AIRCRAFT ACCIDENT
INVESTIGATION BOARD REPORT

MQ-1B, T/N 07-3210
432D WING
CREECH AIR FORCE BASE, NEVADA

LOCATION: EASTERN AFGHANISTAN
DATE OF ACCIDENT: 14 JULY 2014
BOARD PRESIDENT: LT COL SHERYL A. OTT

EXECUTIVE SUMMARY
ABBREVIATED AIRCRAFT ACCIDENT INVESTIGATION

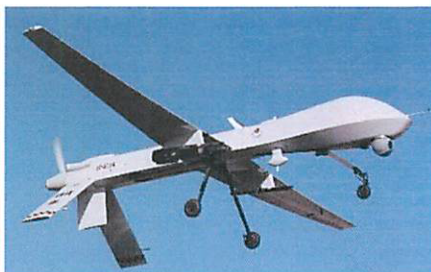
g. MQ-1B, Predator

The MQ-1B Predator is an armed, multi-mission, medium-altitude, long-endurance RPA that is employed primarily as an intelligence-collection asset and secondarily against dynamic execution targets. Given its significant loiter time, wide-range sensors, multi-mode communications suite and precision weapons, the Predator provides a unique capability to perform strike, coordination and reconnaissance missions against high-value, fleeting and time-sensitive targets. Predators can also
