SAFETY INVESTIGATION REPORT

**HELLENIC AIR FORCE F-16D BLK 50
S/N 93-1084 341SQ/111CW**

**ALBACETE AFB (ESP), ALBACETE
26 JANUARY 2015**

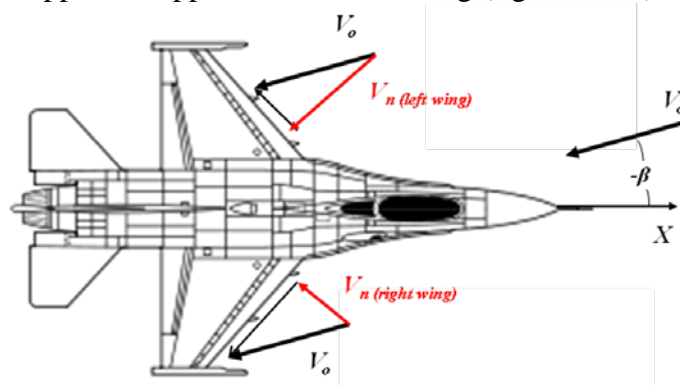
-The F-16 is equipped with an aft-swept wing. In all aft-swept wing A/C, during sideslip, the upwind wing toward the velocity vector (left in MA) produces more lift than the downwind wing as the normal vector of the velocity (the one perpendicular to the leading edge of each wing – V_n (left wind)) is increasing. The "spanwise" vector of the velocity produces no lift. The opposite happens to the other wing (right in MA).

Rolling moment because of sideslip with an aft-swept wing

The movement of the MA's nose to the right during the sideslip produced an aerodynamic right wing down rolling moment. The recorded roll was approximately 7° at the first second following WOW and increased dramatically to approximately 33° in the following second. The roll continued increasing bank until the MA impacted the ground. The main causes of the rolling moment were as follows:

- The fuselage blocked some of the airflow over the right (downwind) wing during the side slip and reduced the lift produced by this wing. The MA was equipped with a center line tank and longer canopy as it was a two-seat model (F-16D). Both factors additively contributed to the airflow blockage as mentioned above.
