UNITED STATES AIR FORCE
AIRCRAFT ACCIDENT INVESTIGATION
BOARD REPORT

MQ-1B, T/N 07-3249
49th WING
HOLLOMAN AIR FORCE BASE, NEW MEXICO

LOCATION: REPUBLIC OF DJIBOUTI
DATE OF ACCIDENT: 17 MAY 2011
BOARD PRESIDENT: LIEUTENANT COLONEL THOMAS E. HAZLEBECK
Conducted IAW Air Force Instruction 51-503
Abbreviated Accident Investigation pursuant to Chapter 11

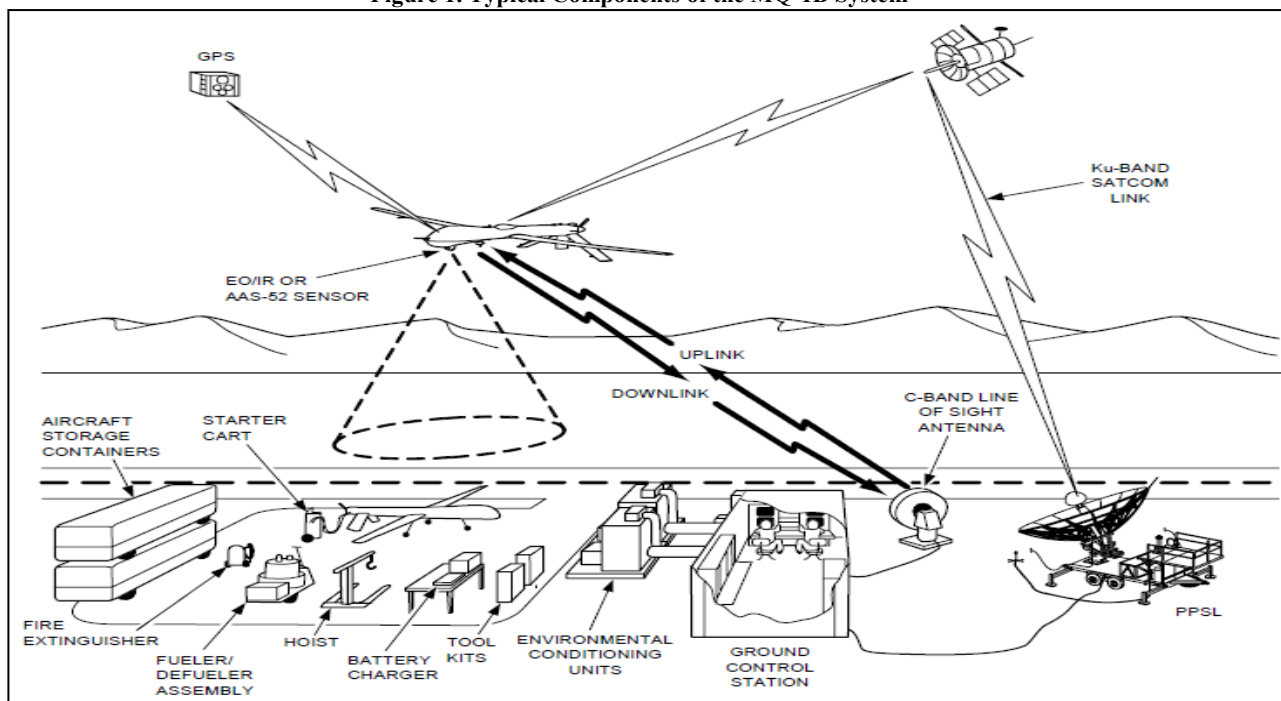
Figure 1. Typical Components of the MQ-1B System

The MQ-1B Predator is a medium- altitude, long-endurance, unmanned aircraft system with primary missions of close air support, air interdiction, and ISR. It acts as a Joint Forces Air Component Commander-owned theater asset for reconnaissance, surveillance and target acquisition in support of the Joint Forces Commander. The MQ-1B is actually a system, not just an aircraft, which consists of four aircraft (with sensors and weapons), a GCS, a Predator Primary Satellite Link (PPSL), and spare equipment along with operations and maintenance crews for deployed 24-hour operations. The entire system is deployable worldwide for operations and can be transported on almost any Air Force cargo aircraft. (Tab DD-3, DD-4)
