**UNITED STATES AIR FORCE**  
**ABBREVIATED ACCIDENT INVESTIGATION**  
**BOARD REPORT**

**MQ-1B, T/N 07-3204**

**20th Reconnaissance Squadron  
432d Air Expeditionary Wing  
Whiteman Air Force Base, Missouri**

**MQ-1B, T/N 07-3204  
Jalalabad Air Base, Afghanistan  
5 June 2011**

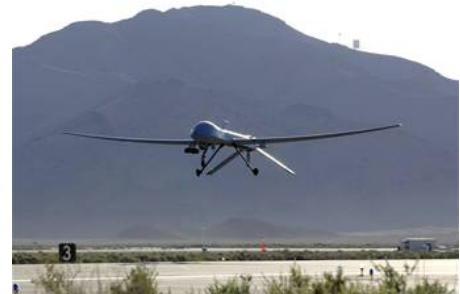
The operational system consists of four aircraft (with sensors and weapons), a GCS, a Predator Primary Satellite Link (PPSL), and spare equipment along with operations and maintenance crews for deployed 24 hour operations. A basic Predator crew consists of a rated pilot and a sensor operator. They fly the MQ-1B Predator from inside the GCS via a line-of-sight (LOS) radio data link and via a satellite data link for beyond LOS flight. A ground data terminal antenna provides LOS communications for takeoff and landing while the PPSL provides beyond LOS communications during the remainder of the mission. (Tab DD-11)

The MQ-1B is equipped with a color nose camera (generally used by the pilot for flight control), a day variable-aperture television camera, a variable aperture infrared camera (for low light/night), and other sensors as required. The cameras produce full-motion video. The MQ-1B Predator also carries the Multi-Spectral Targeting system which integrates electro-optical infrared, laser designator and laser illuminator into a single sensor package. The aircraft can carry up to two laser-guided Hellfire missiles. The MRPA carried one such missile at the time the GCS lost the data link. (Tabs DD-12 and P-2)
