**UNITED STATES AIR FORCE**  
**ABBREVIATED AIRCRAFT ACCIDENT INVESTIGATION**  
**BOARD REPORT**

**MQ-1B, T/N 07-003190**

**18th Reconnaissance Squadron/3rd Special Operations Squadron  
432nd Air Expeditionary Wing/27th Special Operations Wing  
Creech Air Force Base, Nevada/Cannon Air Force Base, New Mexico**

**LOCATION: Afghanistan**  
**DATE OF ACCIDENT: 14 February 2012**  
**BOARD PRESIDENT: Lt Col Cade R. Sonnichsen**

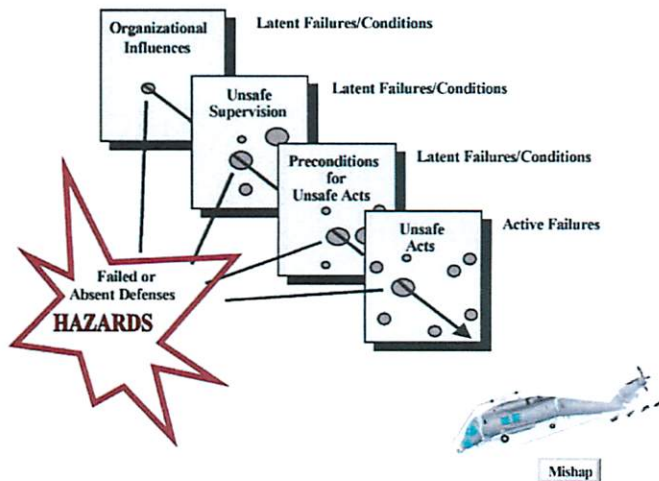
A DoD taxonomy was developed to identify hazards and risks, called the DoD Human Factors Analysis and Classification System (DOD-HFACS), referenced in Attachment 1 of AFI 91-204, *Safety Investigations and Reports*, 24 Sept 2008. DOD-HFACS describes four main tiers of failures/conditions: 1) Acts, 2) Preconditions, 3) Supervision, and 4) Organizational Influences.

The investigation process endeavors to detect and identify failed or absent defenses (hazards), which can be visually depicted by the "Swiss Cheese" model (adapted from Reason, 1990), as seen below:
