**UNITED STATES AIR FORCE**  
**ABBREVIATED AIRCRAFT**  
**ACCIDENT INVESTIGATION**  
**BOARD REPORT**

**MQ-1B, T/N 06-3164**

**196TH RECONNAISSANCE SQUADRON**  
**432D WING**  
**CREECH AIR FORCE BASE, NEVADA**

**DATE OF ACCIDENT: 1 MARCH 2015**

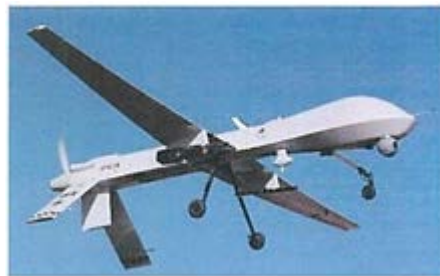
#### **g. MQ-1B, Predator**

The MQ-1B Predator is an armed, multi-mission, medium-altitude, long-endurance RPA employed primarily as an intelligence-collection asset and secondarily against dynamic execution targets. Given its significant loiter time, wide-range sensors, multi-mode communications suite and precision weapons, the Predator provides a unique capability to perform strike, coordination and reconnaissance missions against high-value, fleeting and time-sensitive targets. Predators can also perform the following missions and tasks: ISR, close air support, combat search and rescue, precision strike, buddy-lase, convoy/raid overwatch, route clearance, target development and terminal air guidance. The MQ-1B's capabilities make it uniquely qualified to conduct irregular warfare operations in support of combatant commander objectives. The MQ-1B Predator system consists of an aircraft (with sensors), a ground control station (GCS), a Predator Primary Satellite Link (PPSL), and operations and maintenance personnel for deployed 24-hour operations. The basic crew for the MQ-1B Predator is one pilot and one sensor operator. The crew flies the MQ-1B Predator from inside the GCS via a line of sight (LOS) radio data link and via a satellite data link for beyond-LOS flight. A ground data terminal antenna provides LOS communications for takeoff and landing, while the PPSL provides beyond-LOS communications during the remainder of the mission (Tab CC-17 to CC-22).
