UNITED STATES AIR FORCE
ABBREVIATED AIRCRAFT
ACCIDENT INVESTIGATION
BOARD REPORT

MQ-1B, T/N 99-3057
432D WING
CREECH AIR FORCE BASE, NEVADA

DATE OF ACCIDENT: 25 JUNE 2014

SUMMARY OF FACTS AND STATEMENT OF OPINION
MQ-1B, T/N 99-3057
25 June 2014

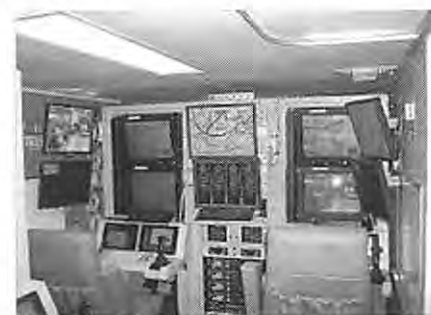
The basic crew for the Predator is a rated pilot to control the aircraft and command the mission, and an enlisted aircrew member to operate sensors and weapons as well as a mission coordinator, when required (Tab CC-20). The crew employs the aircraft from inside the ground control station (GCS) via a line-of-sight data link or a satellite data link for beyond line-of-sight operations (Tab CC-20).

Figure 1. Inside the GCS

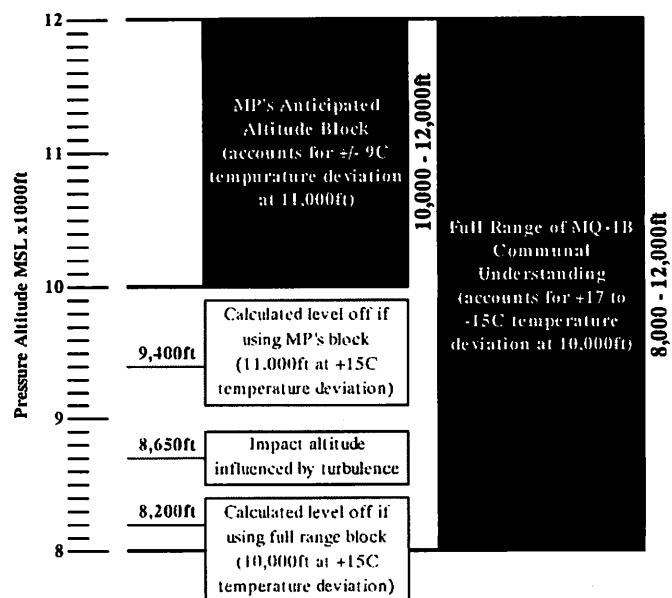
AFH 11-203, Volume 1, section 4.8 and 4.9 describe the difference between PA and DA. PA is based on a standard day atmosphere of 15 degrees Celsius (C) at sea level with a lapse rate of approximately -2C per 1,000ft above sea level. Standard atmosphere conditions rarely occur. DA adjusts pressure altitude for non-standard temperatures by using observed outside air temperature (OAT). If OAT is warmer than standard atmosphere temperature, DA will be higher than PA, generally resulting in poorer aircraft performance. T.O. 1Q-1(M)B-1-1 contains a DA chart in Figure A1-5 (Tab BB-5).

The MP's anticipated recovery altitude range was 10,000-12,000ft MSL, the top half of the full range of communal understanding (8,000-12,000ft MSL) (Tabs R-7, R-8, V-3). Using Figure A1-5, this altitude range incorporates a +/- 9C temperature deviation at 11,000ft MSL (Tab BB-5). At the onset of the turbocharger failure at 19,000ft MSL, OAT was -8C, a +15C temperature deviation from standard atmosphere (Tabs BB-5, DD-19). Figure A1-5 can be used to adjust the anticipated altitude range for DA by assuming a standard lapse rate resulting in a +15C temperature deviation at 11,000ft MSL (Tabs V-3, BB-5). This produces an anticipated level off altitude of 9,400ft MSL (Tab BB-5). Before encountering the worst of the downdrafts, this is approximately where the MRPA leveled off (Tabs R-7, R-9, R-85).

The full altitude range of communal understanding incorporates a +17 to -15C temperature deviation at 10,000ft MSL (Tab BB-5). Using the same method, a 10,000ft altitude adjusted for +15C temperature deviation produces an expected level off altitude of 8,200ft MSL (Tabs BB-5, DD-19). Influenced by turbulence, the MRPA impacted terrain at 8,650ft MSL (Tab S-2). In this case, the full range or lower variations of the communal understanding covered the effects of a higher DA (Tabs BB-5, DD-19). Though available to crews, using Figure A1-5 in the MQ-1B Performance Data to adjust communal understanding

OAT at impact was 22C, a +24C temperature deviation, making DA approximately 11,400ft MSL (Tabs BB-5, DD-19). This temperature deviation was higher than could have been anticipated given OAT at 19,000ft MSL, yet the MRPA was performing well enough to remain within the parameters of the full altitude range of communal understanding (Tabs R-7, S-2, BB-5, DD-19).
