UNITED STATES AIR FORCE
ABBREVIATED AIRCRAFT
ACCIDENT INVESTIGATION
BOARD REPORT

MQ-1B, T/N 07-3197

18TH RECONNAISSANCE SQUADRON
432D WING
CREECH AIR FORCE BASE, NEVADA

DATE OF ACCIDENT: 24 SEPTEMBER 2015

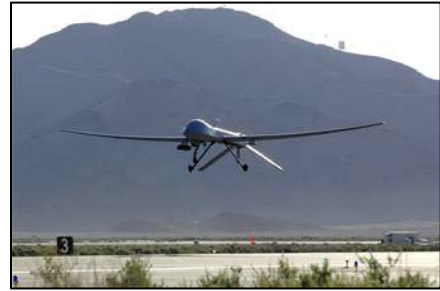
The MQ-1B Predator is an armed, multi-mission, medium-altitude, long-endurance remotely piloted aircraft that is employed primarily as an intelligence-collection asset and secondarily against dynamic execution targets. Given its significant loiter time, wide-range sensors, multi-mode communications suite, and precision weapons, it provides a unique capability to perform strike, coordination and reconnaissance (SCAR) against high-value, fleeting, and

time-sensitive targets. Predators can also perform the following missions and tasks: intelligence, surveillance, reconnaissance, close air support, combat search and rescue, precision strike, buddy-lase, convoy/raid overwatch, route clearance, target development, and terminal air guidance. The MQ-1's capabilities make it uniquely qualified to conduct irregular warfare operations in support of combatant commander objectives. (Tab CC-13)
