UNITED STATES AIR FORCE
ABBREVIATED AIRCRAFT
ACCIDENT INVESTIGATION
BOARD REPORT

MQ-1B PREDATOR, T/N 05-3136
20TH ATTACK SQUADRON
432D WING
CREECH AIR FORCE BASE, NEVADA

SUMMARY OF FACTS AND STATEMENT OF OPINION
MQ-1B Predator, T/N 05-3136
17 October 2015

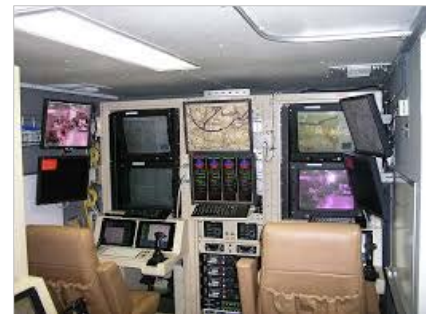
The aircraft is employed from a ground control station (GCS) via a line-of-sight data link or a satellite data link for beyond line-of-sight operations (Tab CC-17). The basic crew for the Predator is a rated pilot to control the aircraft and command the mission and an enlisted aircrew member to operate sensors and weapons inside the GCS. In the Squadron Operations Center (SOC), a mission commander (MCC) provides supervision for daily missions and multiple mission intelligence coordinators (MIC) update intelligence and target information (Tab V-4.1).

Figure 1. Inside the GCS
