**UNITED STATES AIR FORCE**  
**ABBREVIATED AIRCRAFT**  
**ACCIDENT INVESTIGATION**  
**BOARD REPORT**

**MQ-1B, T/N 06-3178**

**LOCATION: FORWARD OPERATING BASE (FOB),**  
**AFGHANISTAN**

**DATE OF ACCIDENT: 20 AUGUST 2011**

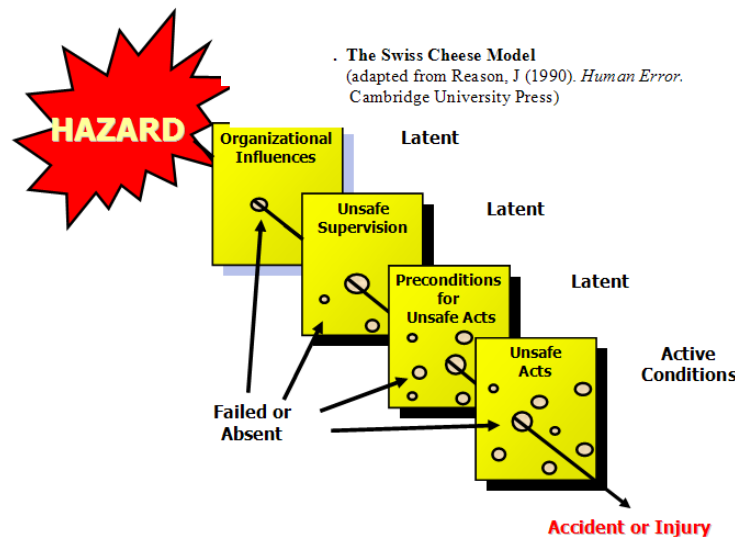
A DoD taxonomy was developed to identify hazards and risks, called DoD Human Factors Analysis and Classification System (DoD-HFACS), referenced in Attachment 5 of AFI 91-204, *Safety Investigations and Reports*, 24 Sept 08. DoD-HFACS describes four main tiers of human factors: 1) Acts; 2) Preconditions; 3) Supervision; and 4) Organizational Influences (AFI 91-204, attach 5).

**Acts** are those factors that are most closely tied to the mishap, and can be described as active failures or actions committed by the operator that result in human error or unsafe situation (AFI 91-204, attach 5).

**Preconditions** are factors in a mishap if active and/or latent preconditions such as conditions of the operators, environmental or personnel factors affect practices, conditions or actions of individuals and result in human error or an unsafe situation (AFI 91-204, attach 5).
